**Countries:** CANADA, UNITED STATES **Document ID:** IK0800559  
**Availability:** ISIS, FleetISIS, IsSIR **Revision:** 0  
**Major System:** ELECTRICAL SYSTEM **Created:** 12/15/2017  
**Current Language:** English **Last Modified:** 12/15/2017  
**Other Languages:** NONE **Author:** Charles Schroeder  
**Viewed:** 126

**Title:** LT Base Cluster Warning Lights - Battery Light when using Cruise Control

**Applies To:** LT with Base Cluster built between May and November 2017

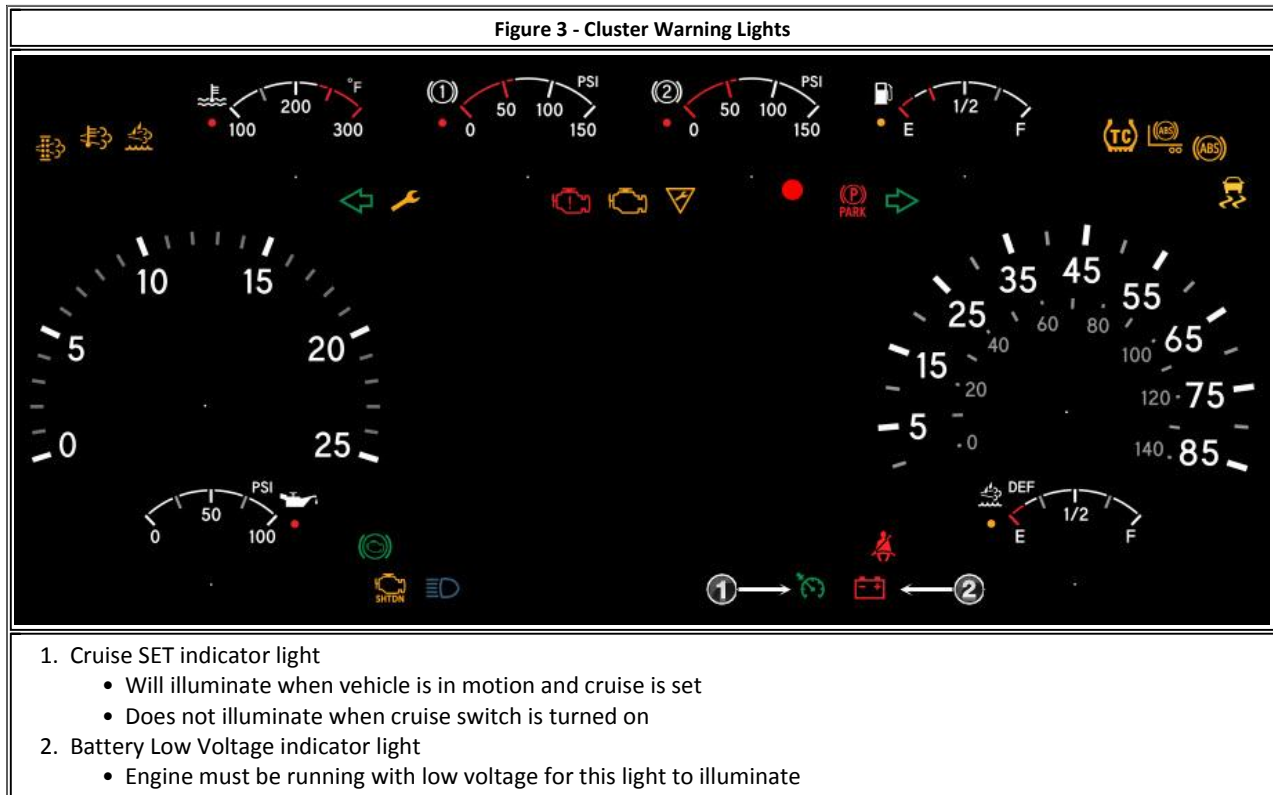
- The complaint of battery light turning on while using cruise control will only occur if the cluster was updated to 40300 using DLB software version older than 15601
- 40300 is the correct kernel that should be applied to base clusters

1. Once connected the vehicle with DLB software version 15601 or higher, DLB will automatically detect cluster hardware type, and correct the internal software bit to the cluster (It does not affect the cluster kernel)
2. Verify cluster kernel is at 40300
3. Vehicle will need to be driven to verify only the cruise light illuminates during cruise control operation
