Technical Service Bulletin

91 MMI connect smartphone app warning messages do not refresh information or remote lock and unlock fails

91 17 15 2044853/2 March 14, 2017. Supersedes Technical Service Bulletin Group 91 number 16-66 dated August 12, 2016 for reasons listed below.

Model(s)	Year	VIN Range	Vehicle-Specific Equipment
A4	2016 -2017	All	With Audi connect
Q7	2017	All	With Audi connect

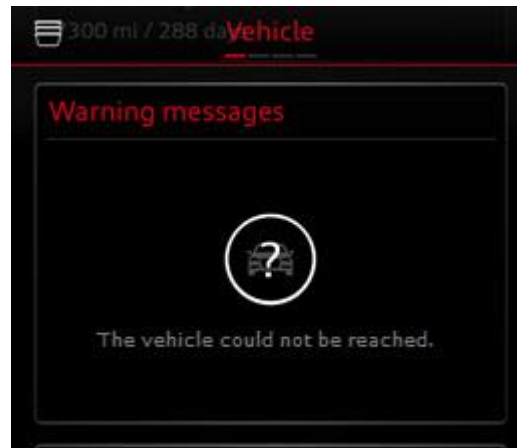
- The function "Warning messages" does not provide new data when the user manually attempts to refresh the data. An error message stating "The vehicle cannot be reached" can be seen in the app and the myAudi web site (Figure 1).
- The vehicle cannot be locked or unlocked with the app, and an error message stating "A technical error occurred" is displayed (Figure 2).

Figure 1. Warning messages cannot be refreshed.

The software in the connected data bus on board diagnostic interface (J533) (address word 0019), needs to be updated to optimize functionality.

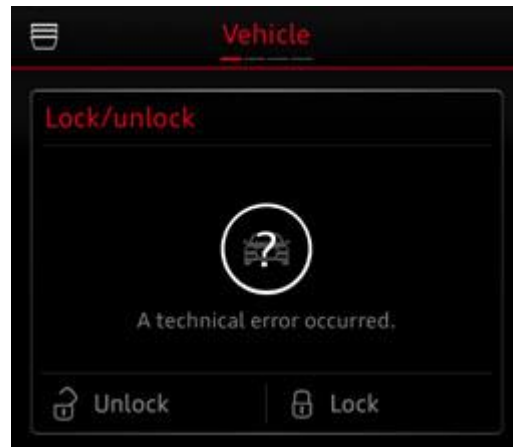
Figure 2. Lock/unlock error.

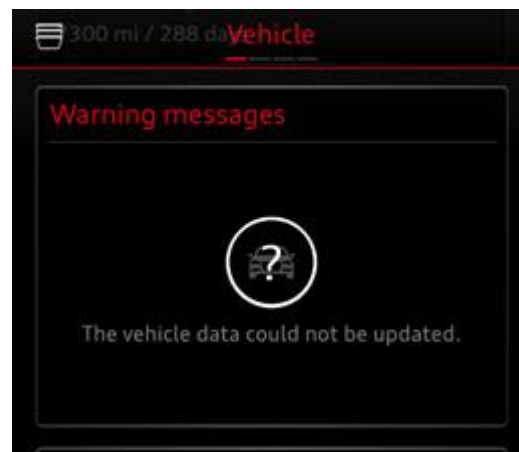
Tip: Not all errors in the MMI connect app indicate a problem. For example, the message “The vehicle data could not be updated” is displayed when the engine is on or when the vehicle is being driven, as data is not refreshed under these conditions (Figure 3).

Figure 3. Normal condition warning message.

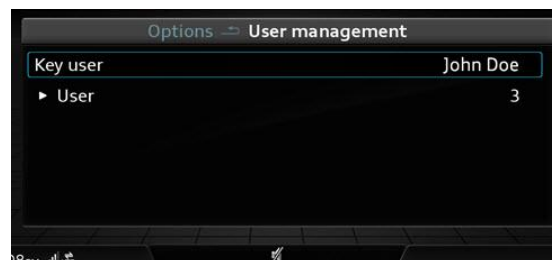
Figure 4. Key User assigned with three secondary users.
