Title: Workstar ISL Transmission Cooler Line Routing

Applies To: Workstar ISL Built Prior to November 29, 2017

DESCRIPTION

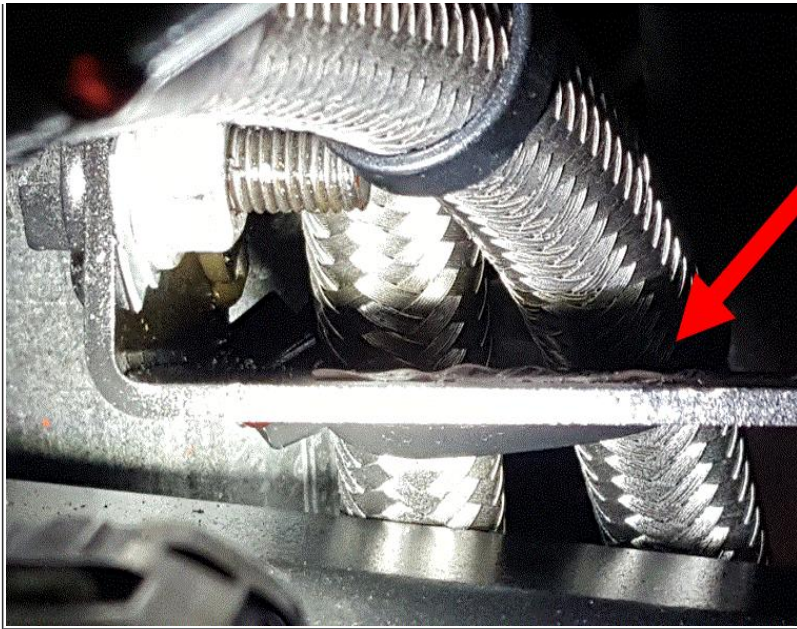
This document will guide the user through rerouting the Transmission Cooler Line when rubbing the bracket, reference Figure 1.

Figure 1: Trans Cooler Line rubbing bracket

Customer Observations or Concerns: Transmission cooler lines rubbing bracket in the engine compartment.

1. Park the vehicle on a level surface, set parking brake, and chock wheels.
2. Locate front engine mount cross member.
3. Inspect hoses for damage and replace if damaged.
4. Install two clamps 32107 on the front engine mount cross member to separate and secure the hoses. Tighten clamp.

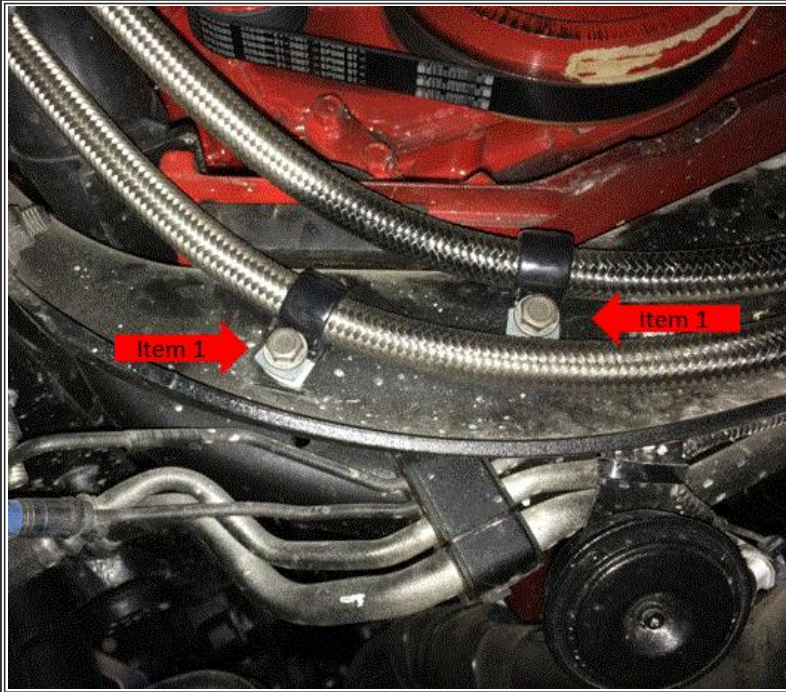
Figure 2: Crossmember and Clamps

Item 1: Clamp 32107 (two)

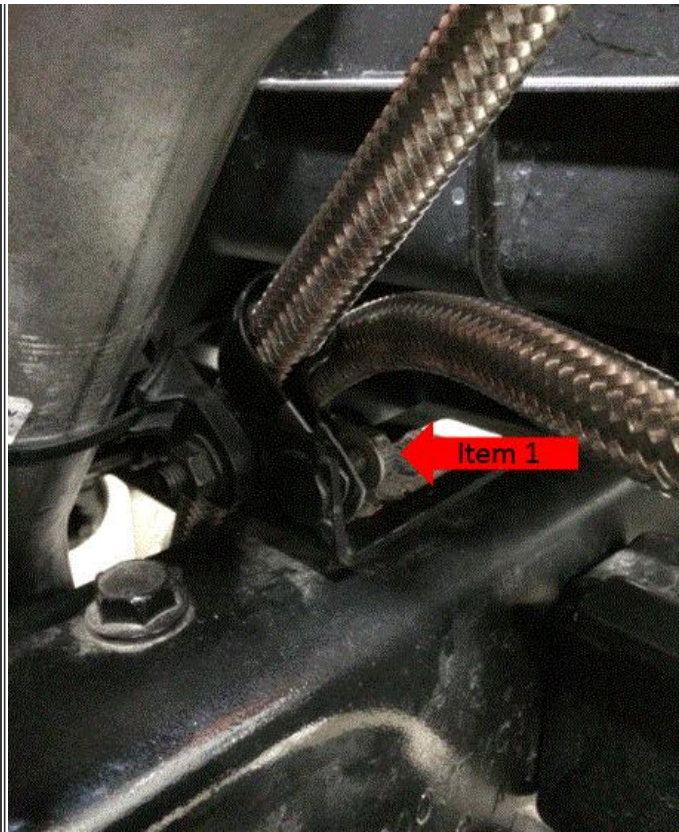
Figure 3: Bracket and Clamp

Item 1: Clamp 32108 (one)

5. Locate the transmission cooler line bracket. Install clamp 32108 on the transmission cooler line bracket. Tighten clamp.
