Countries: CANADA, UNITED STATES Document ID: IK1900253
 Availability: ISIS, FleetSIS, IsSIR Revision: 2
 Major System: ACCESSORIES Created: 11/10/2017
 Current Language: English Last Modified: 12/14/2017
 Other Languages: NONE Author: Charles Schroeder
 Viewed: 259

Title: A/C Condensers for LT and RH Part Number Update

Applies To: LT and RH

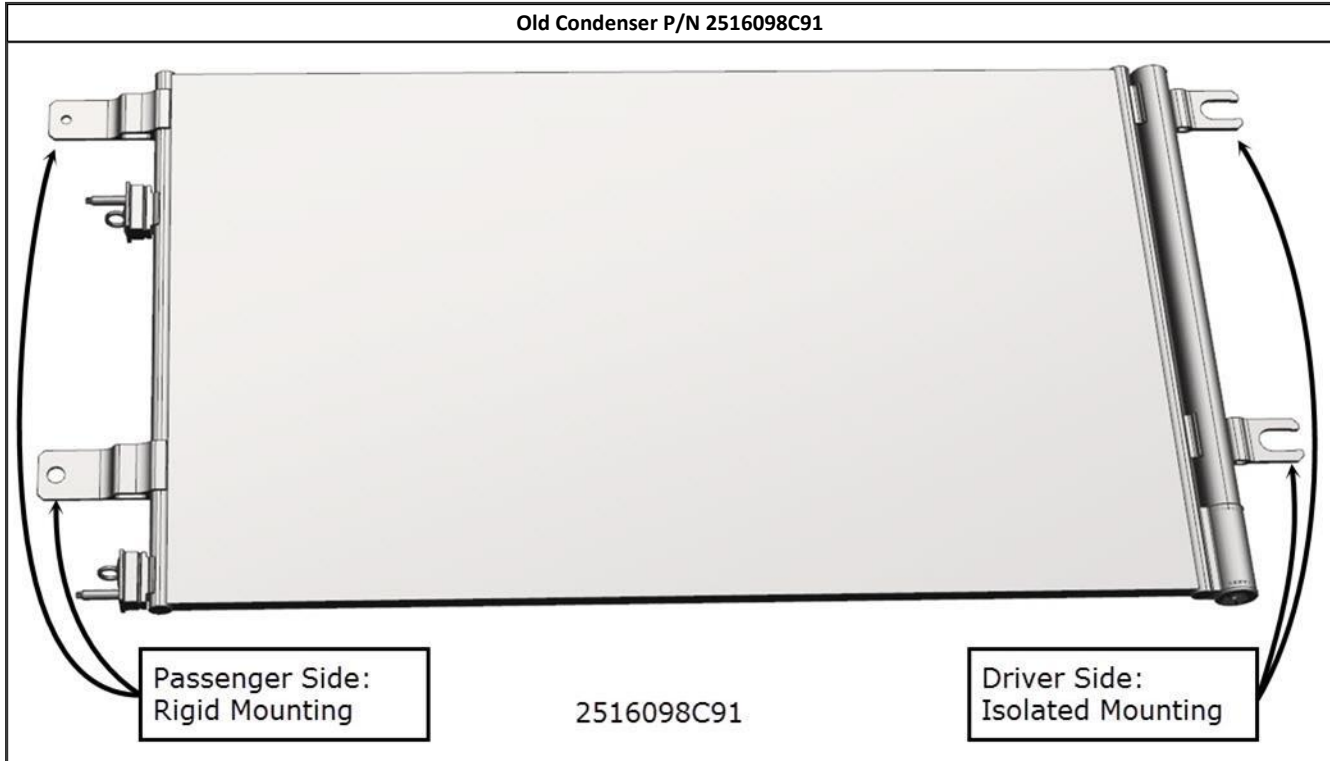
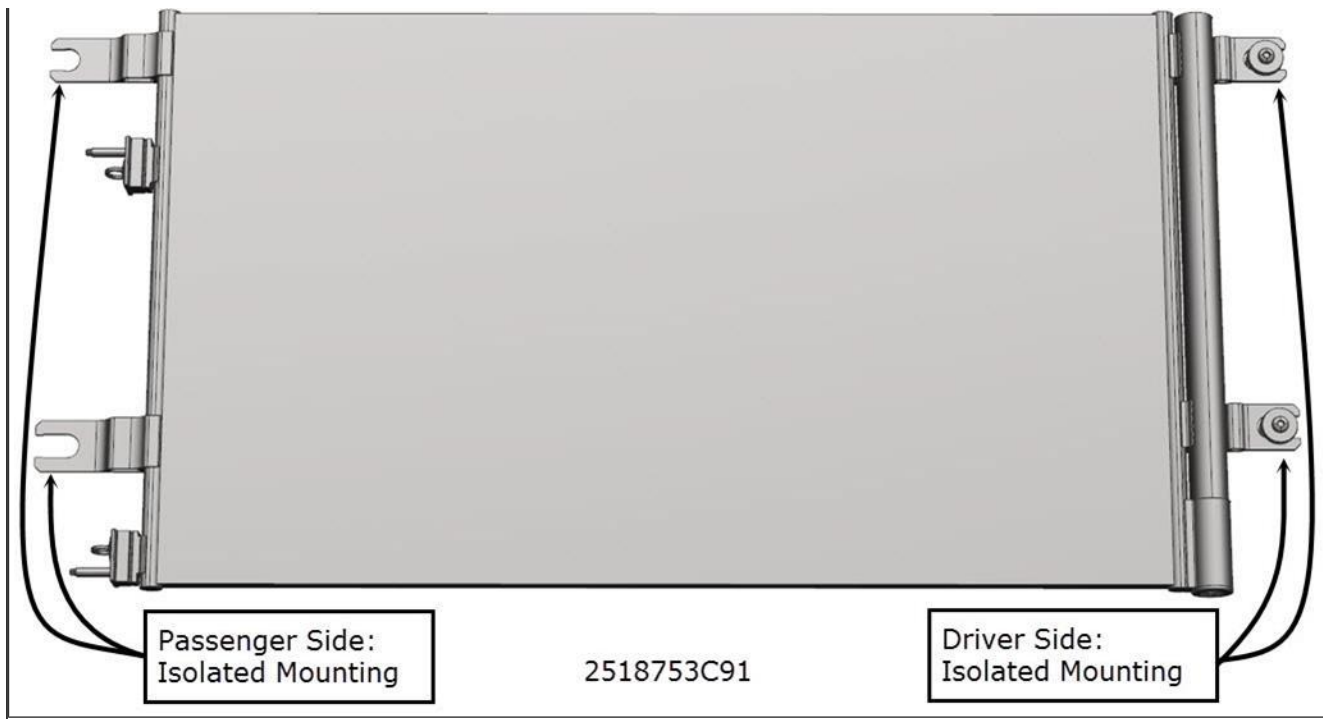
- A/C Inoperative due to refrigerant leaking from A/C Condenser

Condenser P/N 2516098C91 has been replaced with P/N 2518753C91, see images below:

*4 isolators will come with the new condenser

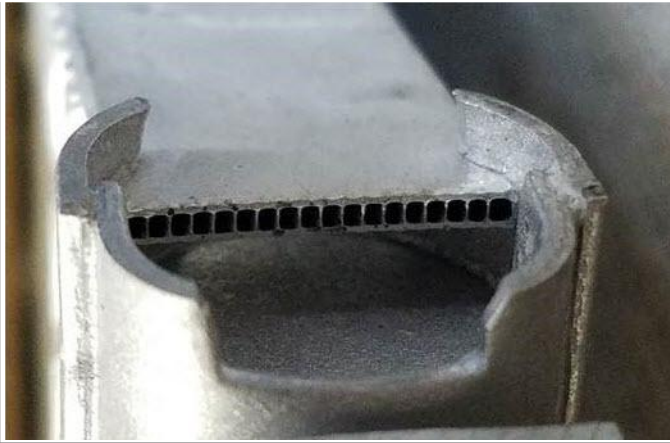
Original Condenser - 18 Microchannels

- A small number of production vehicles had 4 isolators with the 18 Microchannel design (Built between 10/17/2017 and 11/08/2017)
- 4 Isolators with 18 Microchannels was never available as a service part
