Countries: CANADA, UNITED STATES, MEXICO **Document ID:** IK0900121
Availability: ISIS, NotSIR **Revision:** 0
Major System: COOLING **Created:** 7/18/2017
Current Language: English **Last Modified:** 7/19/2017
Other Languages: NONE **Author:** Jon Pierce
Viewed: 50

Title: HVAC line rub

Applies To: Workstars with Cummins B series engines and stationary grille feature code 009HBM

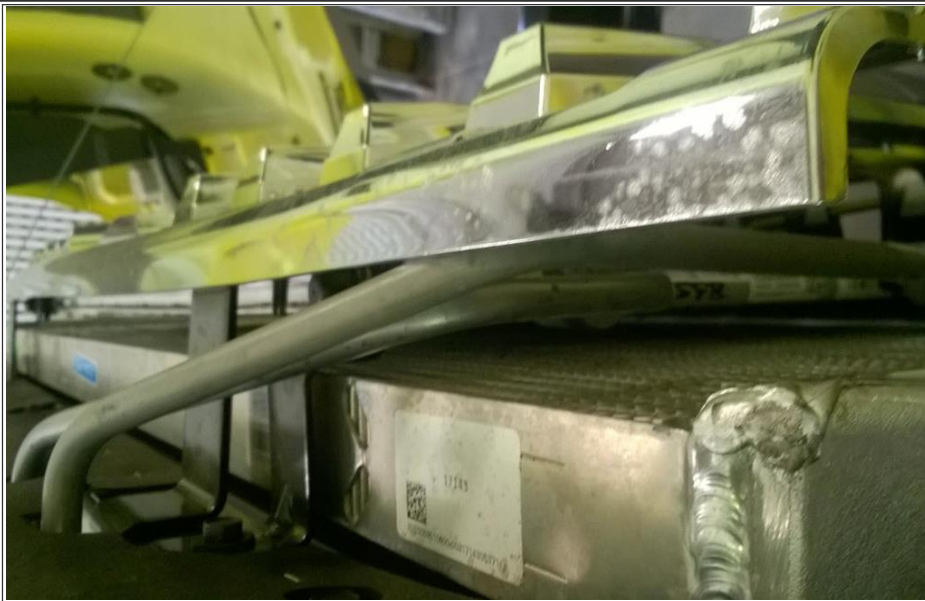
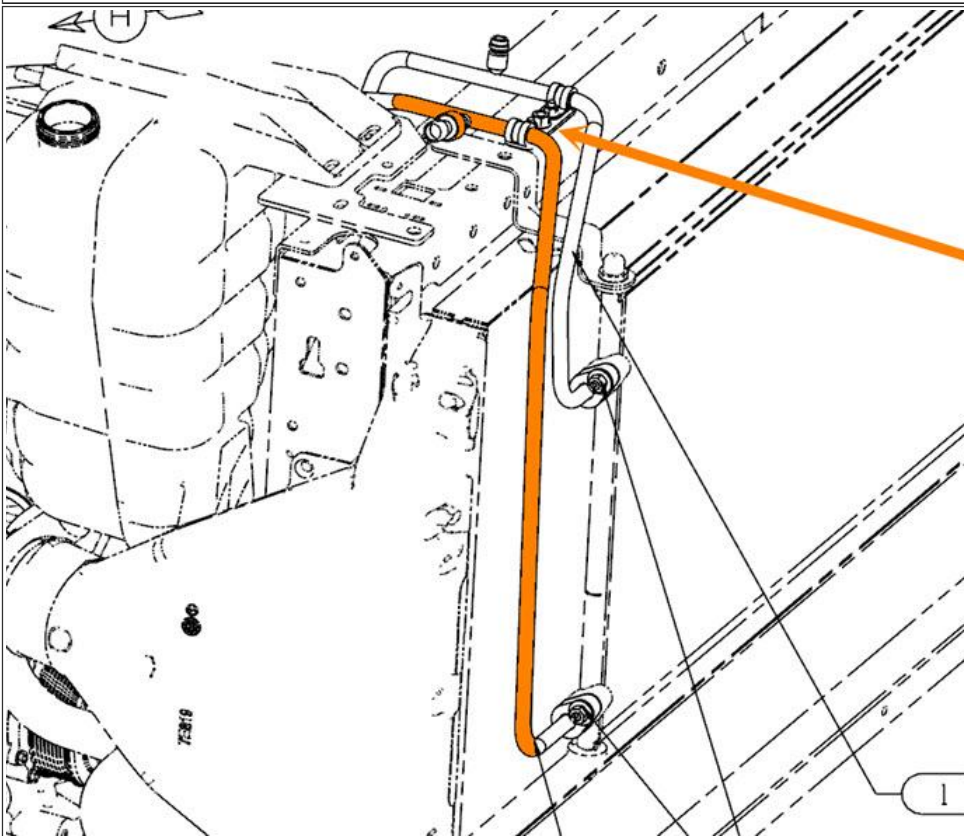
1. Hard contact between the grill and HVAC line.
2. When the hood is lowered the grille may not line up evenly with the hood shroud.
3. Grille damage

Typical rub point when grille is inset too far

1. Install spacers on bolts that attach the grille to the upper mount.
2. Obtain locally longer bolts if needed to accommodate the spacers.
3. Align the mount tabs with the lower mount bracket and lower the grille into place.
4. Align the holes and install screws in the grille and mount brackets. Torque 8 to 10 N•m ((71 to 89 lb-in).
5. Verify hard contact no longer exists and the grille assembly lines up with the grille shroud and does not protrude out past the shroud.
