Document ID: IK1200061

Title: Low Coolant Light with International I6 EGR and MaxxForce® DT,9 and 10

Applies To: I6 EGR (2004 EPA), 2007 EPA, 2010 EPA, 2013 EPA MaxxForce® DT,9 and 10 Engines

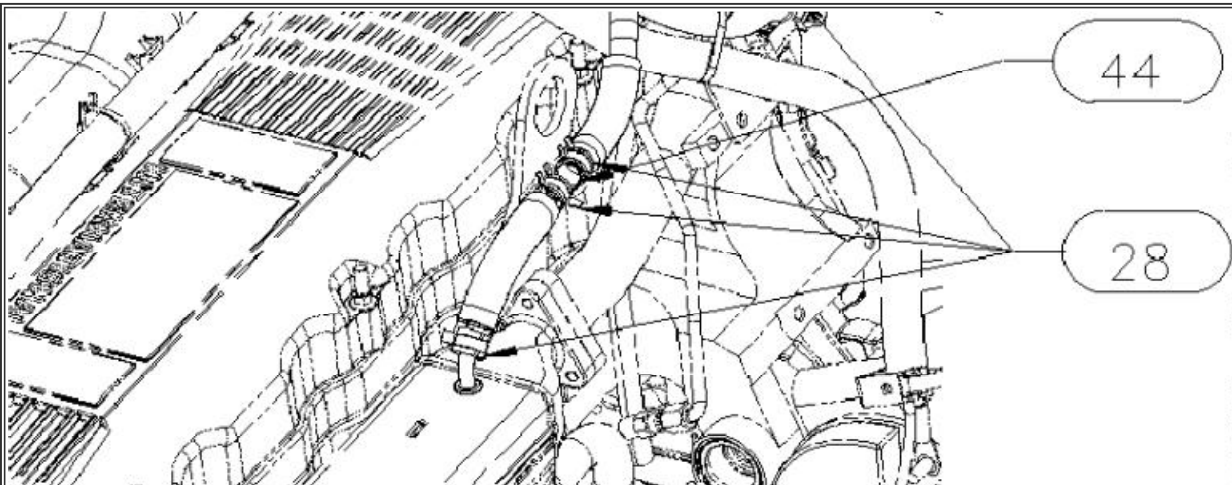
Figure 2: Restrictor Location

This document will guide the user on what to do if you are experiencing low coolant faults with a DT 466 EGR and MaxxForce® DT,9 or 10 engine when coolant level is correct.

Item 28: Hose Clamps
Item 44: Restrictor

5. Cut the EGR return line to the deaeration tank within 5 inches or 120 mm of the EGR cooler fitting and insert the restriction assembly. Use hose clamps to secure the hose to the fitting barbs.

6. Verify that the coolant level is above the second sight glass and that the problem has been corrected.
