FIELD SERVICE CAMPAIGN – 17113

Retaining Nut – Turbo Oil Supply Line

International® WorkStar®

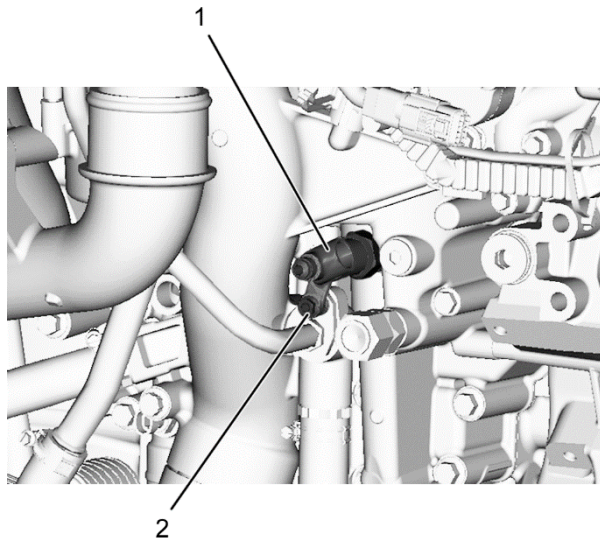
Figure 1. Turbocharger Oil Supply Line Retainer

On certain N13 equipped International® WorkStar® vehicles, the retaining nut securing the turbocharger oil supply line may not be tightened to its specified torque.

1. Oil supply T-fitting
2. M6 retaining nut

6. Using a torque wrench, tighten nut (Figure 1, Item 2) on T-fitting (Figure 1, Item 1) to 10 lb-ft (13 N•m).
7. Inspect area around oil supply line for presence of oil seepage. If oil seepage is present, clean affected area.
8. Close and latch hood.
9. Remove wheel chocks.
