Title: 2609-19 HVAC fault with 4th Gen BCM

Applies To: Post 2007 with BCM logging 2609-19

This document will guide the user through resolving 2609-19 HVAC fault on post 2007 units with BCM

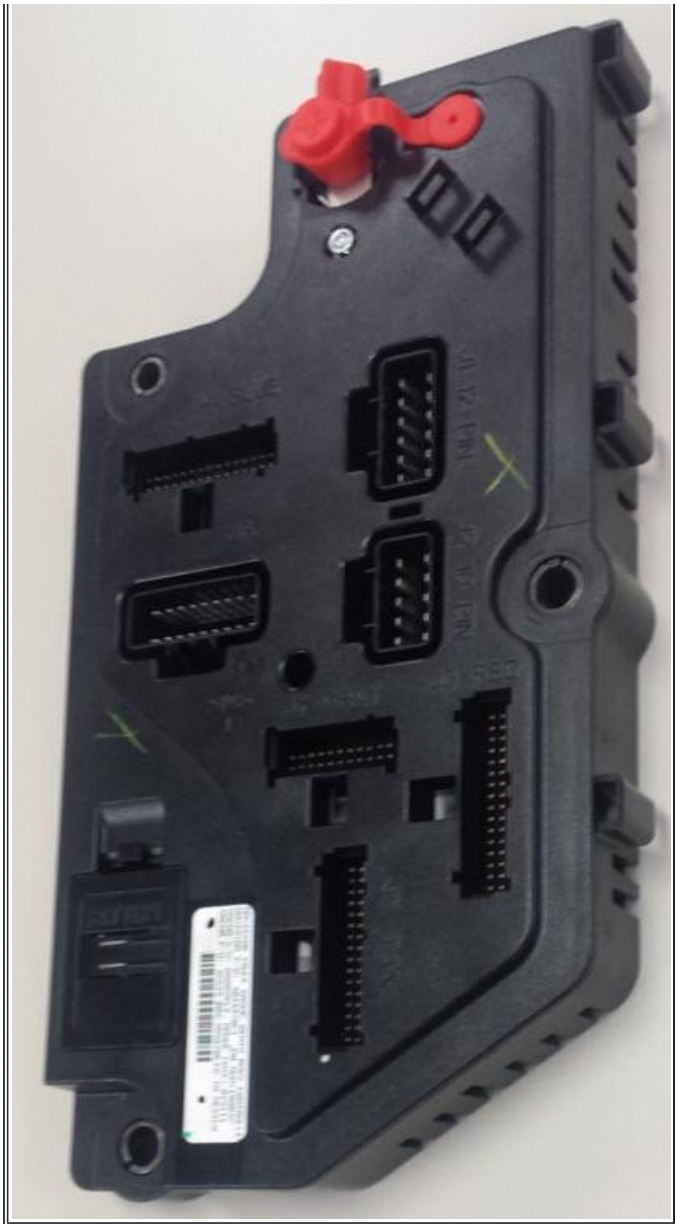
Figure 2 - GEN 4 BCM

Inoperative HVAC (Setting 2609-19) with recent BCM replacement.

Step	Action	Decision
#2	DIAGNOSTIC: Does this have a GEN 4 (all plastic) BCM installed? (Refer to Figure 2)	Yes: Continue to step 3
		No: Article does not apply

Step	Action	Decision
#3	DIAGNOSTIC: Install Gen 2 Reman BCM	retest for 2609-19
