**Document ID:** IK1600233  
**Revision:** 0  
**Created:** 9/21/2017  
**Last Modified:** 9/21/2017  
**Author:** Jon Pierce

**Title:** LT Cab Lean Concern

**Applies To:** all models

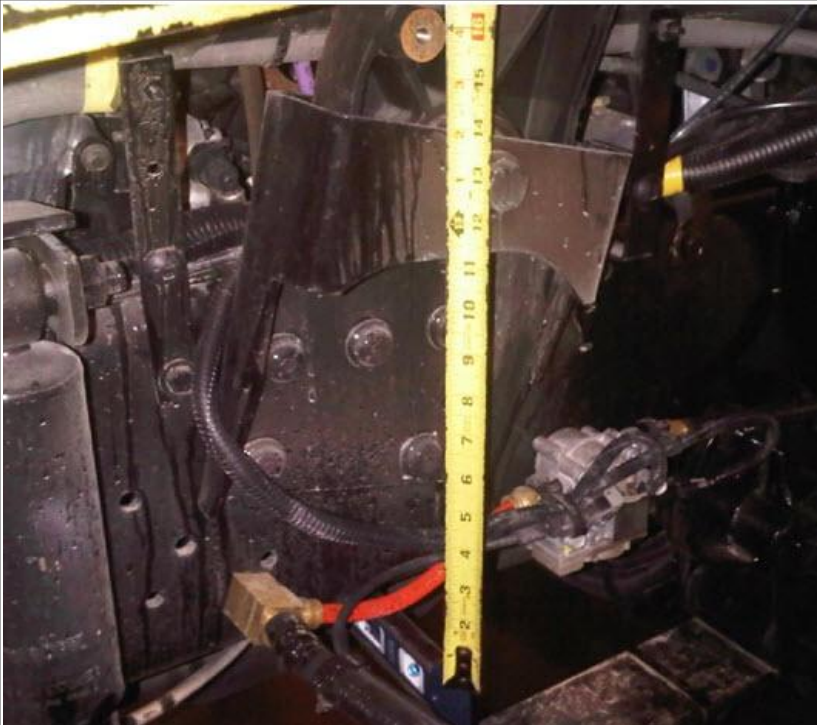
| | Description | Process |
|---|---|---|
| Step<br>2 | | <ol style="list-style-type: none"> <li>1. Park vehicle on a level surface.</li> <li>2. Hold a level to the bottom of the frame rail directly under the cab front isolator and center the level's bubble. Refer to picture – ProStar shown in the example.</li> <li>3. Measure the distance from the level to the center of the cab front isolator bolt. Note the inner front fender may need to be removed for access on some vehicles.</li> </ol> <p>Repeat the procedure on the opposite side of the vehicle.</p> <p>If a lean is confirmed via measurements, please proceed to the repair process.</p> |

1. The front cab mounts are adjustable and no longer hucked together (Prostar cab mount used for demonstration purposes).
2. With the fenders still removed, safely place 2 bottle jacks under the to secure the cab in place.
3. Loosen all 8 cab mounting bolts.
4. Lower the side that has the higher initial measurement and snug the mounting bolts down.
5. Raise the side that had the initial low measurement and snug the bolts down.
6. Replace bolts and nuts as needed. See parts information for the correct bolt and nut part numbers.
7. If the lean condition looks satisfactory torque all cab mount bolts 195 - 240 lb/ft (265 - 325 Nm)
