**Title:** SCR Vehicles Setting DEF Quality Faults due to Crossed DEF Tank Coolant Lines or Inverted DEFTHV

**Applies To:** All SCR Vehicles

This document will guide the user through determining the cause of fault code 3363-16 (FC1713) on vehicles equipped with SCR. BEFORE replacing any components, verify the DEF tank coolant lines are properly routed and the Diesel Exhaust Fluid Tank Heater Valve (DEFTHV) is facing the proper direction according to the procedure below.

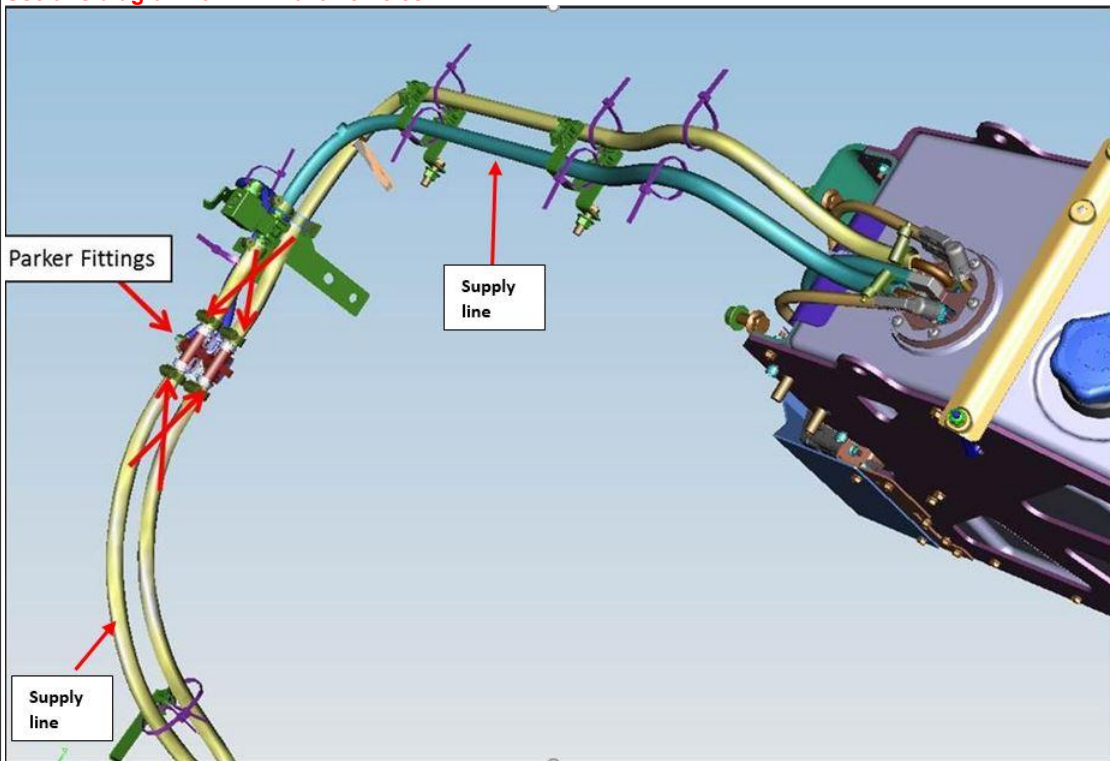
| Step | Action | Decision |
|---|---|---|
| 1 | <p><b>DIAGNOSTIC:</b> Locate supply line. The DEFTHV should be installed on the DEF tank coolant <b>supply</b> line. Verify the lines are not crossed as shown in Figure 1 or Figure 2 below.</p> <p><b>Use this diagram for EPA 2013 vehicles:</b></p> <p><b>Figure 1:</b> DEF Tank Coolant Lines possibly Crossed at the Parker Fittings for EPA 2013 vehicles</p> <p><b>Use this diagram for EPA 2017 vehicles:</b></p> | <p><b>Yes:</b> Go to 5</p> <p><b>No:</b> Remove coolant lines fittings and/c properly Ret (FC1713)</p> <p><b>NOTE:</b> Hose used to clear coolant doe</p> |

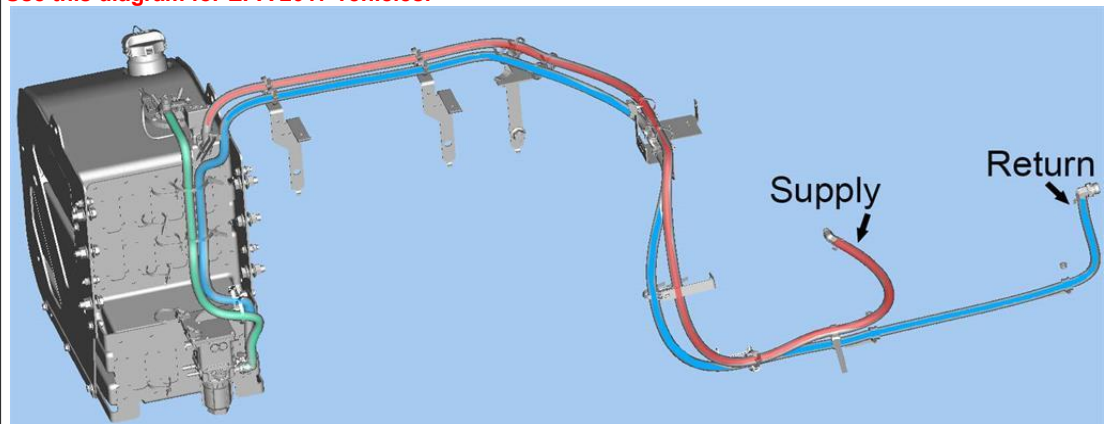
**Figure 2:** DEF Tank Coolant Line orientation for EPA 2017 vehicles

Are the DEF tank coolant lines routed properly (not crossed)?

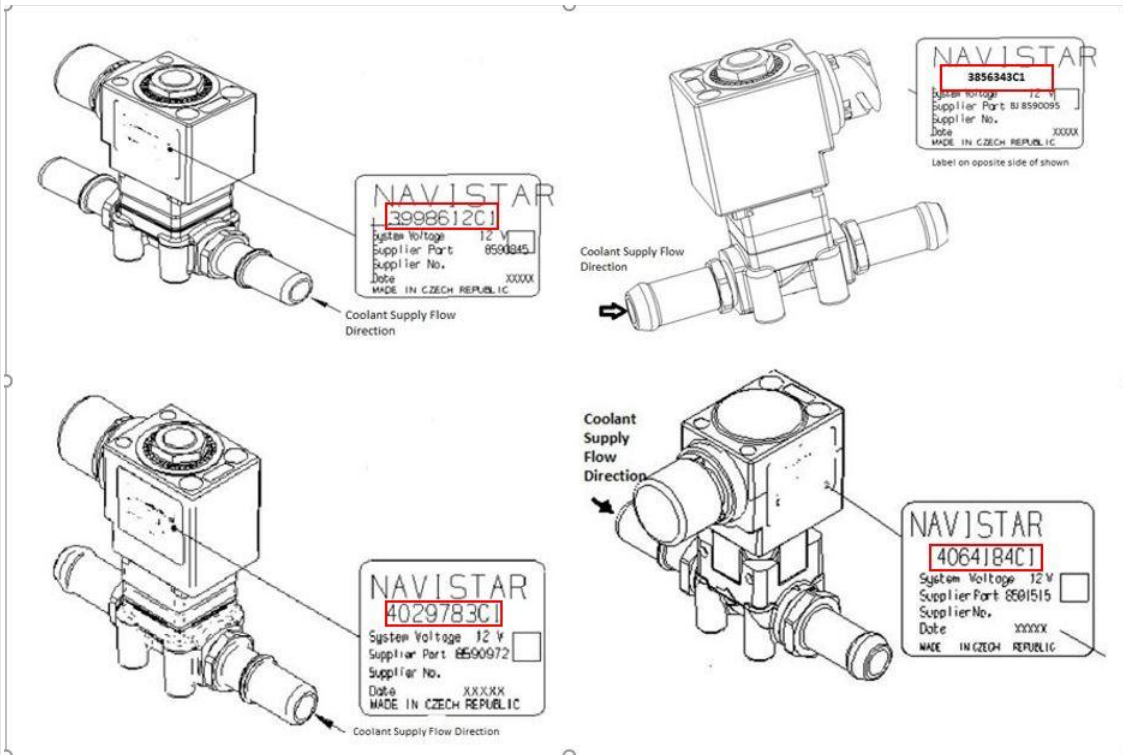
| Step | Action | Decision |
|---|---|---|
| 2 | <p><b>DIAGNOSTIC:</b> Verify the DEFTHV is facing the correct direction on the vehicle. Locate DEFTHV part number(In red box), see Figure 2 below. Correct direction of supply coolant flow is towards the DEF tank.</p> <p><b>NOTE:</b> Electrical connectors of valve may face multiple directions.</p> <p><b>Figure 3:</b> DEFTHV Direction</p> <p>Is the DEFTHV facing the proper direction on the vehicle?</p> | <p><b>Yes:</b> Go to 5</p> <p>If diagnosing than 3363-11 associated F</p> <p><b>No:</b> Reorien direction, cle</p> |

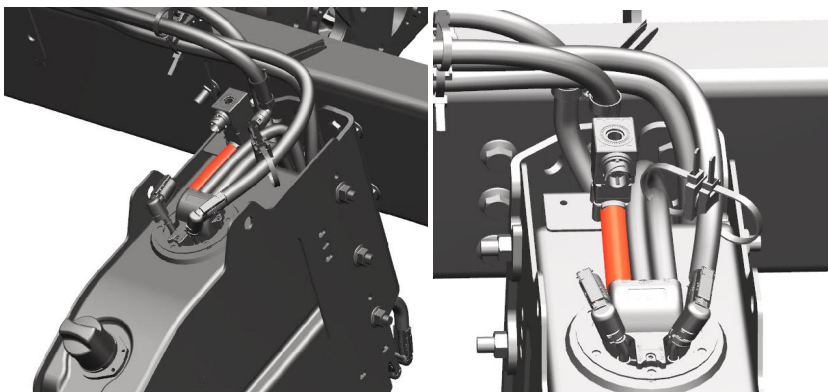
**Figure 4:** DEF Sending Unit Line

With the line disconnected, only residual coolant should exit the line. Allow 2 minutes for residual coolant to exit. If a constant, steady stream is passing through the valve, the valve is stuck open.

After 2 minutes with the coolant line disconnected, is there a constant, steady stream of coolant exiting the supply line?

| Step | Action | Decision |
|---|---|---|
| 3 | <p><b>DIAGNOSTIC:</b> Detecting stuck DEF tank heater valve.</p> <p>The DEF tank heater valve is a normally closed valve. At key off, the valve should be in the closed position. Clamp off the return line so coolant cannot flow backwards through the tank. Disconnect the DEF tank coolant supply line from the DEF sending unit (see supply line location in Figure 4 below).</p> | <p><b>Yes:</b> Replac</p> <p><b>No:</b> Retest f other fault cc see associat</p> |
