Title: LT Ultrashift 1321-14 Missing Wire for Crank Signal Feedback

Applies To: LT Ultrashift

This document will guide the user through adding circuit AF17C to address the 1321-14 fault setting in the Eaton Automated Transmission Module. Source Address 3.

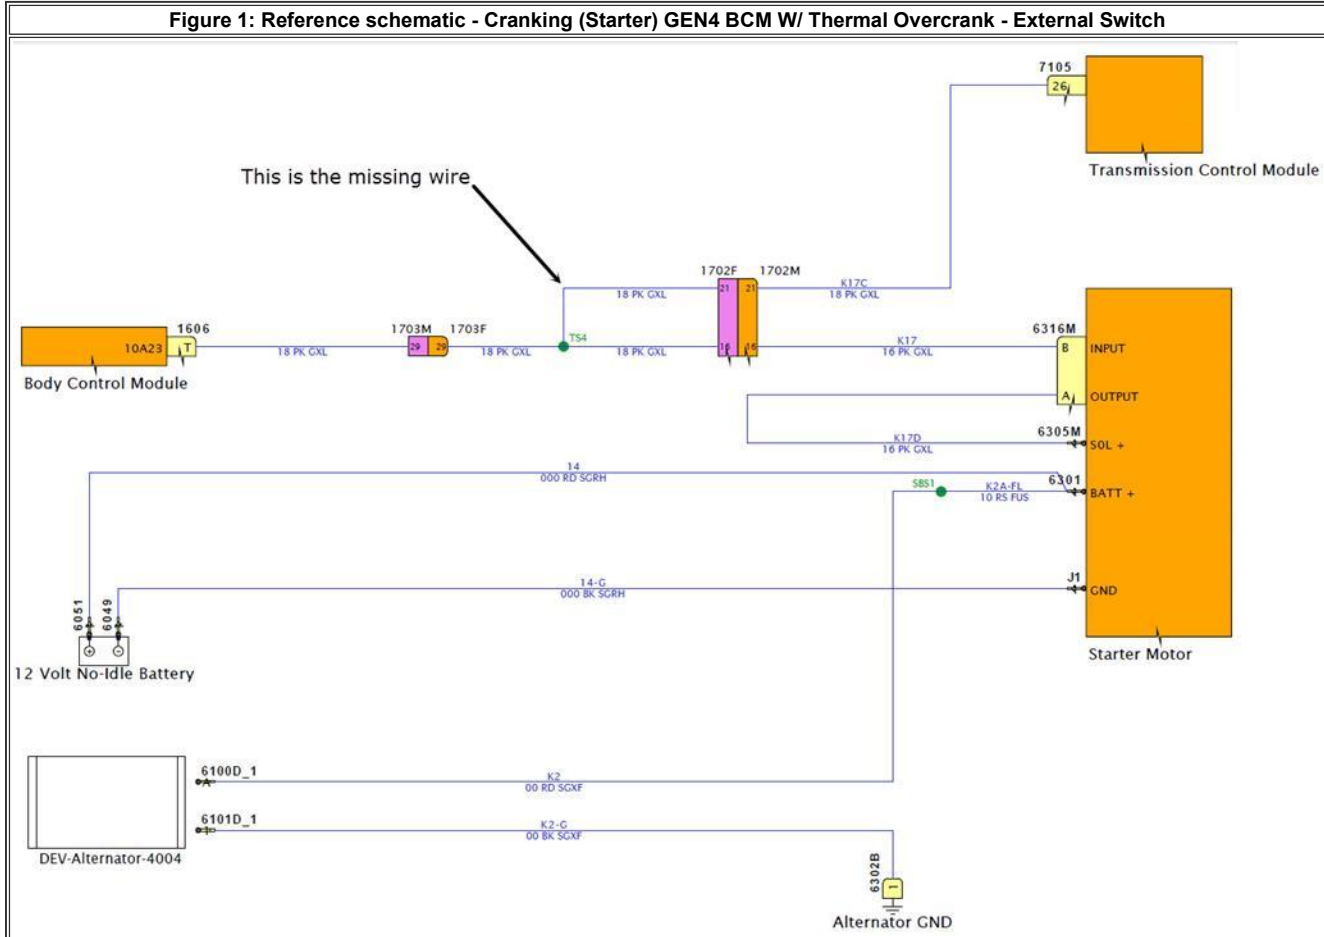
Refer to Figure 1. On IP Harness, use 18 gauge wiring to splice into the wire that is going to 1702-16 and add wire 1702-21. Connector 1702 is a 42 pin connector and it is mounted near the wiper bracket in the engine compartment.

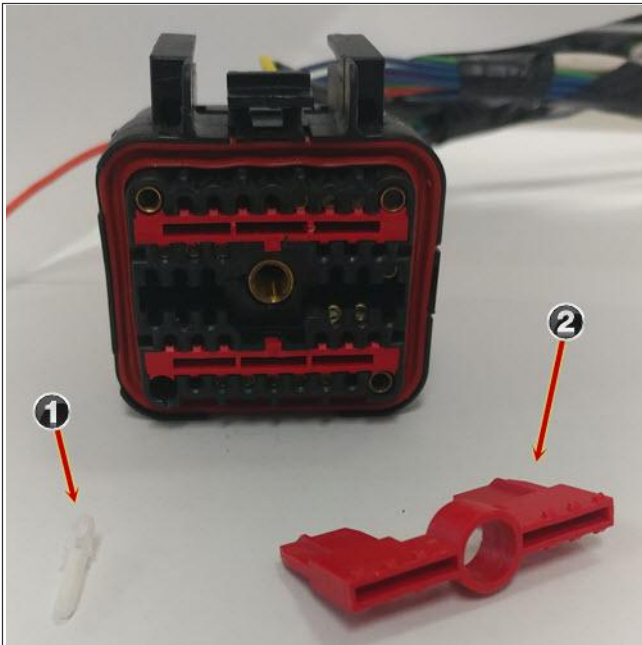
Figure 4: Terminal Plug and Body Lock Removed

1. Terminal Plug removed from Location 21
2. Body Lock removed so the new terminal can be installed
 - A pick can be used under the center of the Body Lock to pry upward to remove

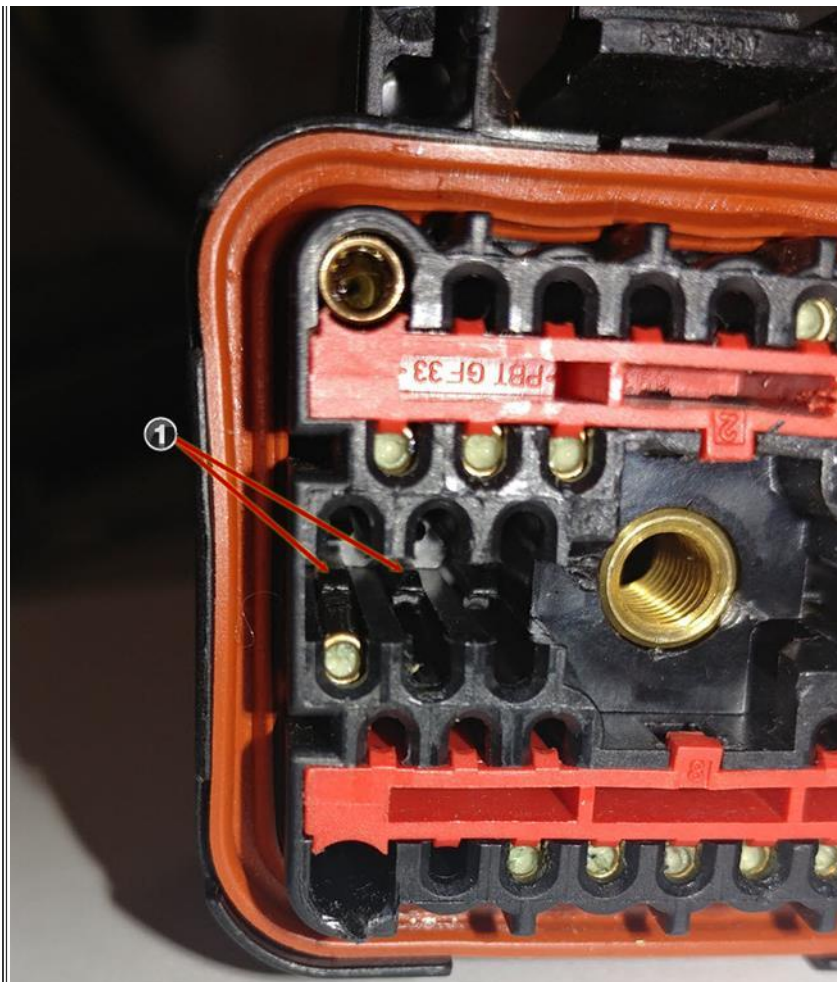
Figure 5: Locking tabs inside connector body

1. Locking tab for the terminal. When inserting the terminal from the rear of the connector you must push forward until an audible click is heard. The click indicates the terminal is fully seated and locked. You should not be able to pull the terminal back out of the connector.

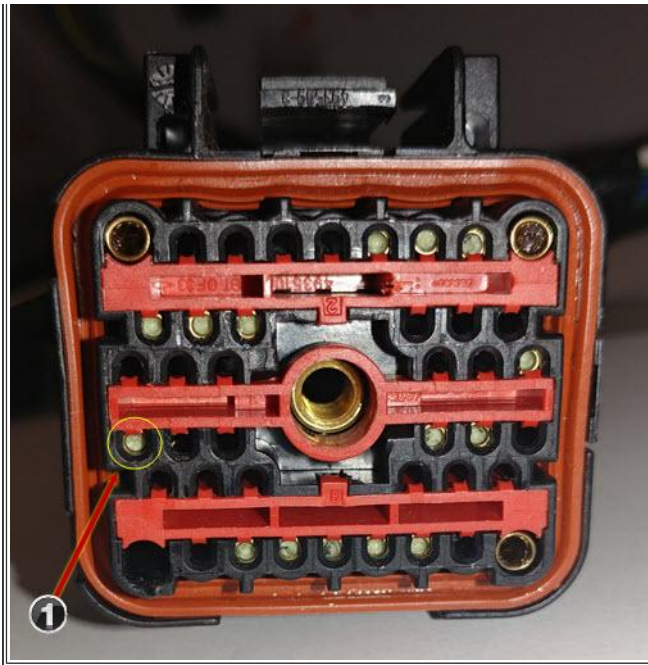
Figure 6: Terminal installation complete

1. Terminal fully installed, body lock had been re-installed
