Title: LT and RH Auxiliary Switch Not Working 08XBN

Applies To: LT RH

This document will guide the user through the repair when the auxiliary switch does not function for feature 08XBN because the relay is missing.

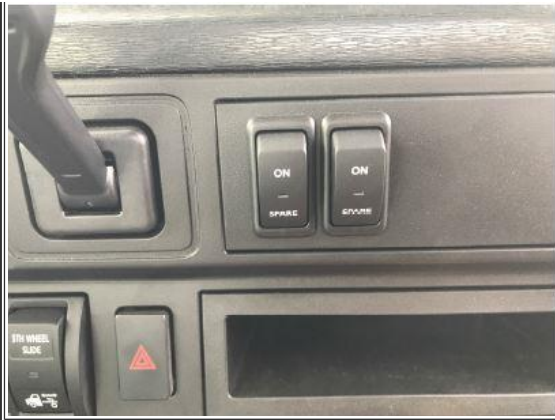
Figure 1: Switches, including Auxiliary Switch

Customer Observations or Concerns: Auxiliary switch does not function. Reference Figure. 1
