| <b>Countries:</b> | CANADA, UNITED STATES, MEXICO | <b>Document ID:</b> | IK1201398 |

**Title:** IC Bus with ISB Frequent Regeneration**Applies To:** IC Bus ISB

This document will guide the user through resolving Frequent Regen issues on IC Bus with ISB 6.7.

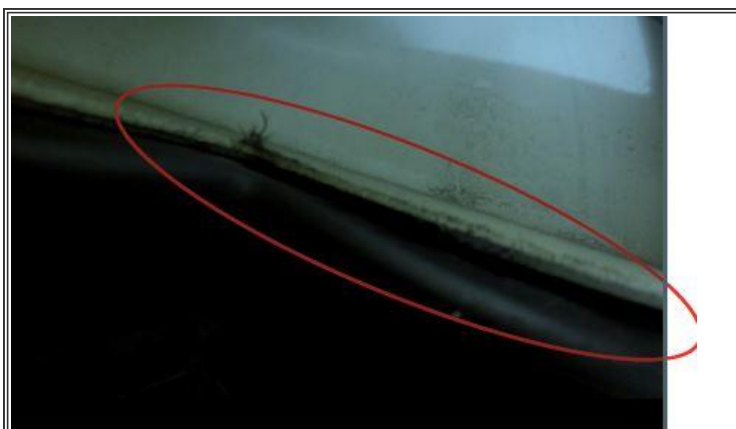
1. Airbox boot seal to the hood compromised. Middle section may appear bent or folded in. The seal position looks off-centered from the hood.

**Figure 1: Gap between Boot seal and Hood**

| Step | Action | Decision |
|---|---|---|
| 3 | <b>DIAGNOSTIC:</b><br><br>With the hood in the fully latched position, inspect the accordion boot seal to hood.<br>See Figure 1 and 2<br><br>Is a gap present between the seal and hood? | <b>Yes.</b><br>Replace the cover assembly. |

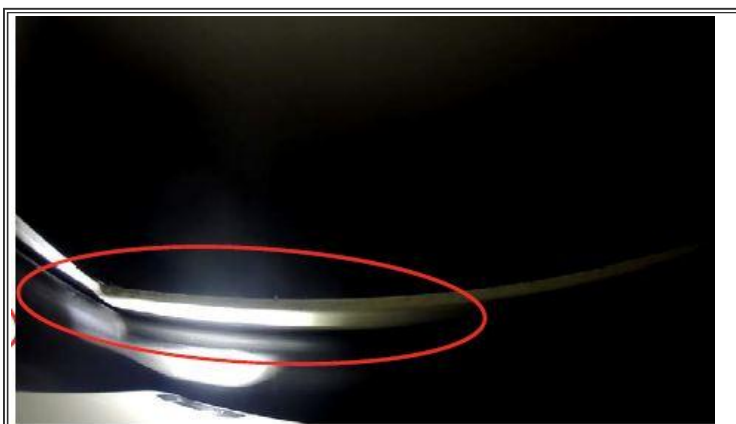
**Figure 2: Hood misaligned with respect to Boot seal**
