| <b>Countries:</b> | CANADA, UNITED STATES, MEXICO | <b>Document ID:</b> | IK1400036 |
| <b>Major System:</b> | REAR AXLE | <b>Created:</b> | 10/4/2017 |

**Title: Power Divider Leaking at Axle Housing**
**Applies To: LT with Meritor Drive Axles**

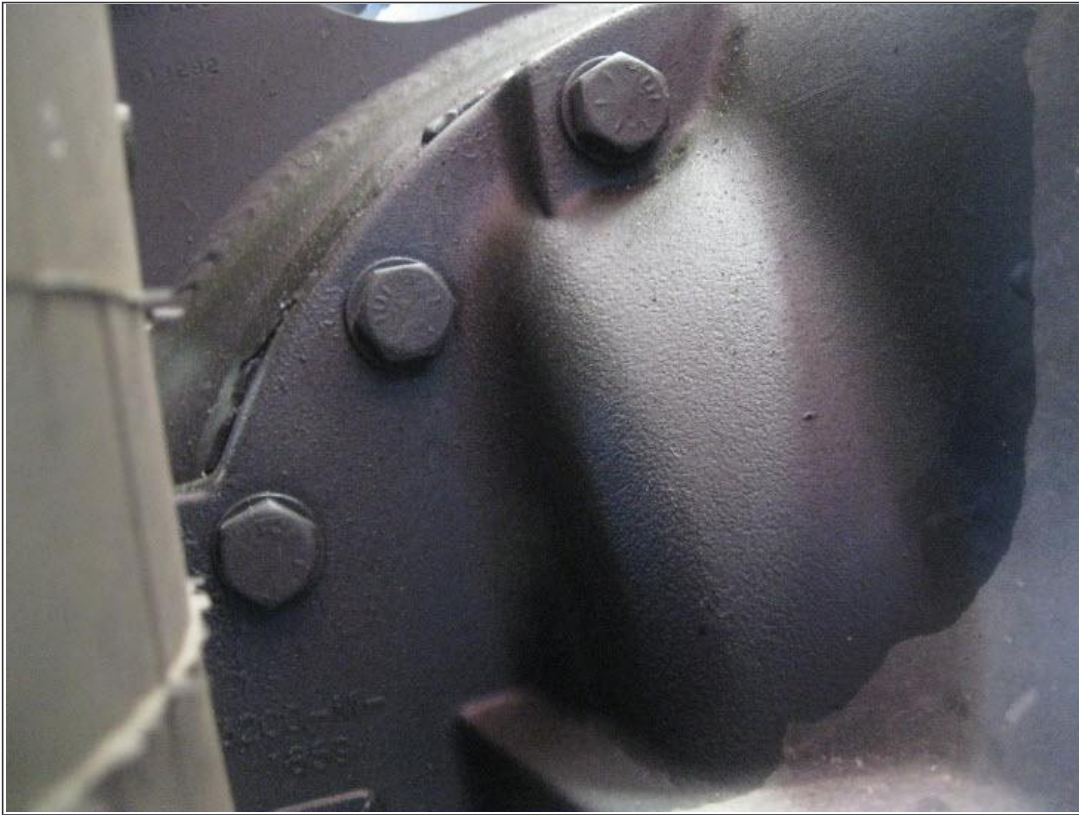
**Figure 1:**

Fluid leaking at the Power Divider (Front Drive Axle) Housing

| Step | Action | Decision |
|---|---|---|
| 1 | <b>DIAGNOSTIC:</b><br>Is the front drive axle leaking from the carrier to housing joint?<br>(Refer to Figure 1 below) | <b>Yes.</b> Refer to repair instructions below |

1. Bring vehicle into shop and park on a flat surface
2. Shift transmission into park or neutral, set parking brake, and install wheel chocks
3. Refer to Meritor [TP-0753](#) for repair instructions
4. Once complete remove wheel chocks
