| <b>Countries:</b> | CANADA, UNITED STATES, MEXICO | <b>Document ID:</b> | IK1600234 |

**Title:** LT Hood Crack by Grille

**Applies To:** LT

This document will guide the user through procedure to address hood with cracks on the inside of the hood by grille.

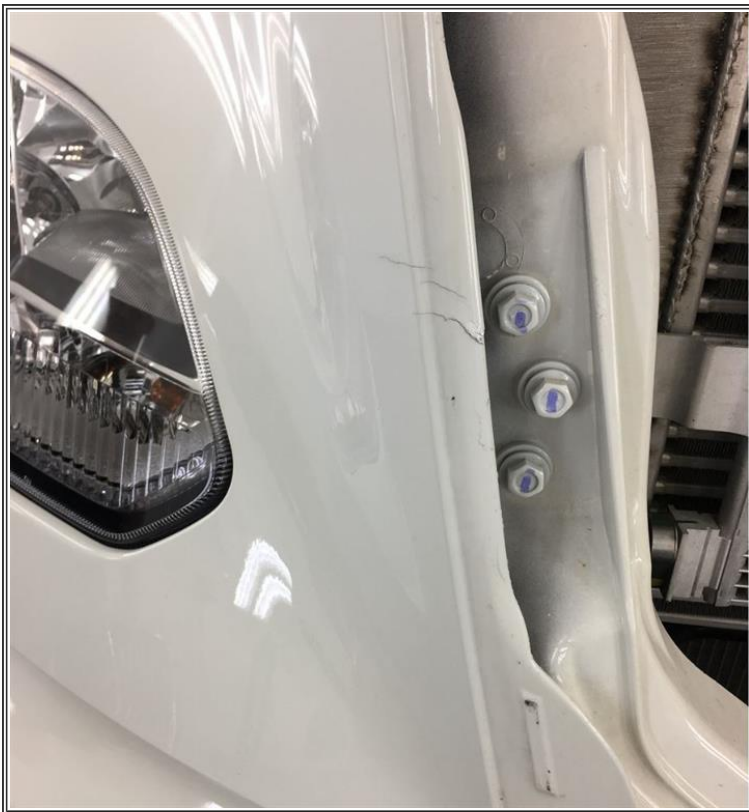
**Figure 1: Hood Crack**

Hood is cracked on the inside of the hood near the grille.

**DO NOT ATTEMPT TO FIX THE CRACK.**

1. Open iApprove following steps outlined in [IK2800048 iApprove Paint/Body Photograph Requirements](#)
2. Photograph the crack (Figure 1) and the hood manufacturing decal (Figure 2), which is located on the underside of the hood and attach to the iApprove.
3. Replace the hood
4. Wait for next steps from Tech Services.
