**Title:** DM harness inspection

**Applies To:** 0005710 STRG COL, TILT & TELE

iKnow for inspecting DM harness for damage, and correct routing

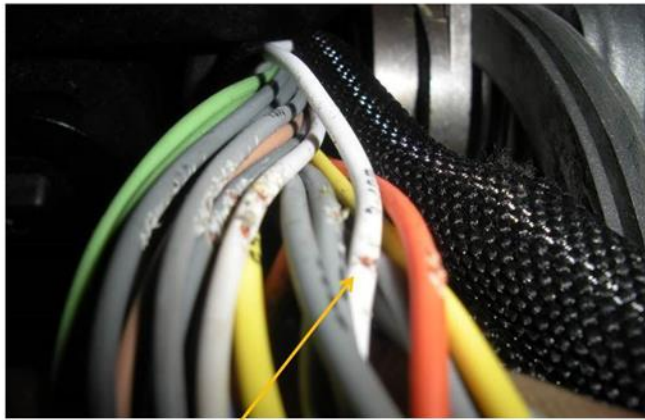
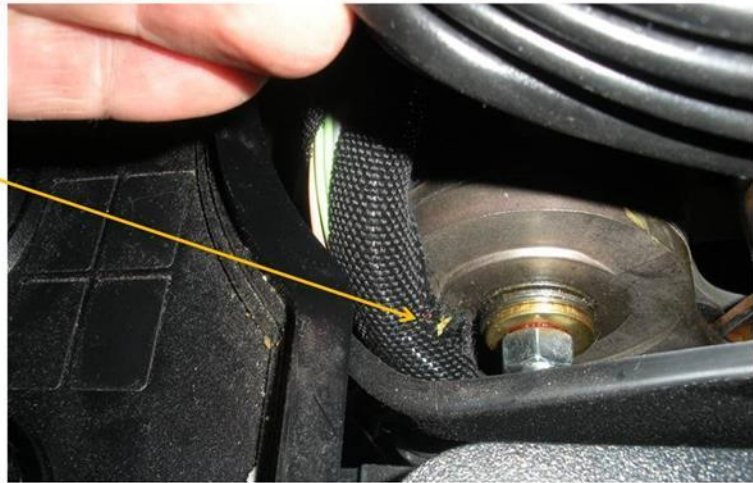
**Figure 2: Image of damaged harness**

Steering wheel switch's not working  
Multifunction switch not working  
DTC's

Damaged wires and loom from rubbing and abrasion

2. If damage is found repair and continue with reroute in figure 3 & 4.
3. If no damage is found continue with Steering Wheel Switch Diagnostics in ProStar technician manual.

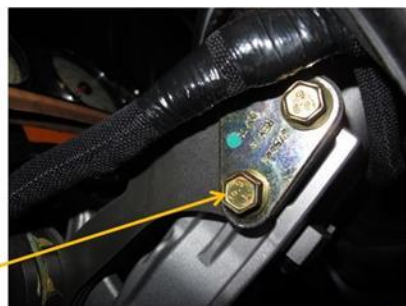
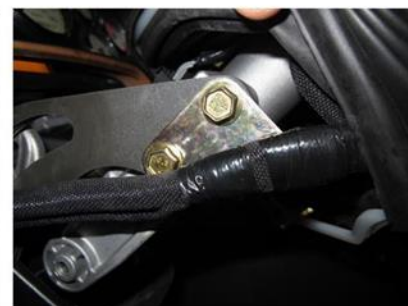
Before – clip hole up

After – clip hole down

Using a 1/2" socket, remove the two screws and "flip" the bracket, so the hole for the clip is "down." (See After – clip hole down photo).

Reinstall the two screws – torque to 200 +/- 25 lbs.-in.

**NOTE:** Prior to installing the wire harness/clip back into the bracket, the wire harness needs to be rerouted – see next slide.
