**Document ID:** IK1201320  
**Revision:** 7  
**Created:** 1/13/2016  
**Last Modified:** 2/9/2017  
**Author:** Caleb Iverson

**Title: 2659-10 EGR Slow Response Diagnostics**

**Applies To: EPA 10 N13B Engines**

This document is intended to provide updated diagnostics for fault code SPN 2659 FMI 10 in N13B engines. This document will also guide through decoding the calibration level and identifying if the calibration is up to date.

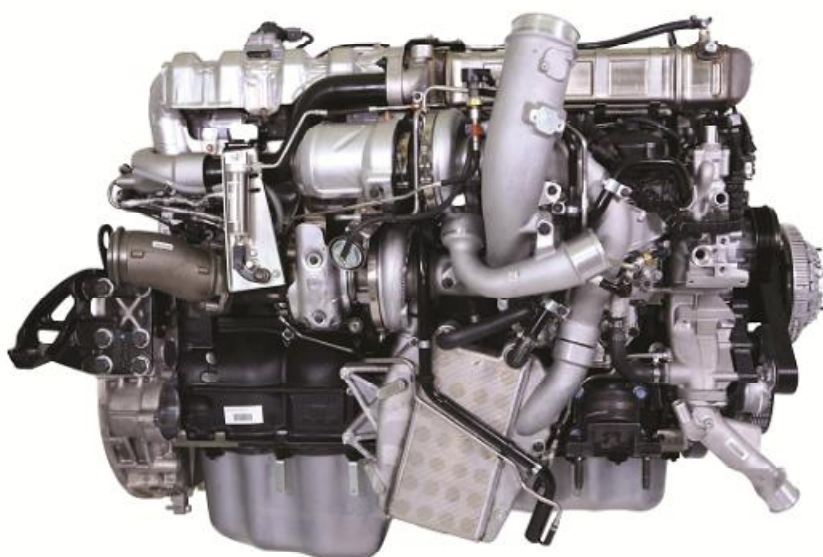
**N13B Identification by ESN 4400001 and up**

**N13B Visual Identification (see image below)**

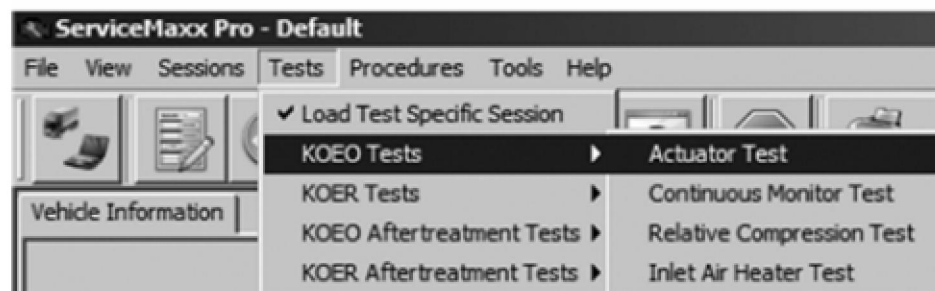
Figure 811 Selecting Actuator Test

1. Select Tests: KOEO Tests > Actuator Test. Follow on-screen instructions.
