| 09.2017 | 09.2019 | 14 | 1(19) |

## AGM BATTERY REPLACEMENT

Prevost vehicles

On the vehicles affected by this bulletin, replace the batteries by a new set (4) of the same model; perform several verifications on the alternator and charging circuit. Finally, update the multiplex software to the latest version and disable Alternator Management on select vehicles.

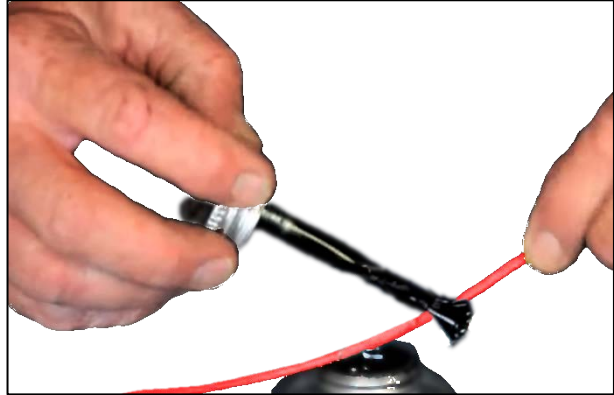
Figure 7: Liquid Tape Application

- 1.9 Use liquid tape to seal the exposed splice point on VDAULT-16.

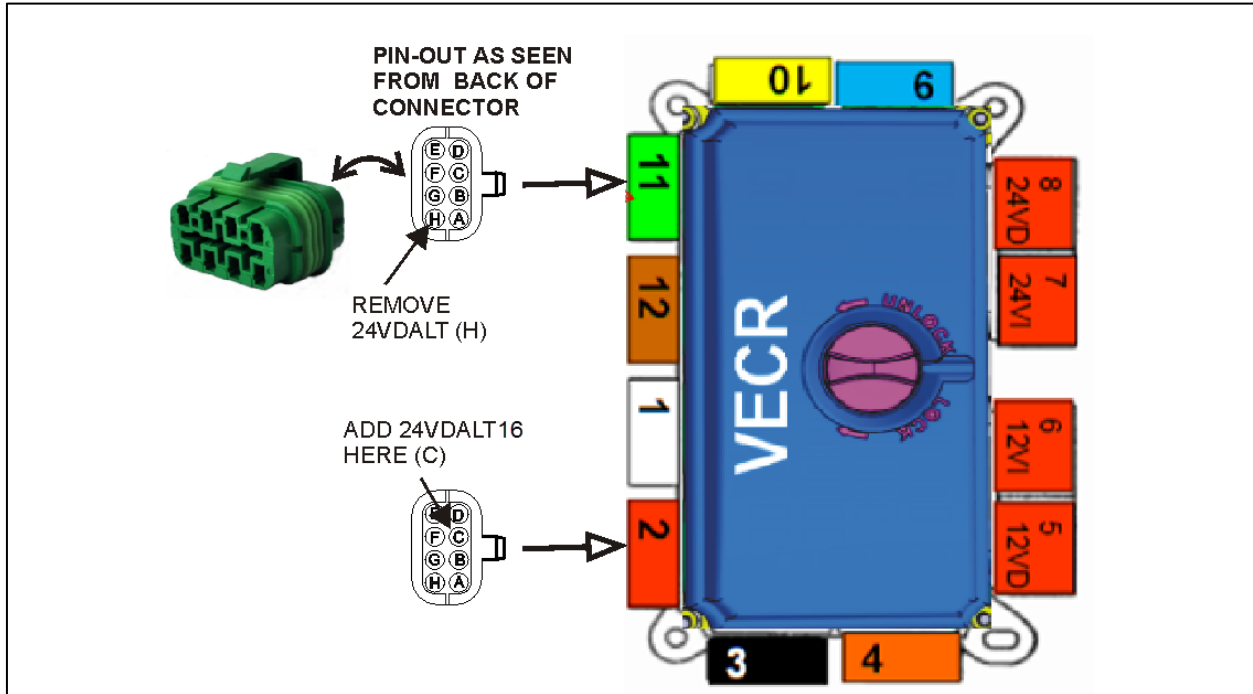
Figure 8: 24VDALT16 wire relocation

- 
- 1.10 Relocate wire 24VDAULT16 to cavity **C** of connector no.2 (red) on the harness. (Figure 8)

*Cavity **C** of connector no.2 should be available. This branch of the circuit will be protected by 10A Circuit breaker CB64 (see Figure 10 below).*

*Should cavity **C** not be available, refer to your vehicle wiring diagram page 5.1 to select another free cavity protected by a 10A or 15A CB (see Figure 8 for reference).*

**IMPORTANT NOTE:** If required, extend wire 24VDALT16 using 16 AWG red electrical wire in order to reach connector no.2. Refer to MATERIAL section for optional parts required extend the wire.

Cut and discard existing terminal. Extend wire 24VDALT16 with heat shrinkable butt splice 563622. Place heat shrink sleeve 062490 over soldered joint. Crimp the terminal 564055 to the wire and seal 12089679 (see Figure 6).

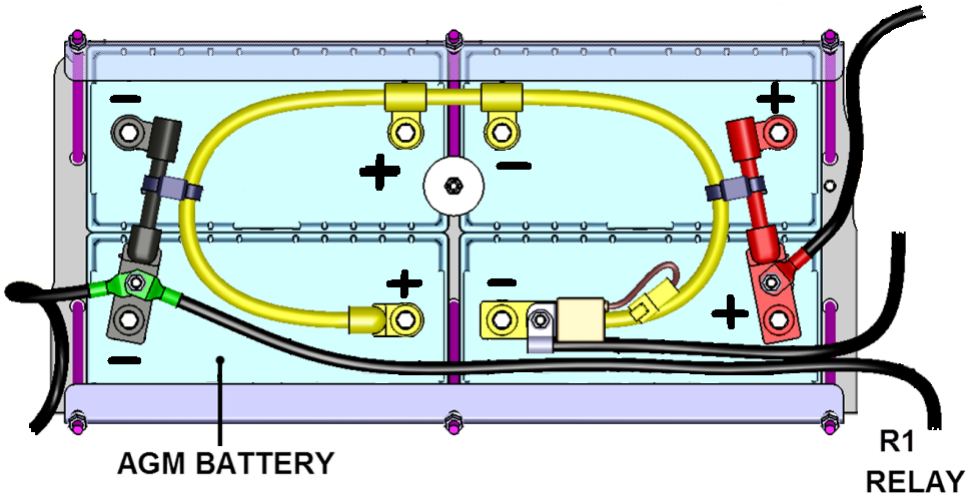
Figure 11: BATTERY CONNECTIONS

24VD battery cable to R1 main battery relay (Figure 11) is still powered after battery master switch is set at the off position.

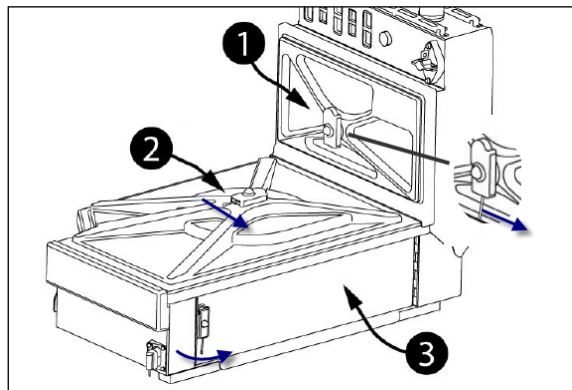
Figure 12: BATTERY PROTECTIVE COVERS

- 3.1 Set the battery master switch (master cut-out) to the OFF position
- 3.2 Remove the battery compartment protective covers by pulling the rod on the spring latch to release and lift cover. Starting with (1) then (2) (Figure 12).

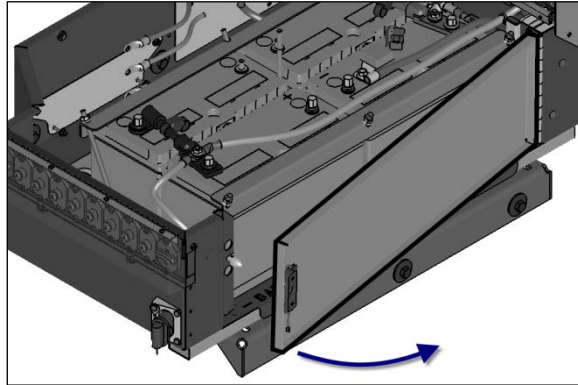
Figure 13 LATERAL ACCESS PANEL

- 3.3 Lateral access panel (3) is hinged. Release it by pulling on the spring rod and swing open (Figure 12 & Figure 13).

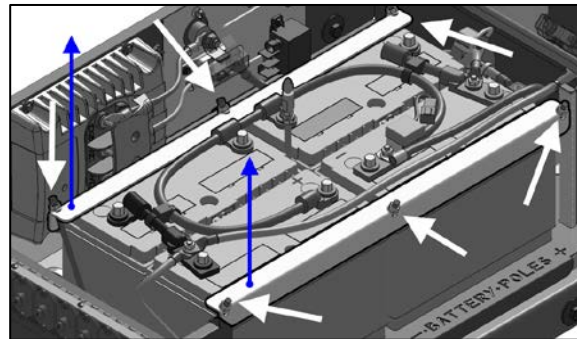
Figure 14: BATTERY HOLDING BRACKET REMOVAL

- 3.4 Unscrew battery holding bracket nuts (6) and remove clamps (2) (Figure 14).

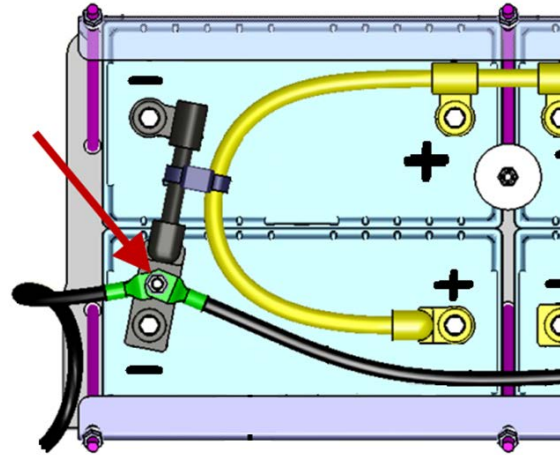
FIGURE 15: 4/0 NEGATIVE CABLE TERMINAL

- 3.5 Loosen negative terminal with the 4/0 cable only, using a 14mm socket and a wrench (figure 5).

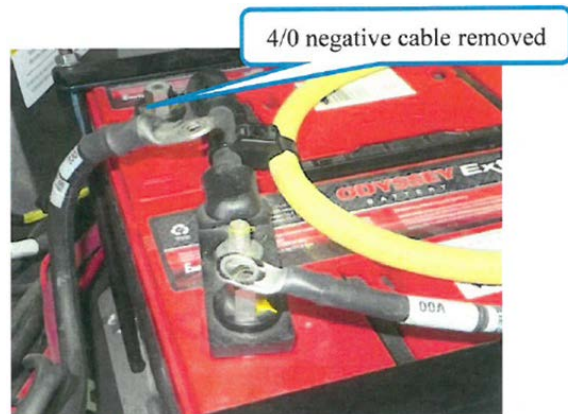
Figure 16: 4/0 CABLE REMOVAL

- 3.6 Remove the 4/0 negative cable only (Figure 16)

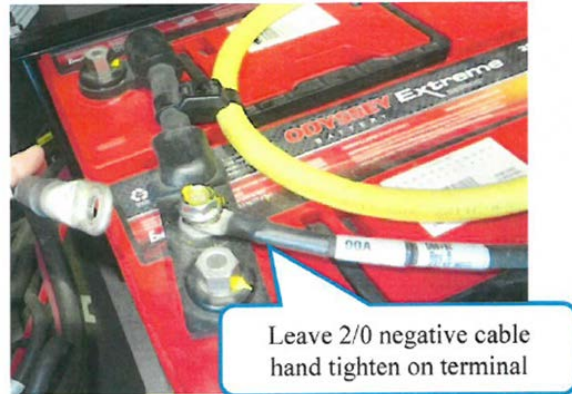
**Figure 17: REPLACE 2/0 CABLE**

- 3.7 Leave the 2/0 negative cable and hand tighten the terminal nut in place (Figure 17)

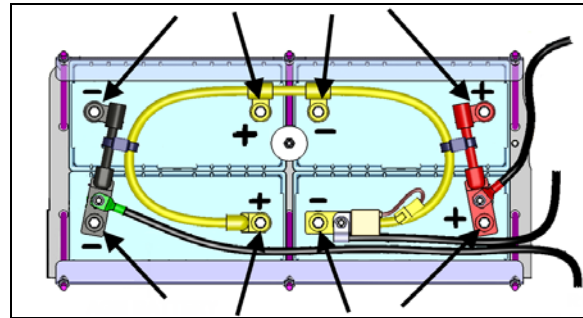
**Figure 18: CONNECTIONS REMOVAL**

- 3.8 Loosen the (8) battery connection nuts using 14mm socket and wrench (Figure 18).

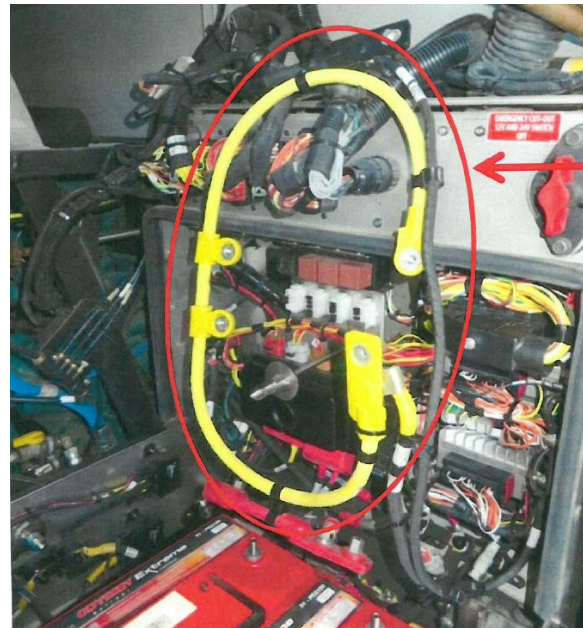
**Figure 19: SECURE UP CABLES**

- 3.9 Lift the battery cable assembly (including cables with their attached terminals) and secure up and out of the way using a wire tie (Figure 19).

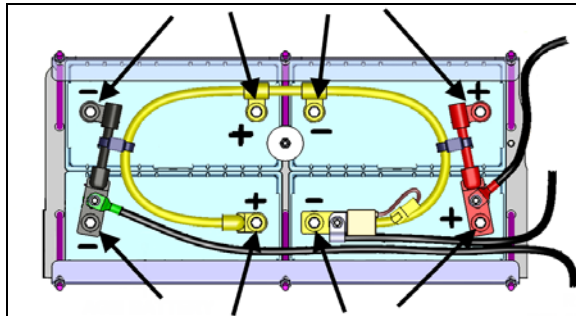
Figure 20: CABLES RECONNECTION

- 3.11 Lower the battery cable assembly and re-connect the (8) battery connections, the negative cables shall be the last reconnected cables.
- 3.12 Torque the battery connections to **180 lb-in** using a 14mm socket and a torque wrench. Apply torque seal mark.

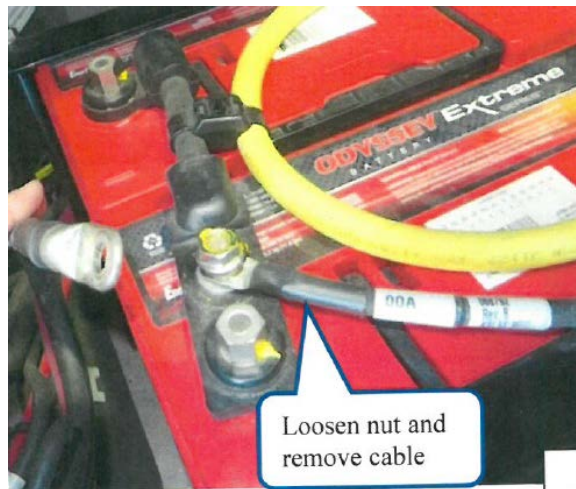
Figure 21: 2/0 CABLE REMOVAL FOR 4/0 RECONNECTION

- 3.13 To properly reassemble the negative battery cables, loosen the terminal nut holding the negative 2/0 cable in place and remove. Seat the negative 4/0 cable (on the bottom) and then place the negative 2/0 cable (on top).

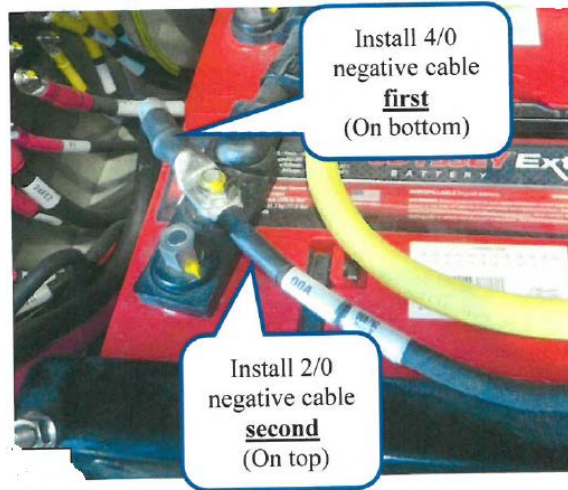
Figure 22: 4/0 AND 2/0 NEGATIVE TERMINALS RECONNECTION

- 3.14 Torque the negative terminal nut to **170 lb-in** using a 14mm socket and a torque wrench. Apply torque seal mark.

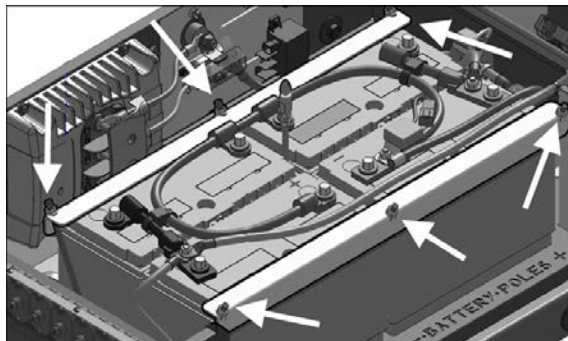
Figure 23: HOLDING BRACKETS RE-INSTALLATION

- 3.15 Re-install the battery holding brackets (2).
- 3.16 Torque holding bracket nuts (6) between **45 to 55 lb-in**. Apply torque seal mark.

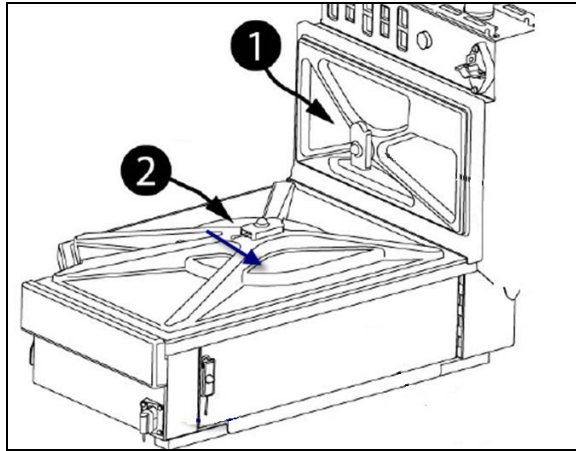
Figure 25: Battery & Electrical Box Covers

- 3.18 Install the battery protective cover (number 2, Figure 25)

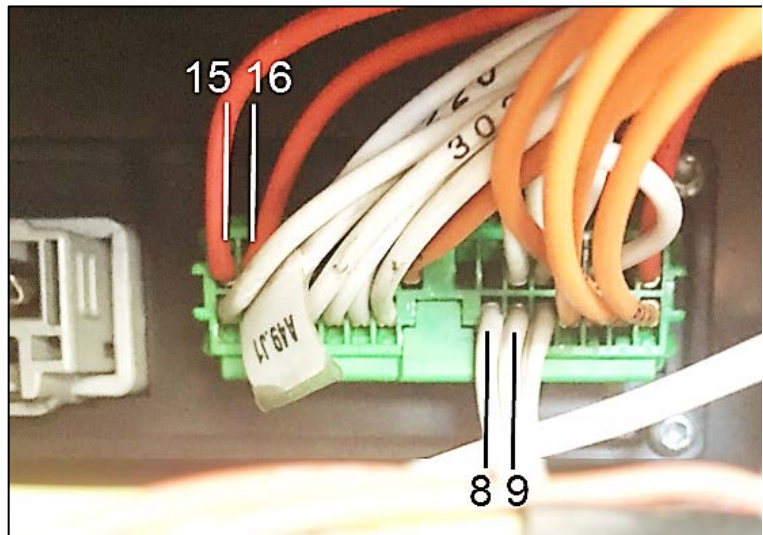
**Figure 26: A49. J1**

- With Key **OFF**:  
All values should be around 0V
- With Key **ON**:  
PIN 8 and 9 should be around 1.2 V  
PIN 15 = 24V Bat.  
(Figure 26)
- With **Engine running**:  
All values should be above 28V.

- 4.4 With key OFF and Emergency cut out switch ON, read voltage at A49 pin 15 and pin 16. If voltage is present, this is an alternator with an internal short circuit. (Figure 26)
- 4.5 Replace shorted alternator per bulletin MI16-17E and report problem on warranty claim
- 4.6 Reinstall removed cable ties.
- 4.7 Install the electrical box protective cover (number 1, Figure 31)

4.2 Alternator control circuit verification: Check Voltage at indicated pins of A49.J1, fill Table 1 below.

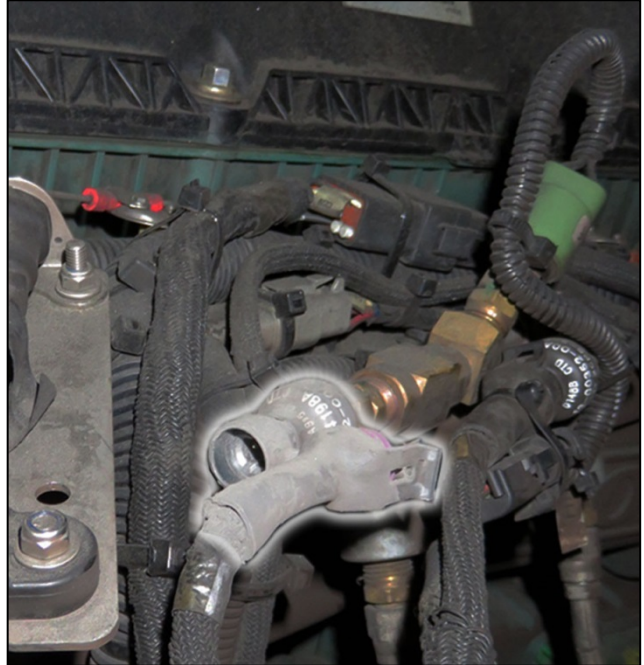
Figure 27: Disconnect Hi-side pressure transducer

- 4.3.2 With HVAC passenger on, disconnect Hi-side Pressure transducer to get full condenser speed.

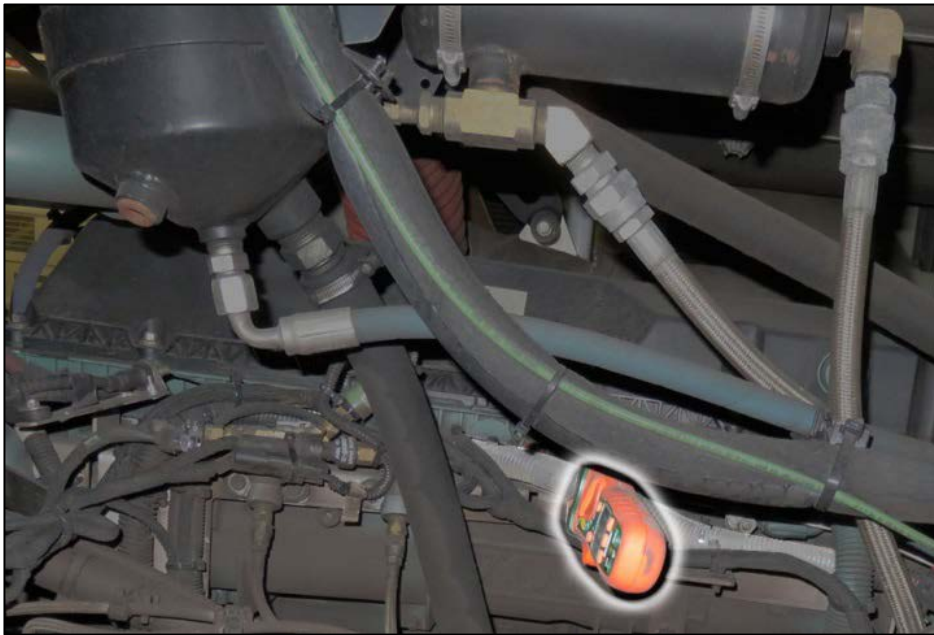
Figure 29: Main alternator cable suggested ammeter clamp position alongside engine.

- Amperage on main alternator cable alongside the engine (Figure 29).
- Amperage at jumper cable between alternator 1 and 2 (Figure 30)

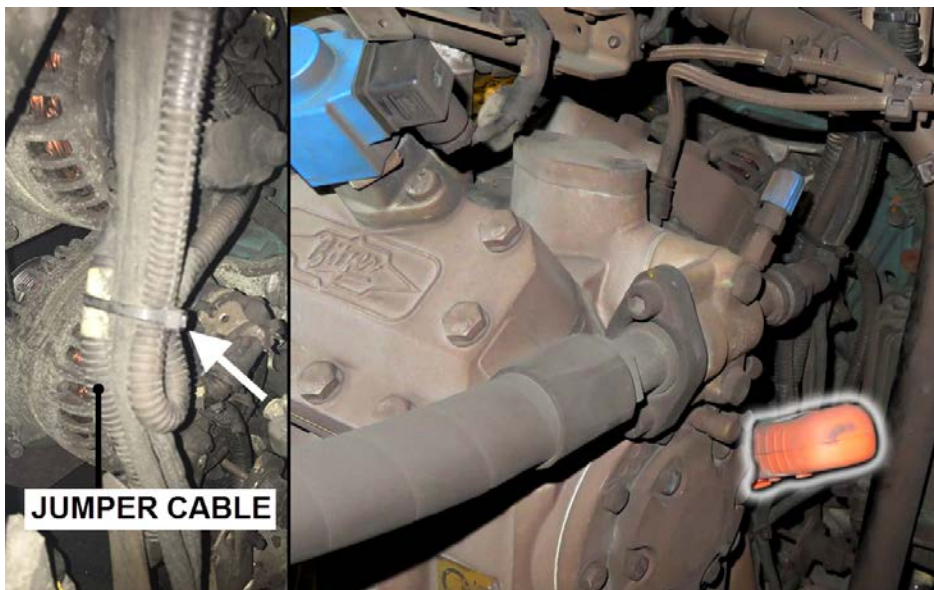
Figure 30: Jumper cable ammeter clamp position

**Note:** Remove any additional wiring harness attached to this jumper cable by cutting cable ties. (Arrow, Figure 30) This will allow clamping only the jumper cable and getting a proper measure of amperage.

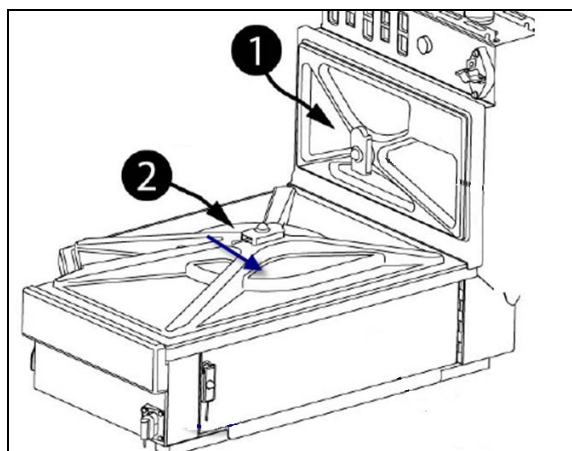
**Figure 31: Battery & Electrical Box Covers**
