Reference	SSM73417
Models	XJ / X351
Title	Heated rear seats operation is incorrect. 15 model year onwards
Category	Electrical
Last modified	06-Jun-2017 00:00:00
Symptom	208000 Climate Control
Attachments	X351 heated rear seat.pdf (X351 heated rear seat.pdf)

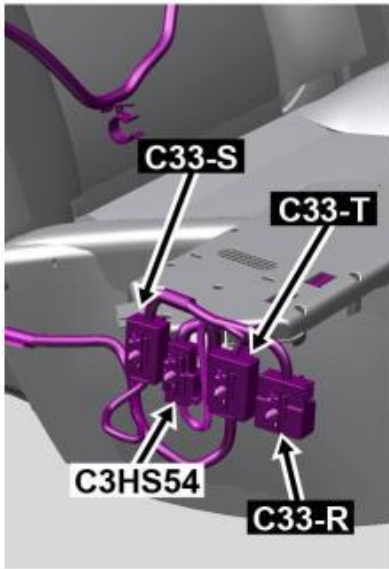
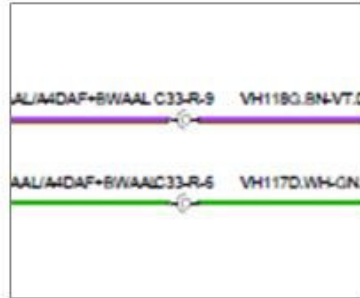
Issue
When the hard keys on the rear seat centre switch pack are operated pressing the Left Hand switch activates the Right Hand seat heater. Pressing the Right Hand switch activates the Left Hand seat heater.

Cause
Incorrect wiring.

Action
Access the connectors on the right hand side of the rear seat. See attachment.
Swap terminal 6 and 9 on connector C33-R using extractor tool 418-595. For further information refer to the electrical library in Topix.

Corrective action on cars built:-
 Swap pins 6 & 9 on connector C33-R located on the right hand side of the rear seat
