## SERVICE BULLETIN

**APPLICABILITY:** 2015-2017MY Legacy and Outback  
2015-2017MY WRX

**NUMBER:** 04-17-17R

**SUBJECT:** Rattling Sound from Steering Rack

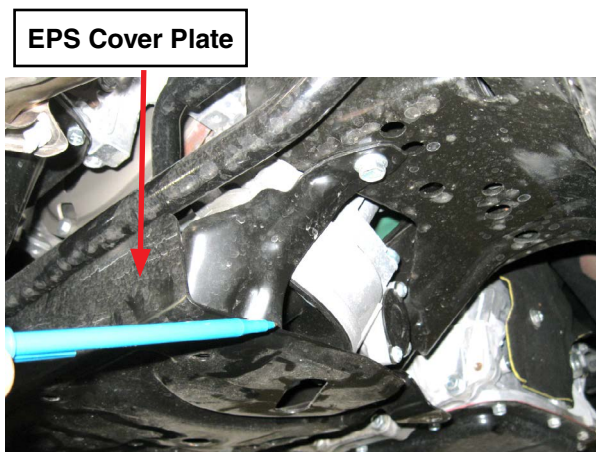
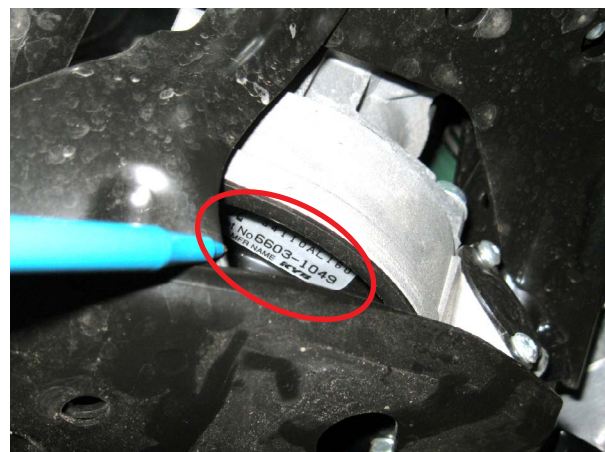
### Lot Number Identification:

Using a flashlight and by looking in from the driver's side, the EPS unit's Lot Number can be verified without removing the EPS cover plate.

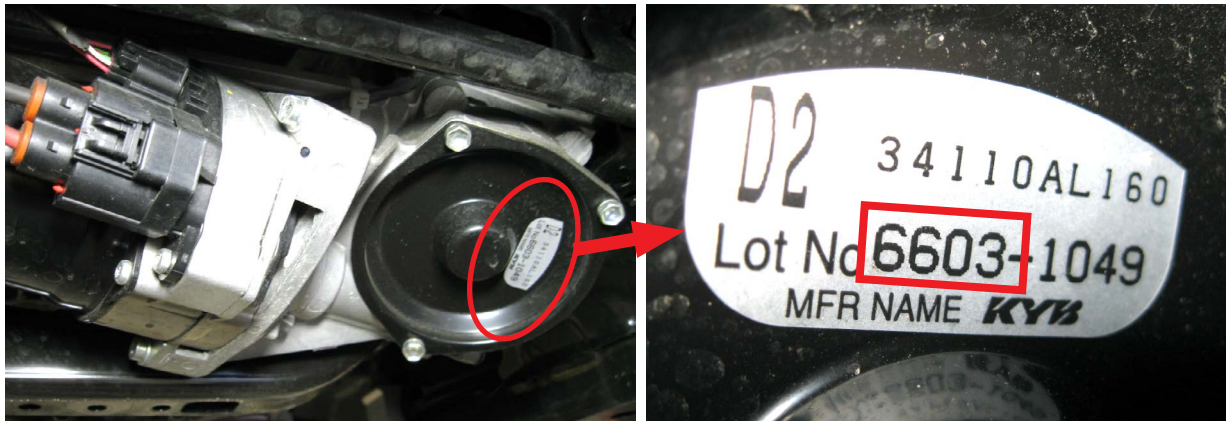
(EPS Cover is removed here for reference only.)

**VERY IMPORTANT:** These 4 digits determine the EPS unit's Lot Number (date code).

- The first number (a 6 in the picture) is the year (2016).
- The second (also a 6 in the picture) indicates the 6th month (June).
- The third and fourth (03 in the picture) is the 3rd day (June 3, 2016)
- The second set of 4 numbers (1049) is the production number or serial number for that specific date.

If the Lot Number is **equal to or after 7421 (April 21, 2017)**, the EPS unit is post-countermeasure and the condition **will not be repaired** by replacing the tension spring.
