SERVICE BULLETIN

APPLICABILITY: 2018MY Legacy and Outback
SUBJECT: Uneven Hood to Headlight Gap

NUMBER: 12-229-17
DATE: 09/05/17

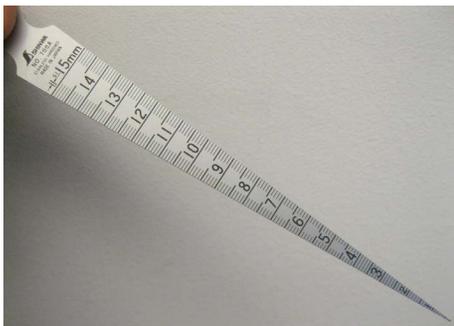
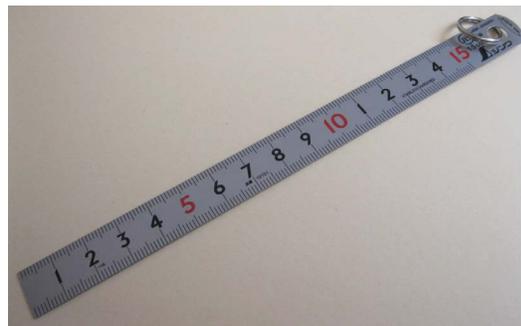
- Always confirm the customer’s concern by measuring the gap as described in step 4. below. If the gap measures greater than 7mm, continue with the steps as outlined.
- All the steps listed below **may not** be needed. Perform adjustments based on the gap measurements taken to achieve the desired results.
- A tapered gap / hole measurement scale or a precision (Machinist’s) pocket ruler should be used.

1. Loosen (do not remove) all 4 nuts securing the hood to the hood hinges (2 each side).
2. Push the hood to the right enough to move it on the hinges approximately 1.5mm.
3. Continue to apply pressure on the hood while re-tightening the nuts on the hinge. Torque all 4 nuts to 25 Nm +/- 5 Nm (18 ft. lbs.).

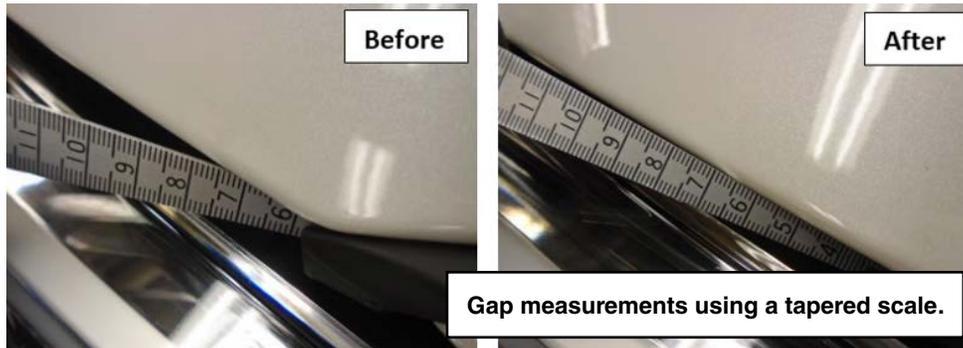
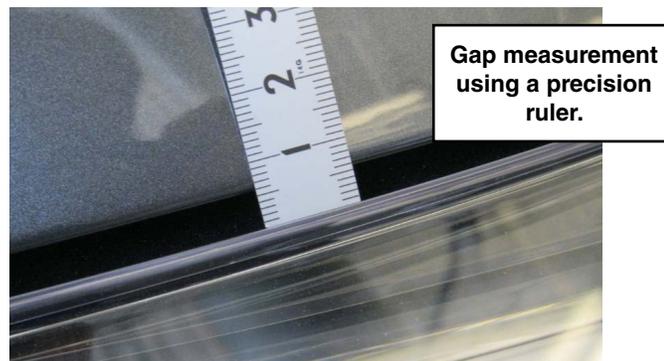
4. **CAUTION:** When closing the hood after performing this adjustment, closely monitor the fender to hood gap near the cowl to ensure there is not any contact. With the hood fully closed, the gap between the hood and headlamps should be **no more than 7mm** and even on both sides.
