SERVICE INFORMATION

APPLICABILITY: 2015MY Forester

NUMBER: 07-92-15R

SUBJECT: Condensation (Fogging) in Rear Combination Lamps

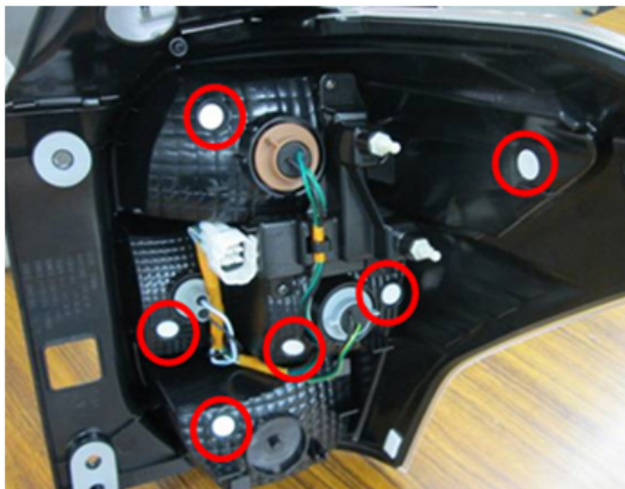
This **Service Information** bulletin announces a design change to the rear combination lamps to address customer concerns of fogging or condensation accumulating on the inside surface of the lens. Six additional breathing holes have been added to the body of the lamp assembly. The additional holes are intended to provide additional ventilation and prevent fogging which may result when severe ambient temperature changes occur.

Rear view of the new combination lamp showing the 6 additional breathing holes.

The new combination lamps were incorporated into production starting with VIN F*530822.

PART NAME:	PART NUMBER:
LENS & BODY COMPL RH	84912SG041
LENS & BODY COMPL LH	84912SG051
