SERVICE BULLETIN

APPLICABILITY: 2015-2017MY Legacy / Outback 2.5 CVT Models **NUMBER:** 16-104-17
SUBJECT: “Bump” Feeling from CVT at Idle in Drive **DATE:** 02/23/17

This bulletin provides a diagnostic procedure along with Transmission Control Module (TCM) reprogramming files to address isolated customer concerns of a “bump” feeling from the CVT. The bump feeling has been reported to occur after the CVT is fully up to operating temperature, in Drive and with the engine at idle.

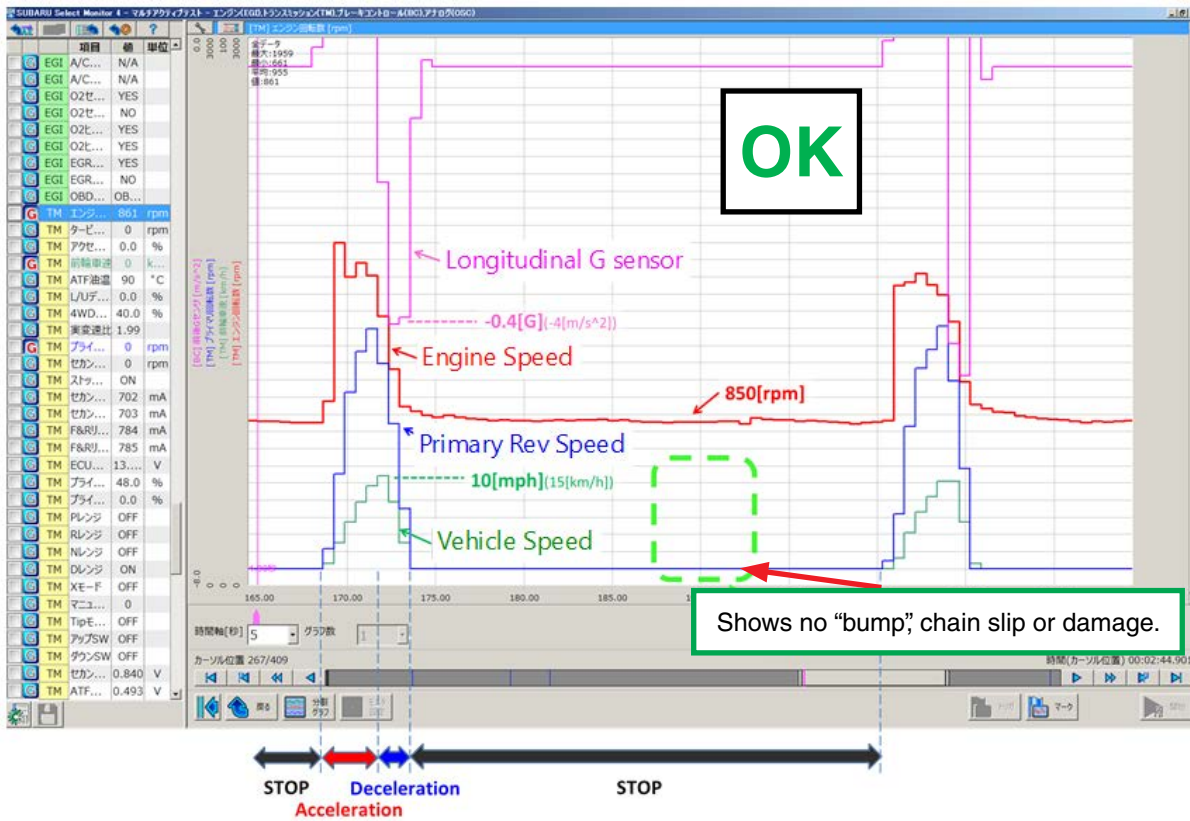
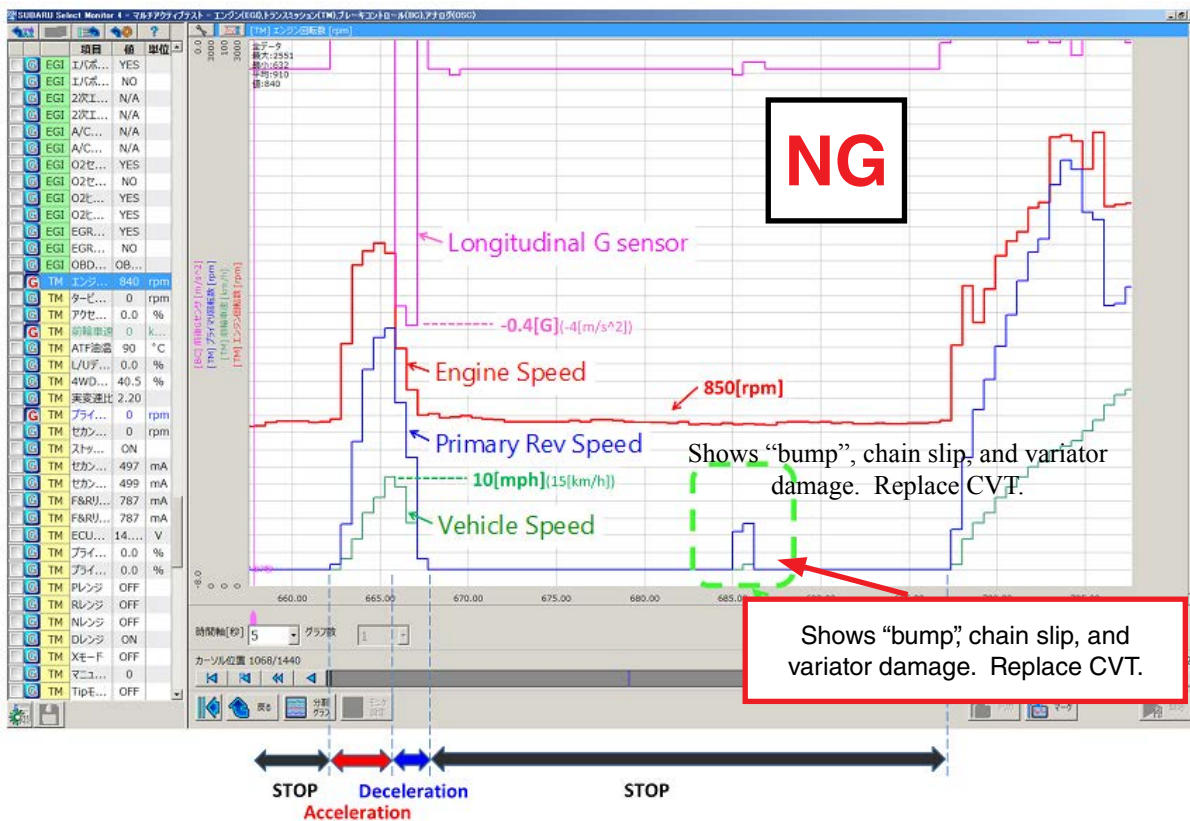
- While performing the testing above, determine if the “bump” condition can be confirmed and / or if the data graph shows any chain slippage. Examples of “OK” and “NG” graphs are supplied below for reference to help make a proper determination.

- If the bump condition is confirmed, there is most likely variator damage requiring CVT assembly replacement. Follow the service procedure in the applicable Service Manual when replacing the CVT assembly is required.
