Clicking Noise From Front Wheel Area During Slow Speed Turns (F Sport 2WD)

Service
Category Brake

Section Brake (front)

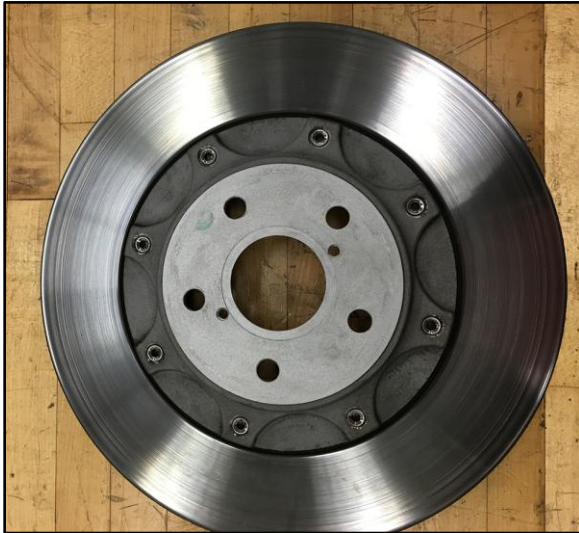
Figure 1. Before (Aluminum)

These vehicles are originally equipped with a lightweight 2-piece aluminum rotor assembly. The click noise that can be heard during sharp turns is a normal condition. For customers that find this objectionable, an alternative steel rotor is available. The visual appearance of the rotor is different. Before performing this repair, it is recommended that the visual differences be reviewed with the customer.

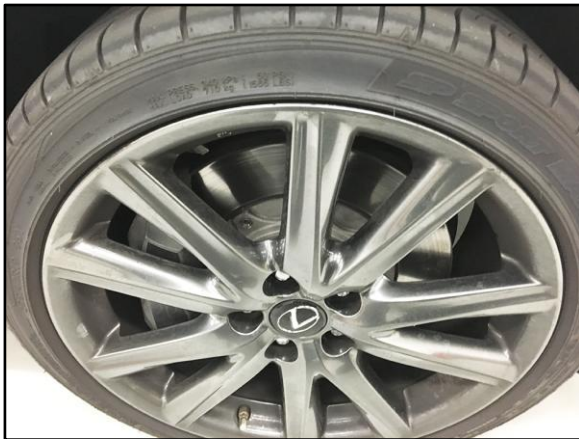
Figure 3. Before* (Aluminum)

* Pictures are an example of 1 wheel type for the vehicle. Other wheel types may have slightly different results.

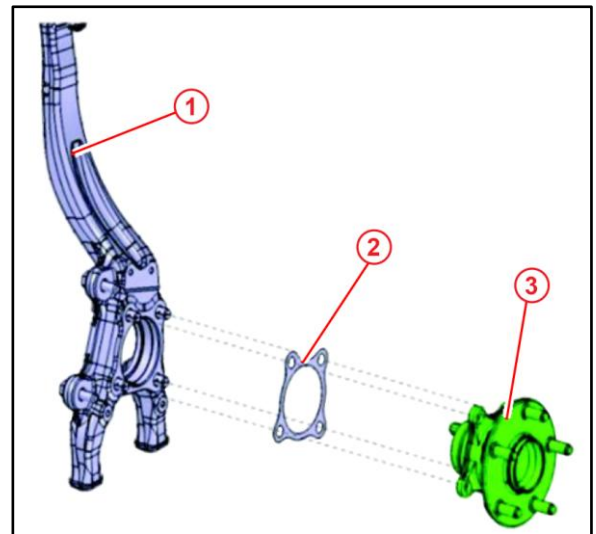
Figure 5.

1	Knuckle
2	Shim
3	Hub Bearing

- B. Install the painted brake shim between the hub and knuckle as shown.

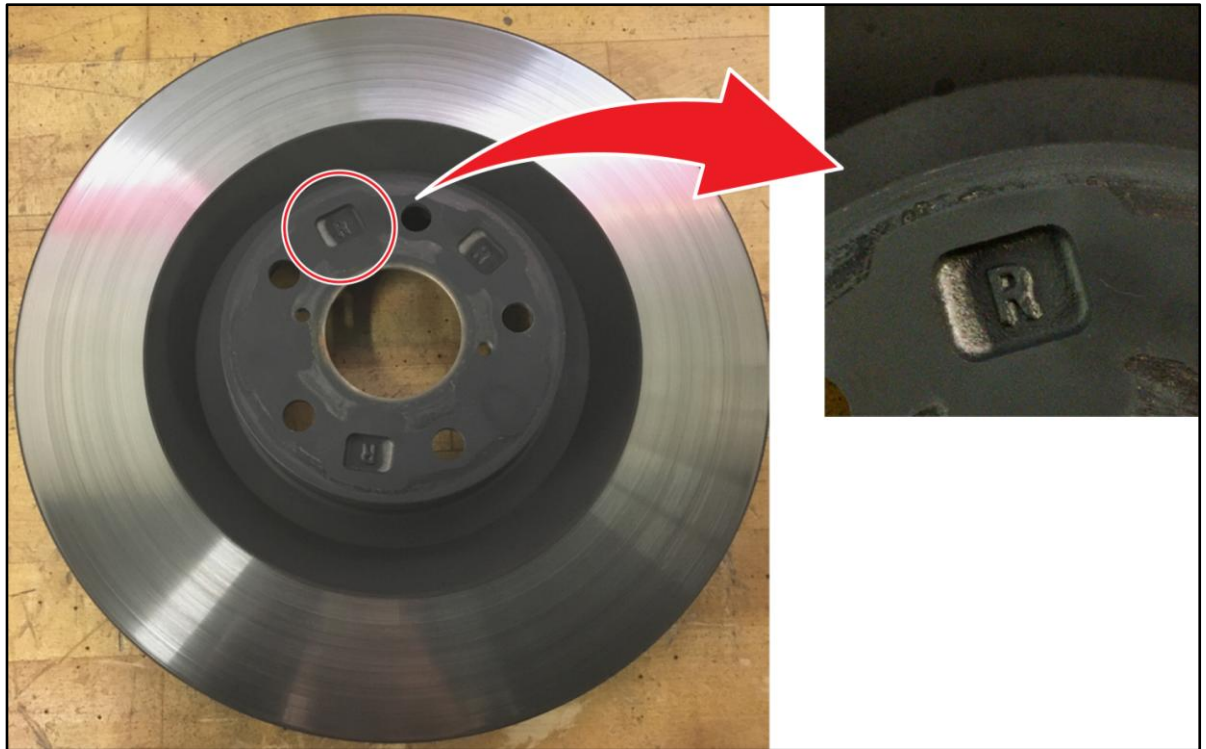
Figure 6.

NEW steel 1 piece rotors do NOT have paint marks as shown in the Repair Manual. They are marked with an “L” or an “R” to show which location to install.

C. Reinstall the hub bearing, NEW rotors and NEW brake pads.
