# Abnormal Cruise Control Feel "Rocking Back & Forth" Between 55 – 75 MPH

**Service Category** Engine/Hybrid System

**Section** Cruise Control

YEAR(S)	MODEL(S)	ADDITIONAL INFORMATION
2016	RAV4

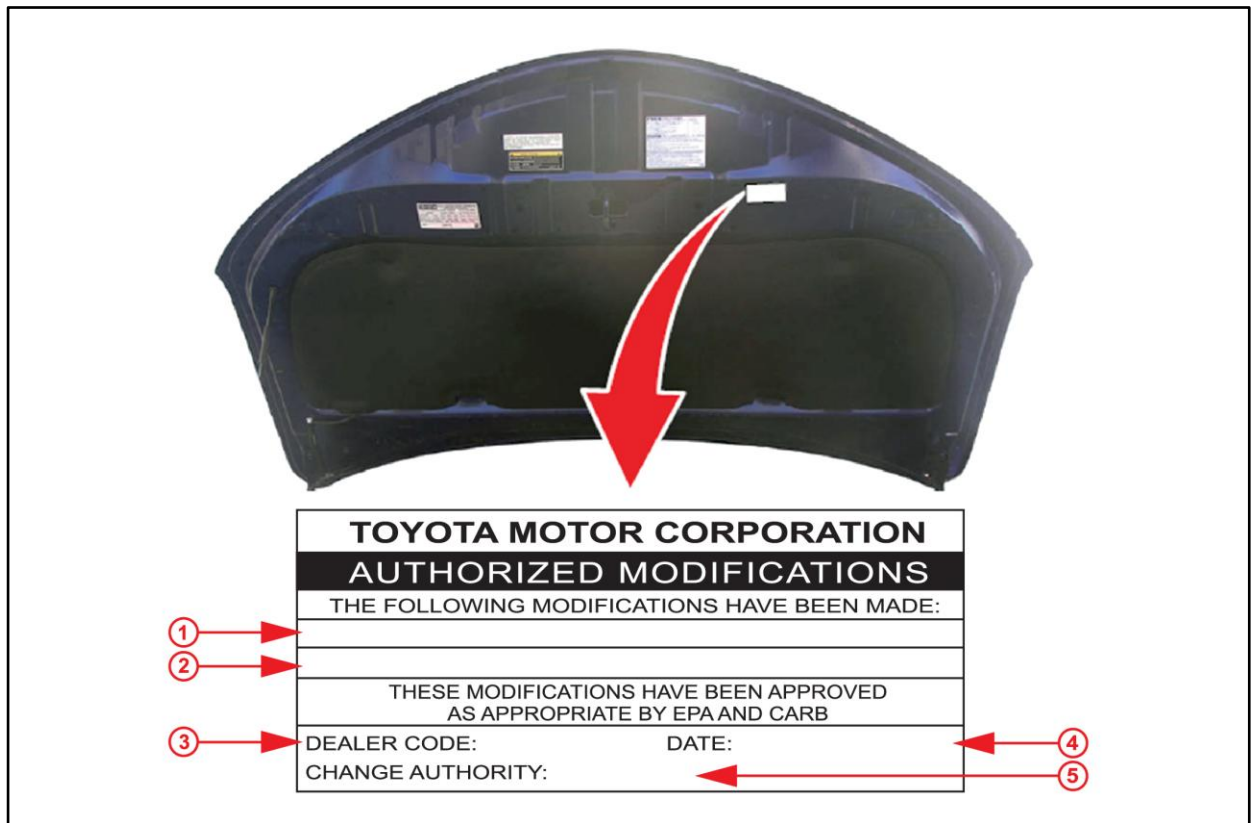
**Figure 1. Location of Authorized Modifications Label for 2016 RAV4**

- Check for the Authorized Modifications Label affixed to the vehicle in the location shown below. Confirm if the ECM (PCM) calibration has been updated.

<b>1</b>	Replacement ECM (PCM) Part Number (i.e., 89661-42V91 or 89661-0R511)
<b>2</b>	New Calibration ID (i.e., 342Q1100 or 342Q2100)
<b>3</b>	Dealer Code

<b>4</b>	Date Completed
<b>5</b>	This SB Number

- Prepare and install the Authorized Modifications Label.
  - Using a permanent marker, enter the following information on the label:
    - ECM part number [Refer to the **Parts Information** section for the **NEW PART NUMBER**]
    - Calibration ID(s) [Refer to the **Calibration Information** section for the **NEW CALIBRATION ID**]
    - Dealer Code
    - Repair Date
    - Change Authority [**This bulletin number**]
  - Install the Authorized Modifications Label to the vehicle at the location shown in Figure 1. The Authorized Modifications Label is available through the MDC, P/N 00451-00001-LBL.
- Verify the rocking condition is no longer present.
