ECM Calibration: Transmission Software Enhancements

YEAR(S)	MODEL(S)	ADDITIONAL INFORMATION
2016	LX570

Some 2016 model year LX 570 vehicles may exhibit one or more of the following conditions:

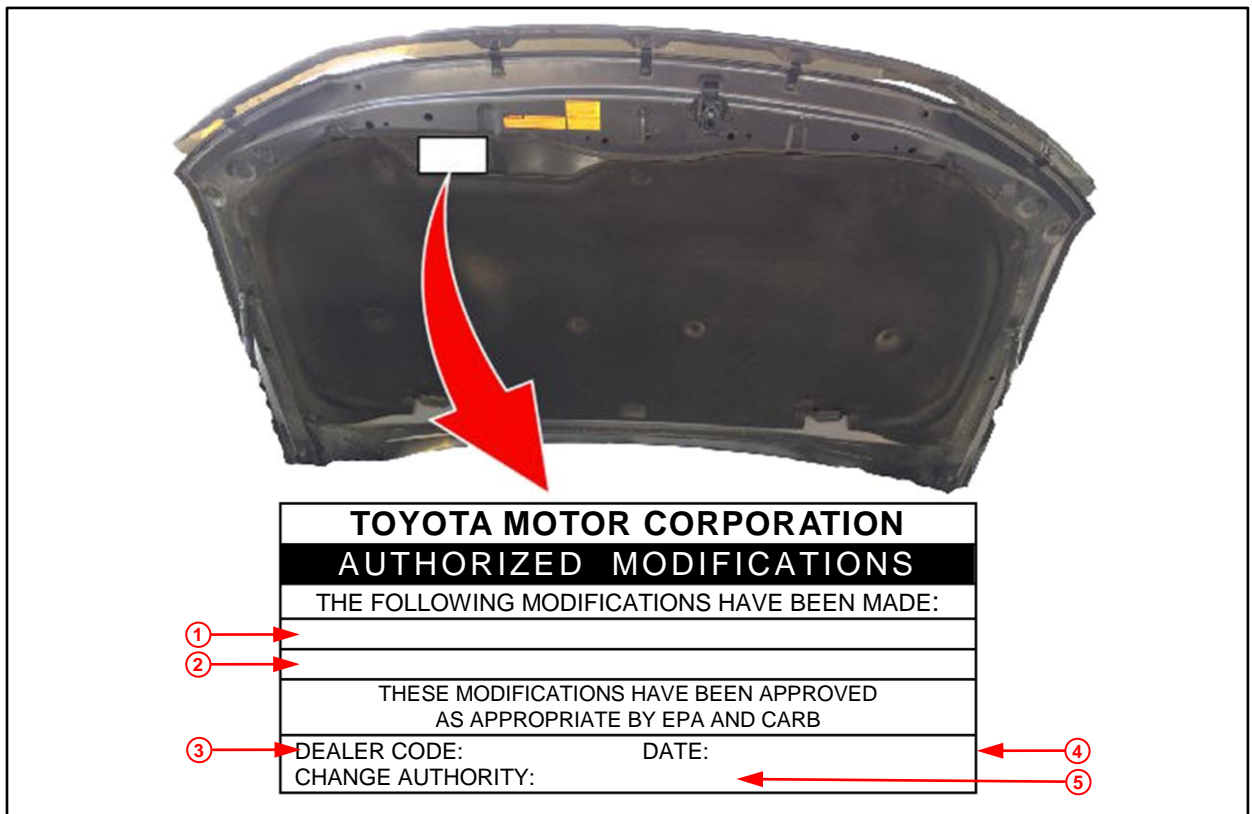
Figure 1. Location of Authorized Modification Label for 2016 LX 570

- Check for the Authorized Modifications Label affixed to the vehicle in the location shown below. Confirm if the ECM (PCM) calibration has been updated.

4. Prepare and install the Authorized Modifications Label.
 - A. Using a permanent marker, enter the following information on the label:
 - ECM part number [Refer to the **Parts Information** section for the **NEW PART NUMBER**]
 - Calibration ID(s) [Refer to the **Calibration Information** section for the **NEW CALIBRATION ID**]
 - Dealer Code
 - Repair Date
 - Change Authority [**This bulletin number**]
 - B. Install the Authorized Modifications Label to the vehicle at the location shown in Figure 1. The Authorized Modifications Label is available through the MDC, P/N 00451-00001-LBL.
5. Perform transmission initialization.
Refer to the Technical Information System (TIS), applicable model and model year Repair Manual:
 - 2016 LX 570:
Drivetrain – Automatic Transmission/Transaxle – “AE80F Automatic Transmission/Transaxle: Automatic Transmission System: [Initialization](#)”
