# Reduced Power When Accelerating From a Stop

**Service Category** Engine/Hybrid System

**Section** Hybrid/Battery Control System

YEAR(S)	MODEL(S)	ADDITIONAL INFORMATION
2016 - 2017	Prius	VDS(s): KBRFU

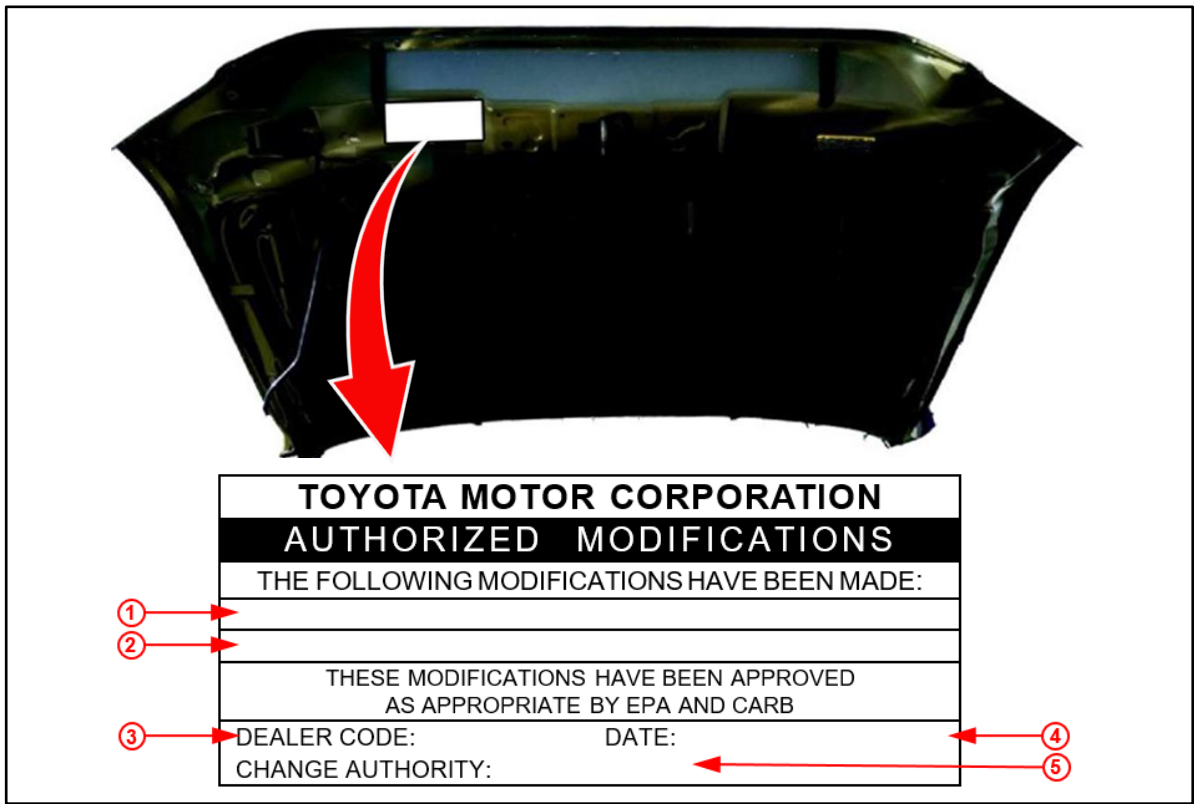
**Figure 1. Location of Authorized Modifications Label on 2016 – 2017 Prius**

3. Check for the Authorized Modifications Label affixed to the vehicle in the location shown below. Confirm if the HV ECU calibration has been updated.

<b>1</b>	Replacement HV ECU Part Number (i.e., 89981-47553)
<b>2</b>	New Calibration ID(s) (i.e., 899834751300-899854702200)
<b>3</b>	Dealer Code

<b>4</b>	Date Completed
<b>5</b>	This SB Number

- Prepare and install the Authorized Modifications Label.
  - Using a permanent marker, enter the following information on the label:
    - ECM part number [*Refer to the **Parts Information** section for the **NEW PART NUMBER***]
    - Calibration ID(s) [*Refer to the **Calibration Information** section for the **NEW CALIBRATION ID***]
    - Dealer Code
    - Repair Date
    - Change Authority [***This bulletin number***]
  - Install the Authorized Modifications Label on the vehicle at the location shown in Figure 1. The Authorized Modifications Label is available through the MDC, P/N 00451-00001-LBL.
- Ready the vehicle ON, warm it up to normal operating temperature and test drive to confirm proper vehicle operation.
