ΤΟΥΟΤΑ	Tech Tip	T-TT-0457-17	Septem	ber 22, 2017
Subject Front Door Glass Run Loose Falling Out/Deformed USA Service Category				
		Window/Glass		
2015-2017 MY Sienna				
APPLICABLE VEHICLES				
2015-2017		Sienna		
CONDITION

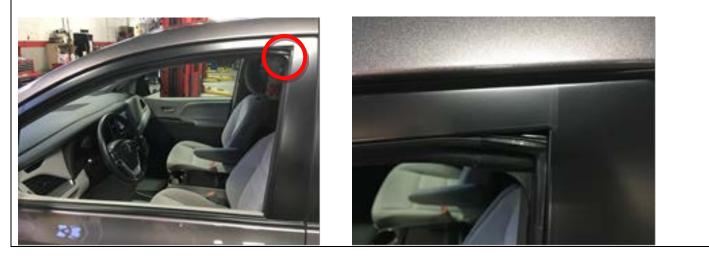
Some 2015-2017 MY Sienna vehicles' front door glass run could be pulling out of the upper B-pillar corner while operating the window.

Create a report for any vehicles identified with the condition described above. Be sure to leave the glass run in its current installed condition for the details requested in the next section.
