TECHNICAL INSTRUCTIONS

SPECIAL SERVICE CAMPAIGN H0P

INSTRUMENT PANEL WIRE MODIFICATION

CERTAIN 2017 MY YARIS (A/T)

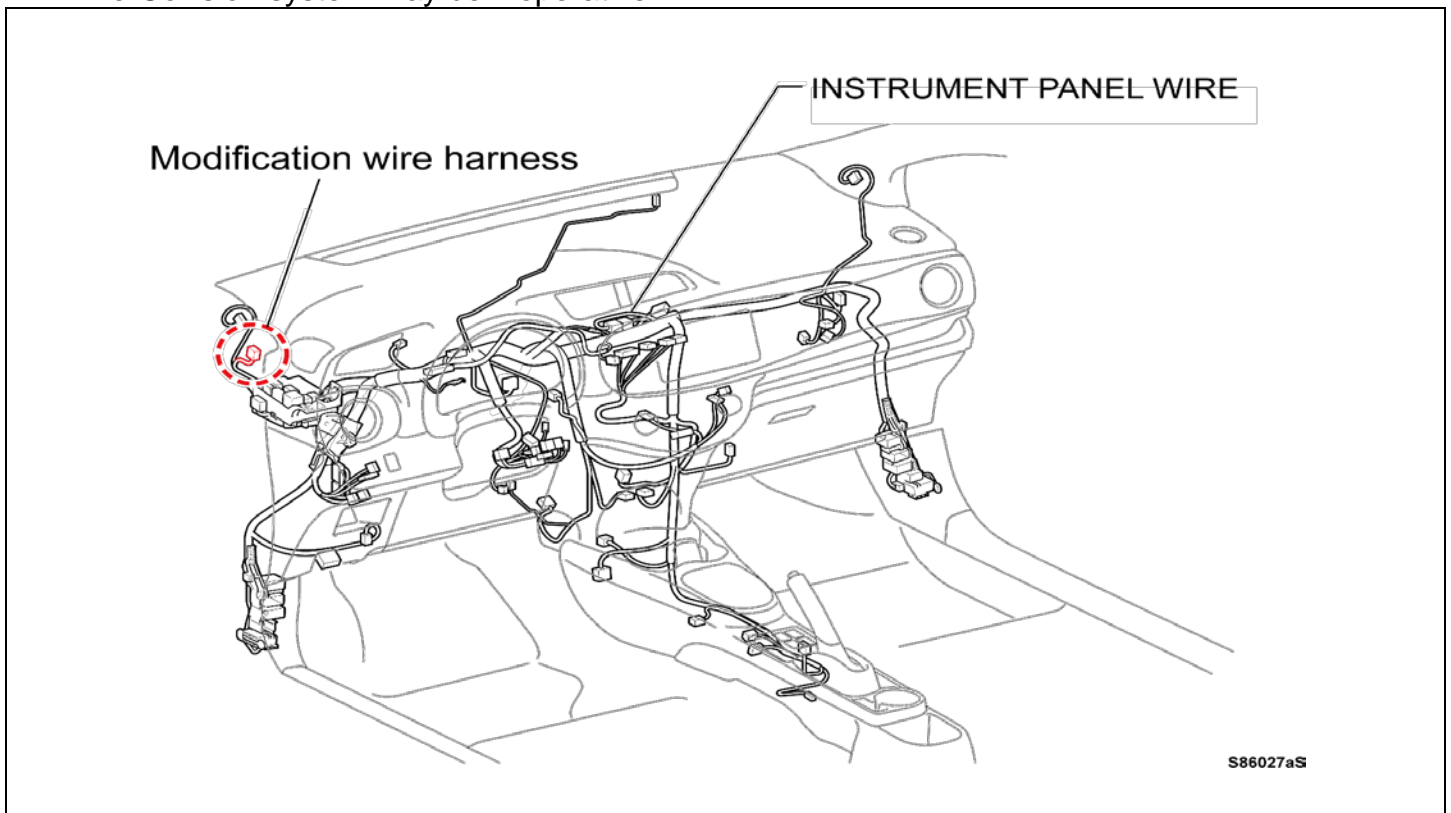
In the subject vehicles, an incorrect instrument panel wire harness may have been installed during the vehicle assembly process. The incorrect instrument panel wire harness may not be compatible with the Pre-Collision system front sensor. As a result, the Automatic High Beam and Pre-Collision system may be inoperative.

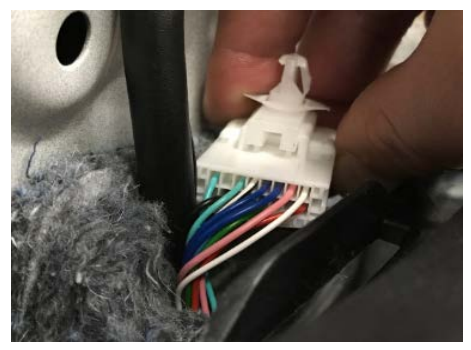
There are 2 light green wires! Make sure to cut wire that is more toward middle of connector.

- a. After removal from the body, rotate the clip to expose the wires

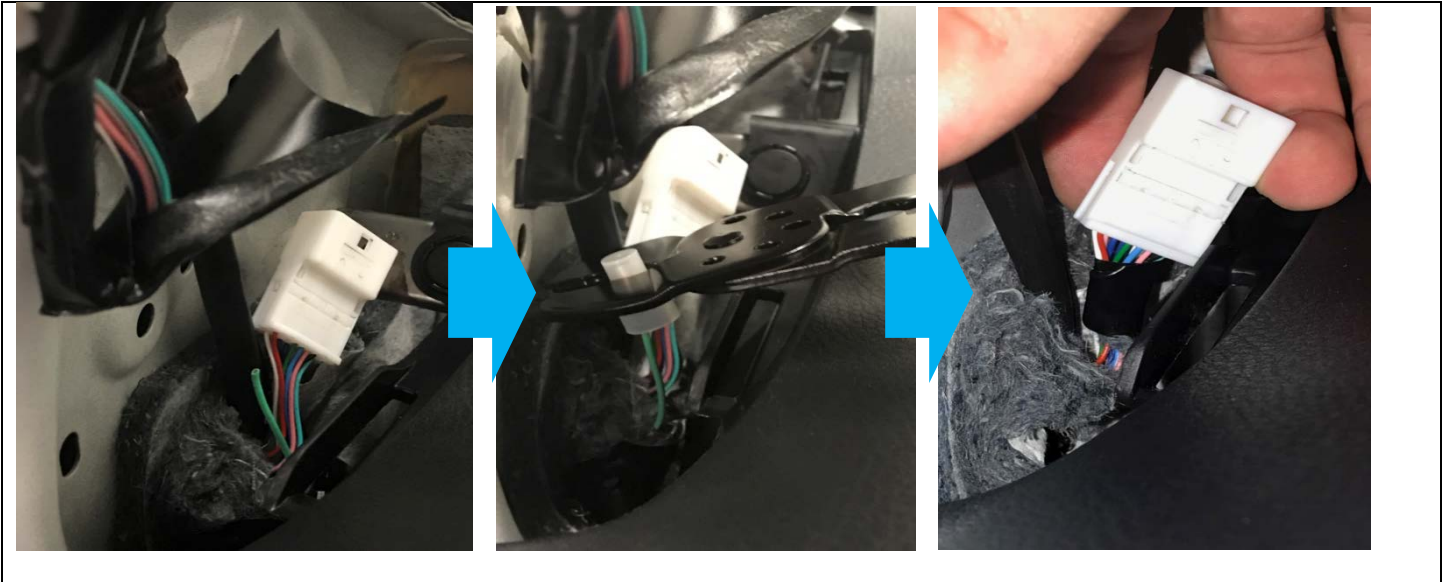
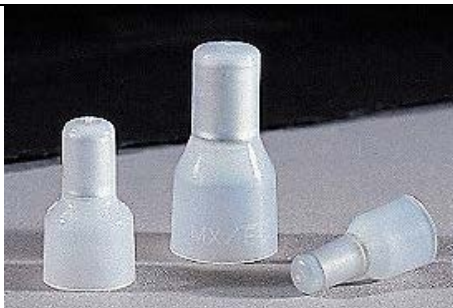
Nylon Closed-End Crimp Connector

This wire is B+ 12V supply. It must be securely capped and taped to instrument panel wire bundle to avoid shorting.

- c. Cap the top of the cut wire and crimp it. Securely fasten the cut wire to the instrument panel wire with the vinyl tape
