Headlamp Durability Enhancement

Service Category Vehicle Exterior

Section Lighting (ext)

YEAR(S)	MODEL(S)	ADDITIONAL INFORMATION
2011 - 2013	CT200H

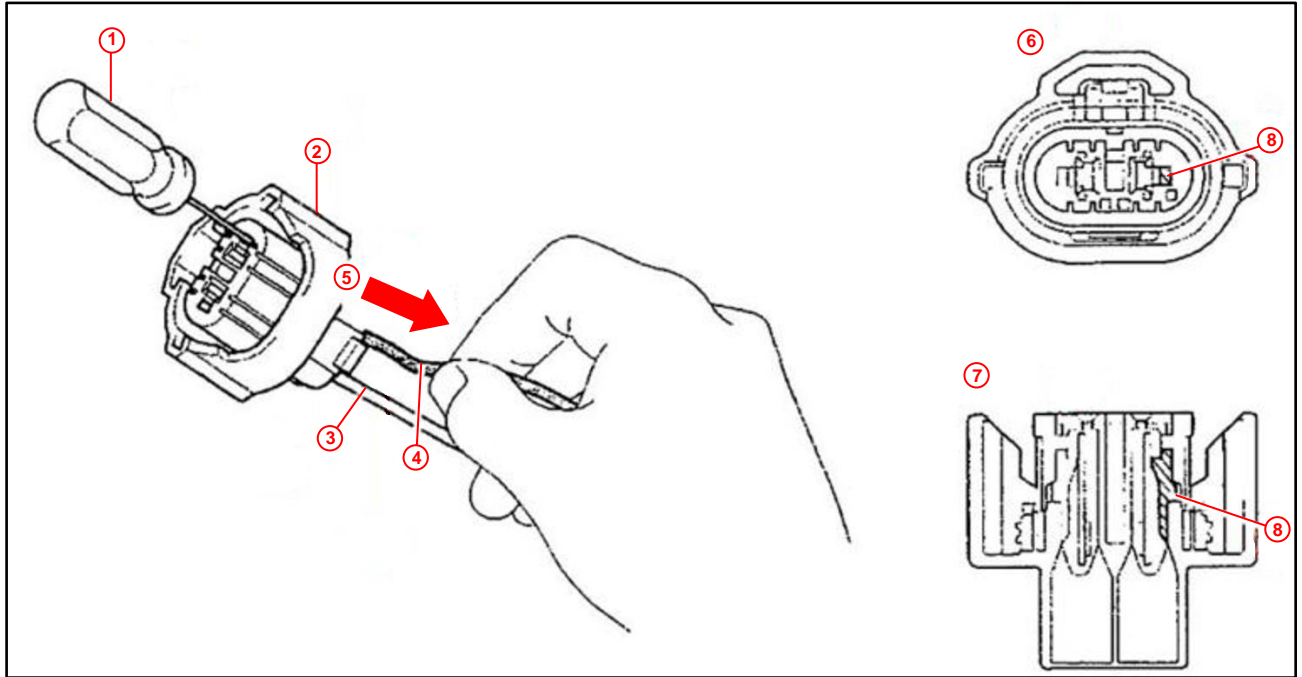
Figure 1.

1	Terminal Removing Tool "F"
2	Headlamp Bulb No. 2 Connector
3	Engine ROOM Main Wire Harness (White-Black)
4	Engine ROOM Main Wire Harness (Violet)

5	Remove Violet Wire Harness from Connector
6	Front View
7	Cross Section
8	Lock

- Modify the existing headlamp harness and install the engine wire No. 4 harness.

This wiring harness extends the factory headlamp wiring harness and will be placed between the headlight socket and existing headlamp wiring harness. The harness will be cut with a special crimping tool to make an adequate crimp. It is important to use the suggested crimp tool and follow the instructions below to ensure a proper crimp.

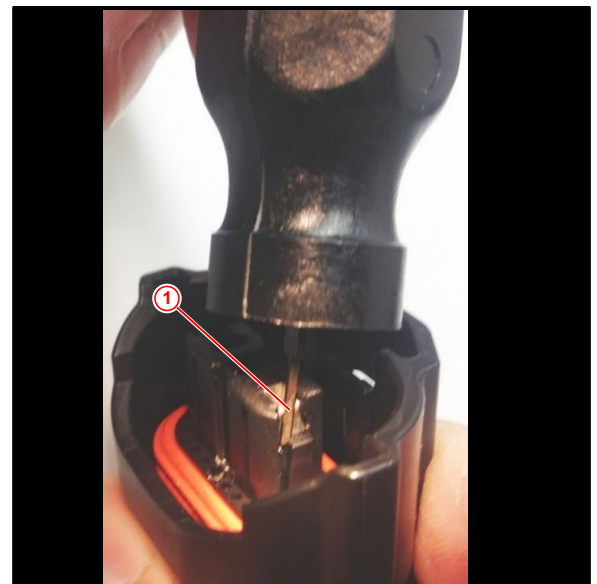
Figure 3.

1	TerminalLock
---	--------------

- (1) AFTER the terminal cap is removed, gently insert the terminal removing tool "F" into the connector between the terminal and the terminal lock (see Figures 1 and 3), then gently push the terminal lock to the outward side of the connector. Do NOT overstress the lock or it will NOT properly hold the terminal when reassembled.

NOTICE
 When inserting terminal removing tool "F," pry carefully outward just enough to remove the terminal from the wire side. Excessive pressure may damage the lock or bend the tool.

- (2) As the lock is held outward, gently pull on the violet wire from the back of the connector to remove it.

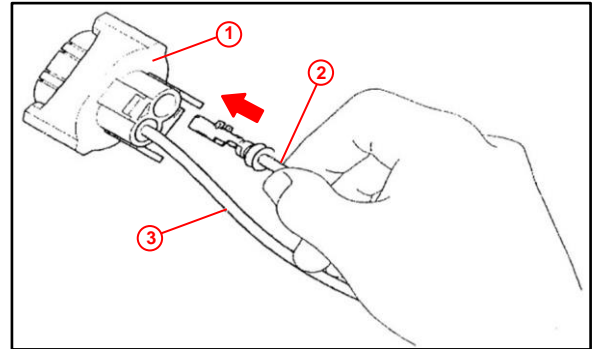
Figure 4.

1	Headlamp Bulb No. 2 Connector (Low Beam)
2	Insert Engine Wire No. 4 into Terminal (White-Black)
3	Engine ROOM Main Wire Harness (White-Black)

- C. Insert the terminal of engine wire No. 4 (white-black) into the headlamp bulb No. 2 connector.

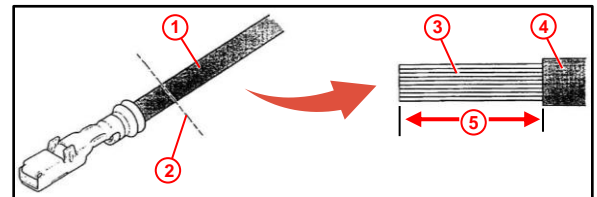
Figure 5.

1	Engine ROOM Main Wire Harness (Violet)
2	Cut Here
3	Strip Off 10 mm of Insulation
4	Wire Insulation Coat
5	10 mm

- D. Cut the violet wire previously removed from the headlamp bulb No. 2 connector near the terminal.
- E. Remove the wire outer coat insulation 10 mm from the edge.

NOTE
Measure the length of the wire carefully to ensure the wire fits properly.

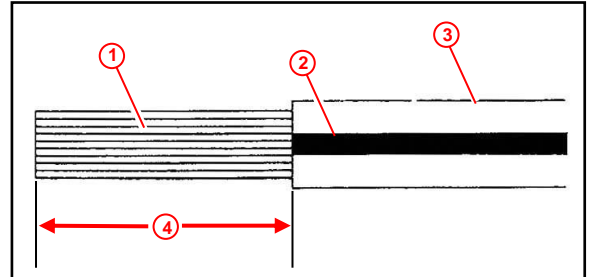
Figure 6.

1	Strip Off 10 mm of Insulation
2	Wire Insulation Coat
3	Engine Wire No. 4
4	10 mm

- F. Remove 10 mm of the wire outer coat insulation from engine wire No. 4 (white-black wire).

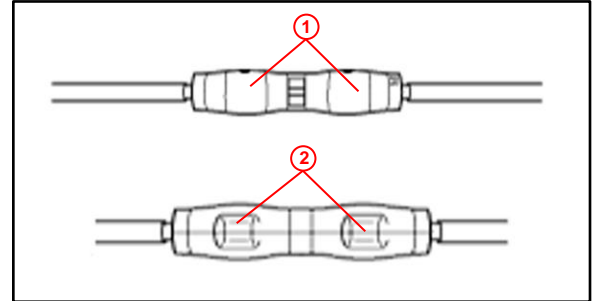
Figure 8.

1	Apply a 2 Crimp Here
2	Crimped Sleeve Tube

- J. Apply one additional crimp on both sides of the center crimp, as shown.

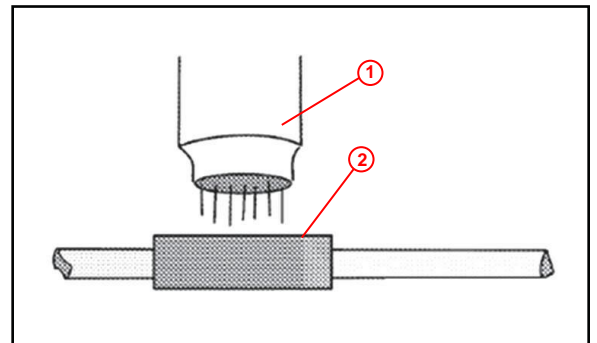
Figure 9.

1	Heat Gun
2	Shrink Tube

- K. Slide the heat shrink tubing over the crimp and apply sufficient heat with a heat gun to close the heat shrink around the wire insulation.

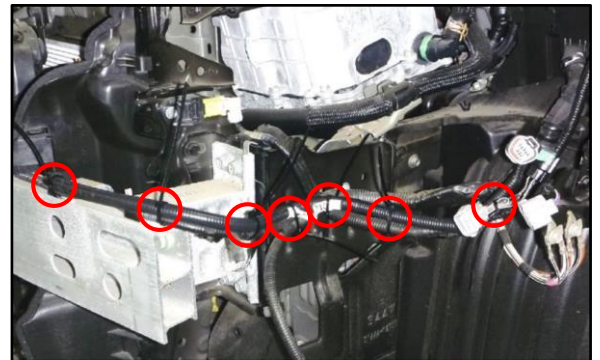
Figure 10. Nylon Ties Less Than 100 mm Apart

- (1) Install the connector from the engine wire No. 4 harness connector into the headlamp assembly.
- (2) Route the No. 4 harness by following the contour of the current harness. (Test fit routing as necessary to ensure fit.)
- (3) Apply nylon ties less than 100 mm from each other, facing outward.

Seven tie wraps are needed for the driver side.

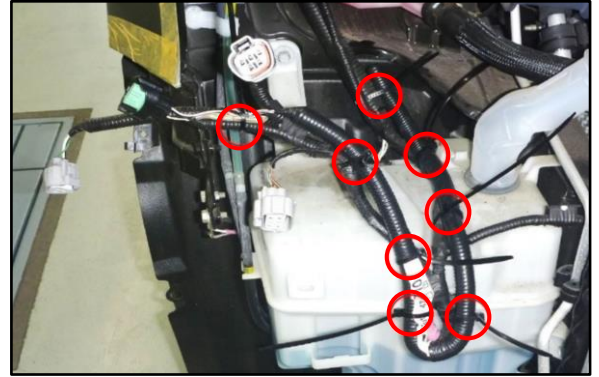
Figure 11. Nylon Ties Less Than 100 mm Apart

- (1) Plug the engine wire No. 4 harness connector into the headlamp assembly.
- (2) Route the No. 4 harness by following the contour of the current harness. (Test fit routing as necessary to ensure fit.)
- (3) Apply the nylon ties less than 100 mm from each other, facing outward.

Eight tie wraps are needed for the passenger side.
