Technical Service Bulletin

43 DRC running gear: DTC(s) stored for front shock absorbers

43 17 28 2049664/2 December 14, 2017. Supersedes Technical Service Bulletin Group 43 number 17-27 dated December 5, 2017 for reasons listed below.

Model(s)	Year	VIN Range	Vehicle-Specific Equipment
RS7	2014 - 2017	All	With sports running gear with variable damping

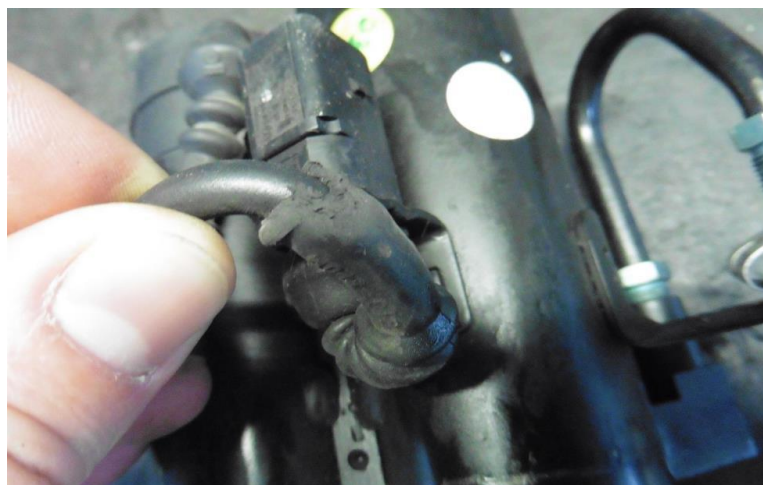
- DTC(s) about a malfunction of the vehicle level sender or the valve for damping adjustment on the front axle are logged in the electronic damping control module, J250 (address word 0014).
- The insulation of the electric cable of the shock absorber is damaged by wear (Figure 1).

Figure 1. Damaged insulation on the electric cable for the shock absorber.

The missing insulation allows water to get to the electronic components in the shock absorber, causing corrosion. As a result the function is restricted.

1. Replace the affected shock absorber according to the repair manual.
2. When fitting the shock absorber make sure the electric cable is routed correctly. The connector with the labelling must point forward (Figure 2). The cable must also not be twisted or under tension to prevent any damage to the wires in the cable and to the outer insulation (Figure 3). It is recommended to hang cable and connector freely on the absorber first, then secure it.

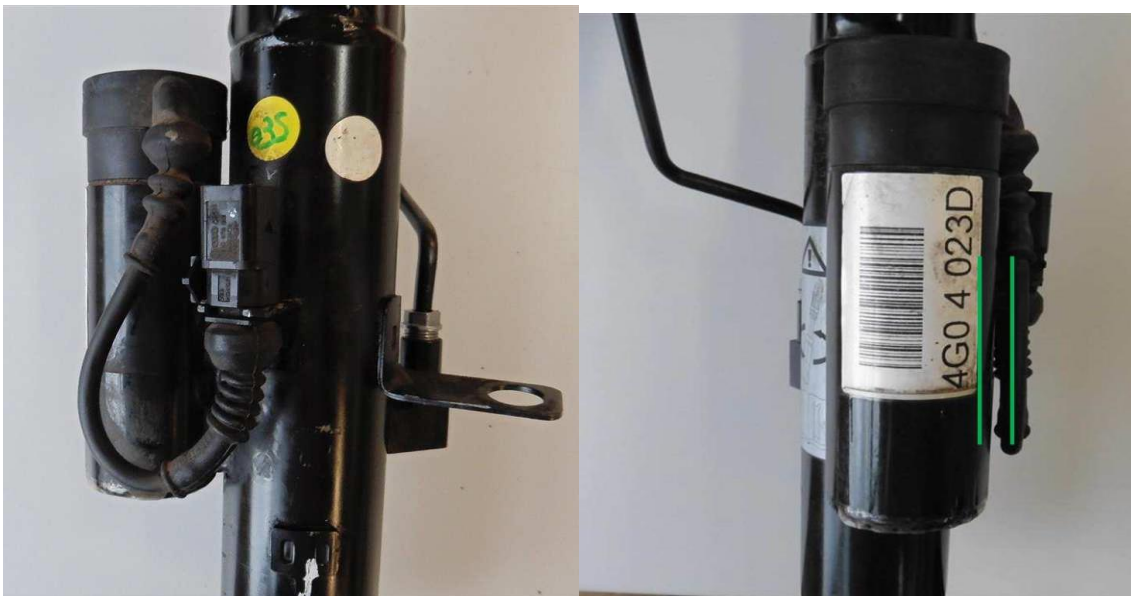
Figure 2. Correct connector alignment and cable routing.

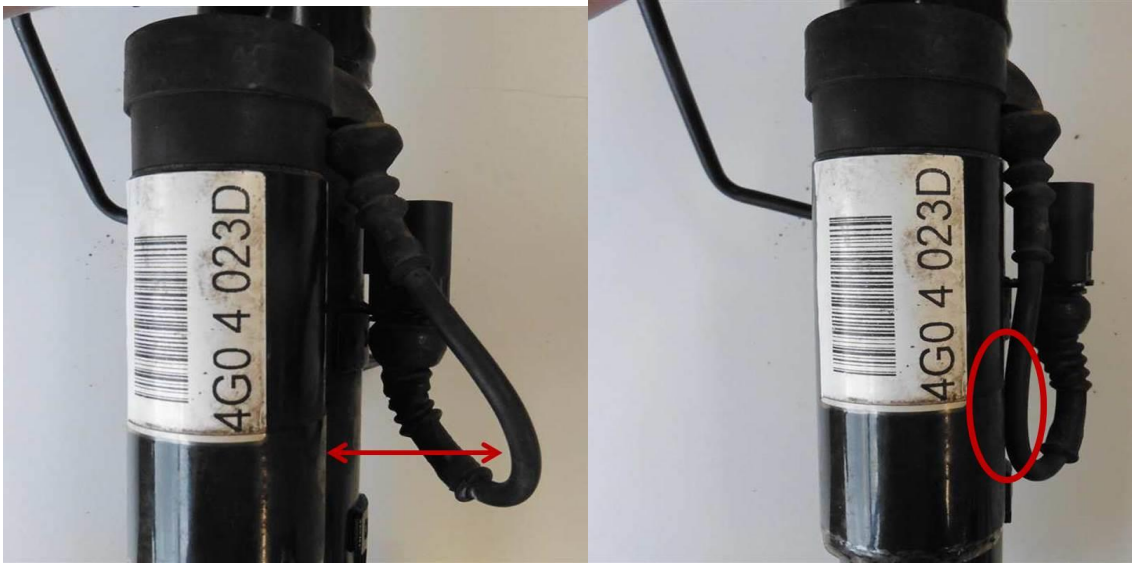
Figure 3. Twisted cables.
