Technical Service Bulletin

64 Creaking noises from front or rear windshield area

64 17 46 2046397/3 December 4, 2017. Supersedes Technical Service Bulletin Group 64 number 17-43 dated September 19, 2017 for reasons listed below.

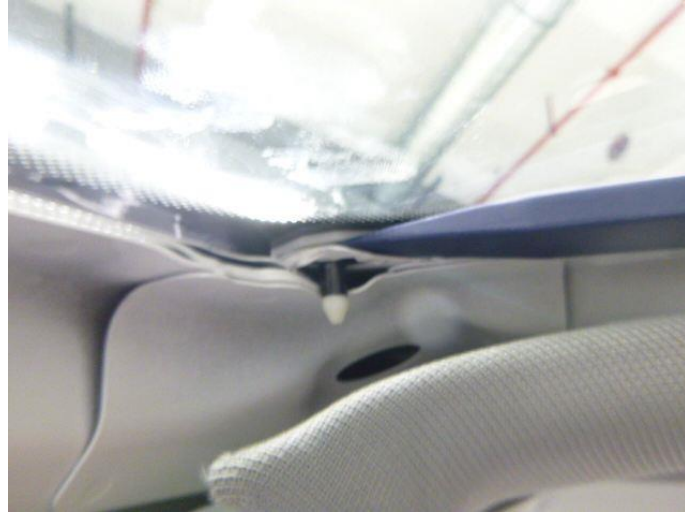
Creaking noises in the front windshield area on the upper A pillar or on the upper corners of the rear windshield. The noise can occur on the left or right sides of the front and rear windshield.

The guide pins on the upper end of the windscreen and rear window, which are needed in production for positioning, make noises when scraping on the body.

Figure 1. Increase the distance between plastic pin and metal lug.

1. If the noise occurs on the windshield in the A pillar area, remove the sun visor and the A pillar trim according to the repair manual. Once you can see the plastic pin and the metal lug which is in the plastic pin as shown in the illustration. Increase the distance between plastic pin and metal lug with a plastic wedge by bending down the metal lug by 1-2mm (Figure 1).

2. After the repair, check whether the noise is still there by pressing down on the windshield near the guide pin. If the noise is still there, you can increase the distance between plastic pin and metal lug a little more.
