Technical Service Bulletin

91 Audi connect myAudi pin not saved for stored online destinations

91 17 63 2047433/3 December 6, 2017. Supersedes Technical Service Bulletin Group 91 number 17-38 dated July 27, 2017 for reasons listed below.

Model(s)	Year	VIN Range	Vehicle-Specific Equipment
A6, A7	2016 – 2017	All	MIB2 High

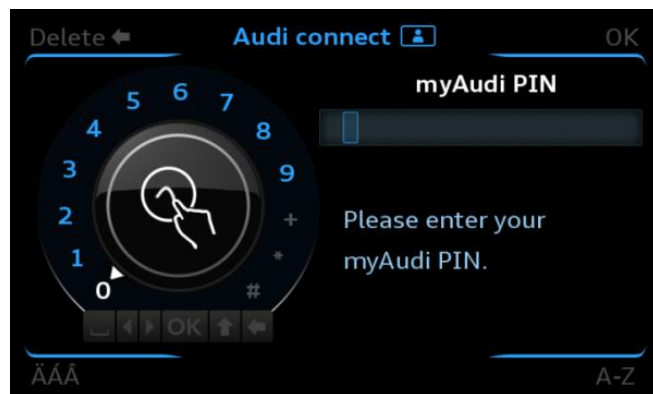
The vehicle is a MY2016 or MY2017 A6, A7, S6, S7, or RS7 and the customer states that when retrieving the stored myAudi online destinations, the myAudi PIN (Figure 1) is not saved and must be entered each time after the vehicle has been switched off for a long period of time. Additionally, the customer's vehicle is equipped with MMI Navigation plus (MIB2 High; PR code "7UG").

Figure 1. myAudi Pin entry screen.

The condition is the result of an MMI software bug and can be fixed by updating the MMI software. The software bug only prevents the myAudi PIN from being stored in the navigation area of the MMI menu. The myAudi pin is saved in the Audi connect menu for accessing custom news feeds.

The service solution is to update the MMI software to SW1062 for MY16 and SW0924 for MY17 to fix the myAudi PIN issue.

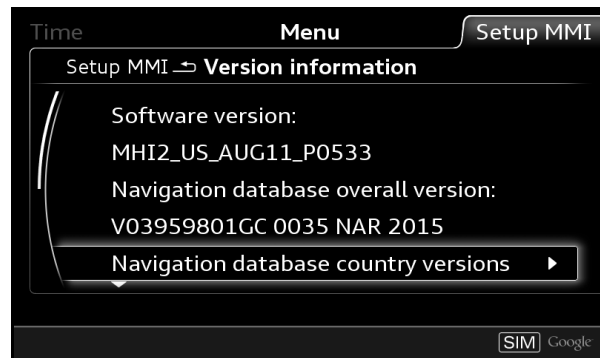
Figure 2. MMI Version Information.

1. Verify that the customer's MMI requires the software update by going to the *Main Menu* >> *Setup MMI* >> *Version Information* (Figure 2).
