# Technical Service Bulletin

## 91 MIB2 MMI Bluetooth quality at the other end of call is distorted; caller cannot hear driver or hears only an echo

91 17 64 2041925/4 December 7, 2017. Supersedes Technical Service Bulletin Group 91 number 16-98 dated December 21, 2016 for reasons listed below.

Model(s)	Year	VIN Range	Vehicle-Specific Equipment
A6, A7	2016	All	MIB-2 Navigation

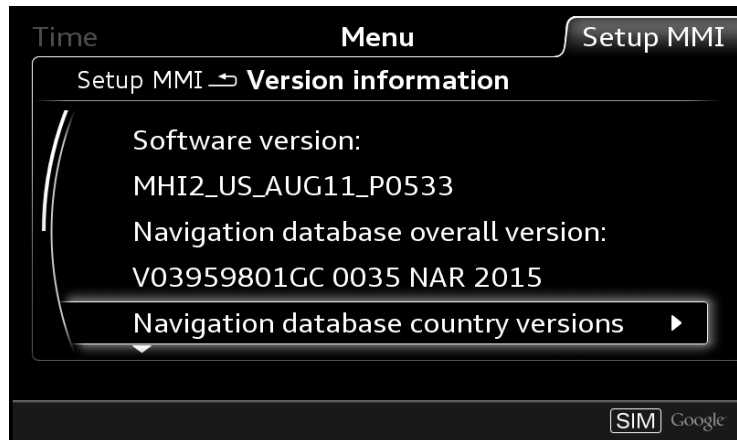
**Figure 2.** MMI Version Information.

1. Verify that the customer's MMI requires the software update by going to the *Main Menu* >> *Setup MMI* >> *Version Information* (Figure 2) and ensure the Software version is less than 0539 (Can be P0533 or K0533, where P = production software and K = Kunden or Customer update).

The service solution is to update the MMI software to SW1062 (K0539).
