# Technical Service Bulletin

## 91 A3 e-tron smartphone app & web portal vehicle data cannot be updated with error "Vehicle not reachable"

91 17 65 2049406/1 December 7, 2017.

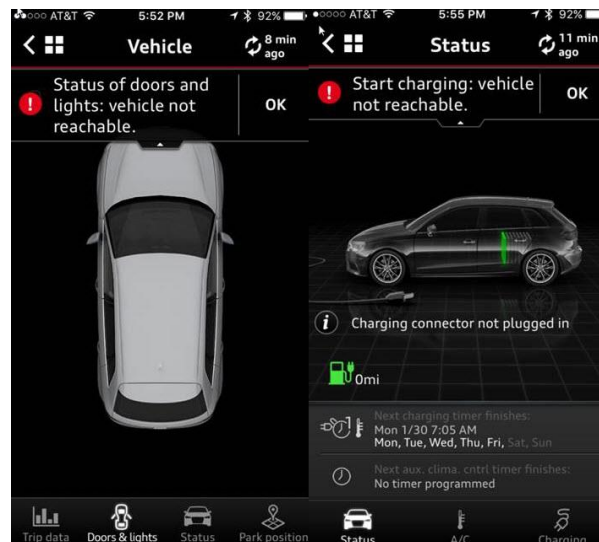
The customer states that the Audi connect services from the A3 e-tron smartphone app or web portal do not work. The message "Vehicle not reachable" appears when refreshing the data or when attempting to update the vehicle charge or HVAC settings (Figure 1).

**Figure 1.** Error message in e-tron smartphone app.

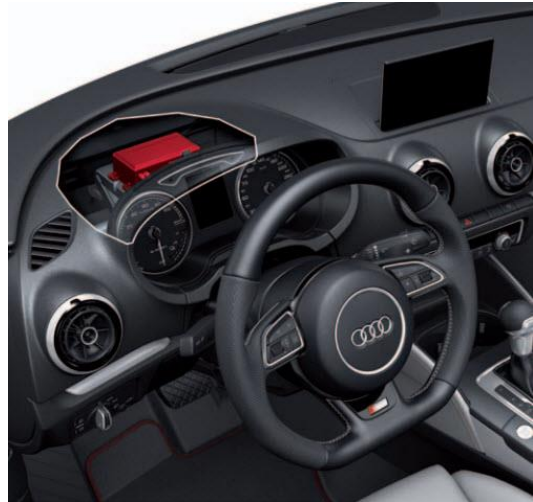
*Figure 2. OCU location (Red).*

This repair involves installing an extra external cellular antenna in the vehicle. The new antenna will either be used by the MMI, PR Code 7UG, or connected directly to the control module for emergency call module and communication unit (OCU), J949 (address word 0075), PR Code 7Q0. It is important to note there are two different possible MMI systems (PR codes 7UG or 7Q0) with two different repair processes.
