Technical Service Bulletin

70 Noises from headliner/sunroof area

70 17 65 2044417/7 November 1, 2017. Supersedes Technical Service Bulletin Group 70 number 17-64 dated September 20, 2017 for reasons listed below.

Model(s)	Year	VIN Range	Vehicle-Specific Equipment
A4 allroad, Q7	2017 - 2018	All	Not Applicable

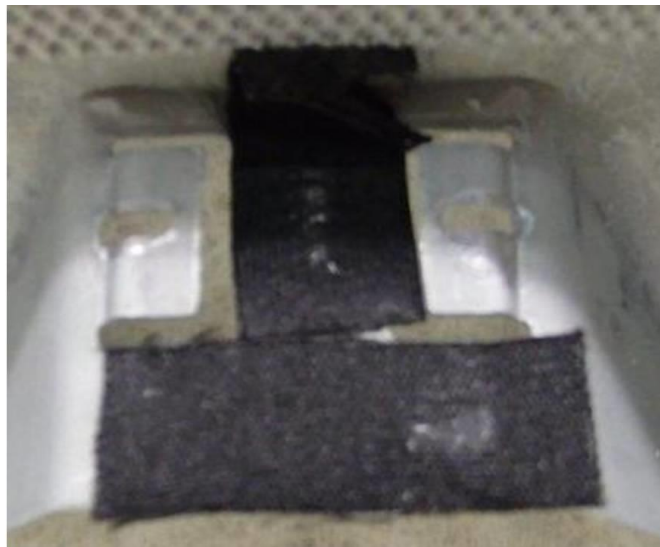
Figure 2. Location of the webbing adhesive tape application.

3. Remove the clips and apply the webbing adhesive tape underneath them, as shown (Figure 2).

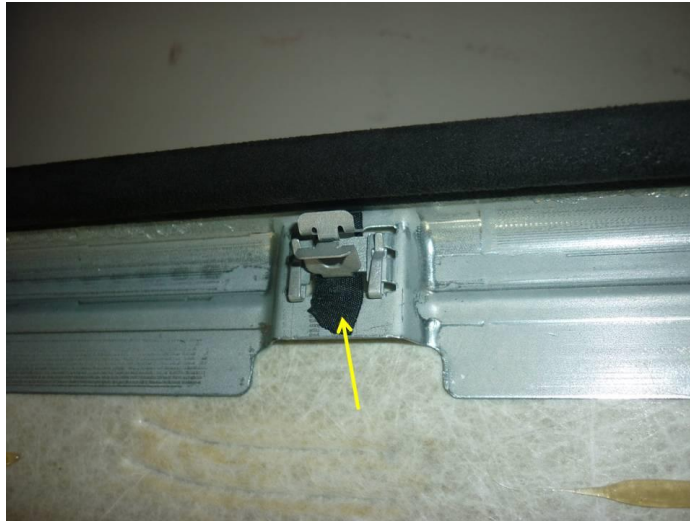
Figure 3. Clips reinstalled.

4. Reinstall the clips (Figure 3).

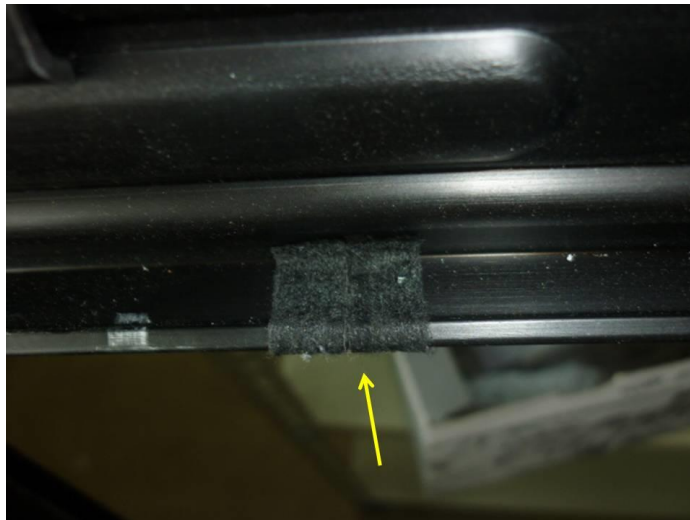
Figure 4. Application area on sunroof frame area of clip engagement.

5. Apply webbing adhesive tape to the sunroof frame lip at each clipping point (Figure 4).

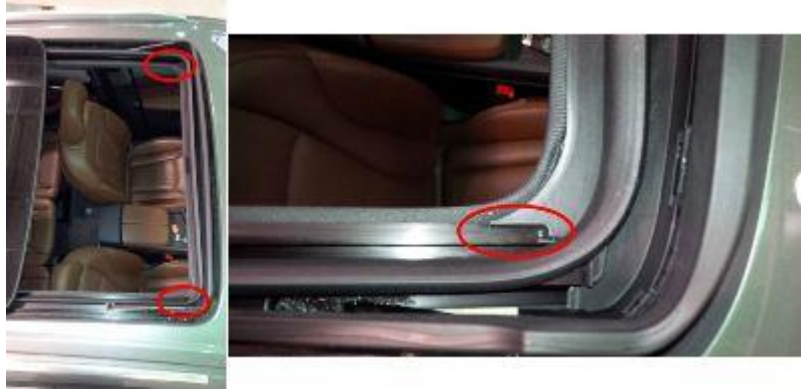
6. There are two additional points of contact at the front sunroof frame plates that could be a source for noise (Figure 5).

Figure 5. Areas of the sunroof frame to be isolated with webbing adhesive tape.

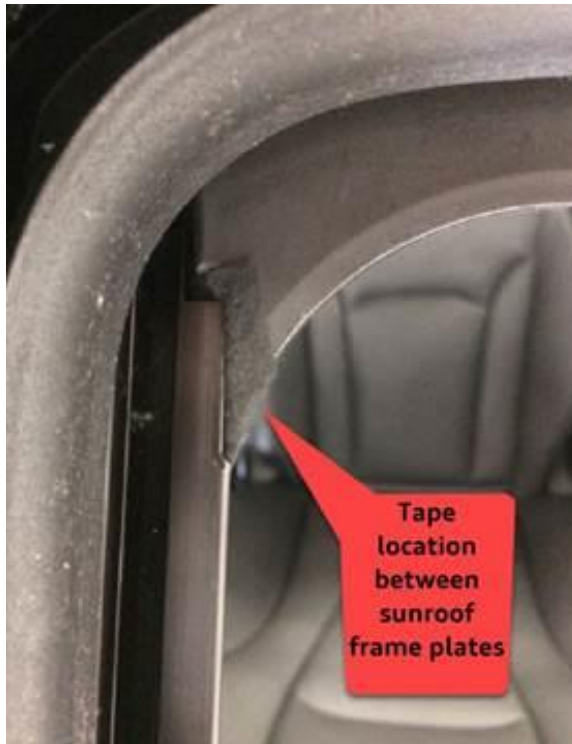
Figure 6. Webbing adhesive tape applied between the side and front sunroof frame plates.

7. Apply webbing adhesive tape between the sections of the sunroof frame plates on both the right and left sides as shown in the illustration (Figure 6).
