Technical Service Bulletin

90 Audi Drive Select button on steering wheel does not function

90 17 86 2048839/1 November 13, 2017.

Model(s)	Year	VIN Range	Vehicle-Specific Equipment
R8	2017	All	Without plus package

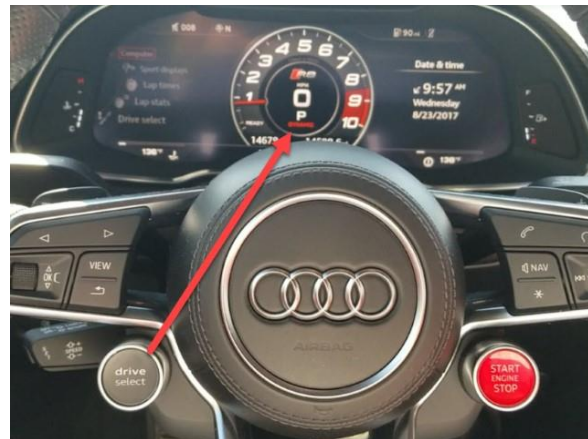
First Scenario: Upon the first press of the Audi Drive Select button, the current driver profile is shown (Figure 1). There is no change to the current setting until a second press of the button. If the second press is not performed within three seconds of the first press of the button, then the current profile will be shown again and no change will be made. The customer must press the button twice within three seconds to allow the selection of a new driver profile. The MMI menu for Drive Select Profiles does not show when the button is pressed (Figure 3). This is a normal condition.

Figure 1. Drive Select Mode change Gauge Cluster.

Please inform the customer of the first two “normal” scenarios listed in the *Technical Background*. Ensure that the customer understands the two normal conditions and has the correct expectations. If the customer is experiencing the condition listed in scenario three as mentioned above, then proceed with the service repair below.

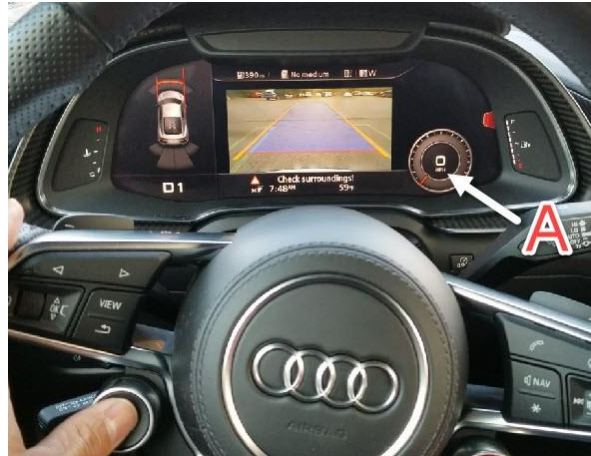
Second Scenario: When the vehicle is in the backup camera mode, there is no change shown in the virtual cockpit while the camera image is visible. However, the profile change happens in the background (Figure 2). This is a normal condition.

Figure 2. Drive Select Mode not shown in the Gauge Cluster.

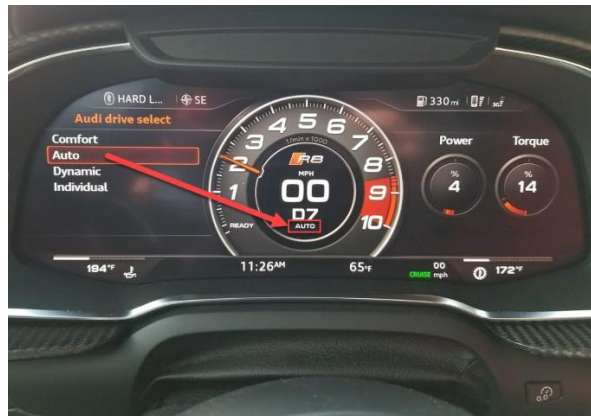
Third Scenario: When the customer presses the drive select button multiple times (within three seconds of each press) immediately after starting the engine, and after allowing the virtual cockpit to initialize, there is no visible change to the driver profile after each button press. There is a known software concern which can prevent the button from functioning normally after the vehicle is started following a sleep cycle. If the customer is experiencing this concern, then proceed to the *Service* section.

To overcome this issue listed in scenario three, the driver can use the MMI controls to navigate to the Audi Drive Select menu manually (Listed under Vehicle Settings – Figure 3), and after viewing this MMI menu, the Drive Select steering wheel button will begin to function normally only during the current ignition cycle. Once the vehicle is allowed to sleep, the concern is repeated again on the subsequent ignition cycle (Figure 3).

Figure 3. MMI Drive Select Mode shown in Vehicle Settings and Gauge Cluster.

Update the operating software of the vehicle electrical system control module, J519 (address word 0009) with the SVM. To access SVM, within ODIS start *GFF >> Flash >> Start Flashing >> SVM code input*.
