# Technical Service Bulletin

## 91 MMI3G+ Audi connect only reaches 2G service - Telephone module replacement instructions for A4,A5,A5 Cab,Q5,Q7,A8

91 17 57 2039476/8 November 3, 2017. Supersedes Technical Service Bulletin Group 91 number 16-70 dated September 7, 2016 for reasons listed below.

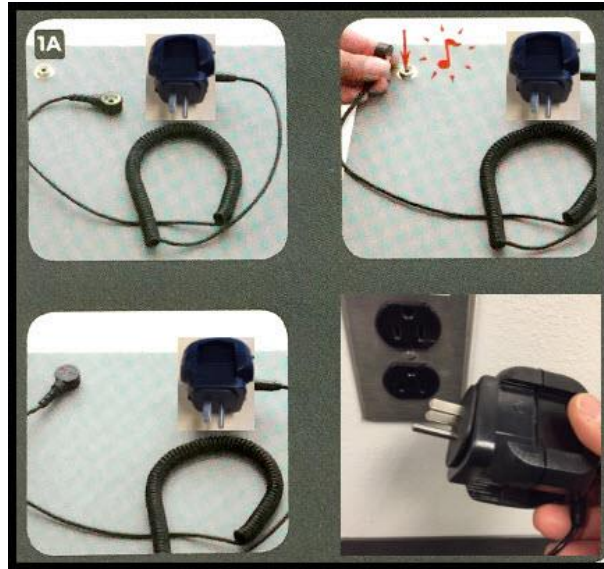
**Figure 2.** VAS6613 ESD work surface grounding plug.

4. Ground the ESD mat by plugging the 110V grounding strap into a wall socket or power strip (Figure 2). If a power strip is used, it must be plugged into a grounded wall outlet (see attached user instructions for VAS6613 titled "VAS6613 ESD Workspace Guide.pdf").

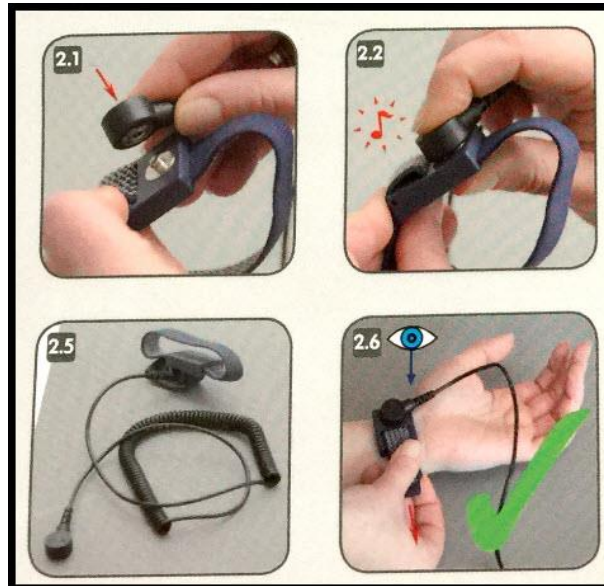
**Figure 3.** VAS6613 ESD work surface grounding wrist strap.

5. Ground yourself by placing the elastic strap around your wrist. Make sure it is securely touching your skin. It cannot be loose-fitting or over your shirt cuff (Figure 3).

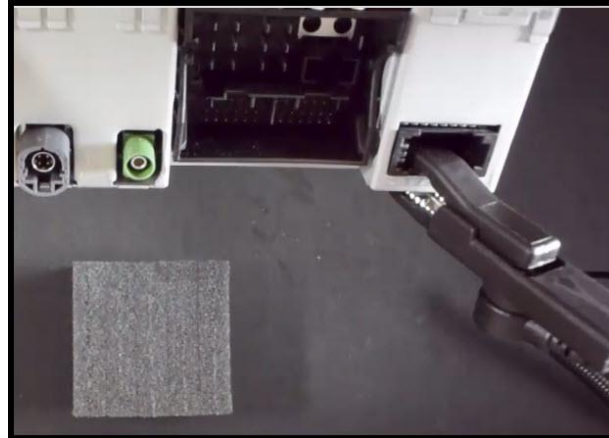
**Figure 4.** VAS6613 ESD work surface grounding device clip.

6. Ground the MMI main unit by placing an alligator clip on the back, ensuring that it makes contact with the metal housing of the main unit. The most secure location is at the MOST connector (Figure 4).

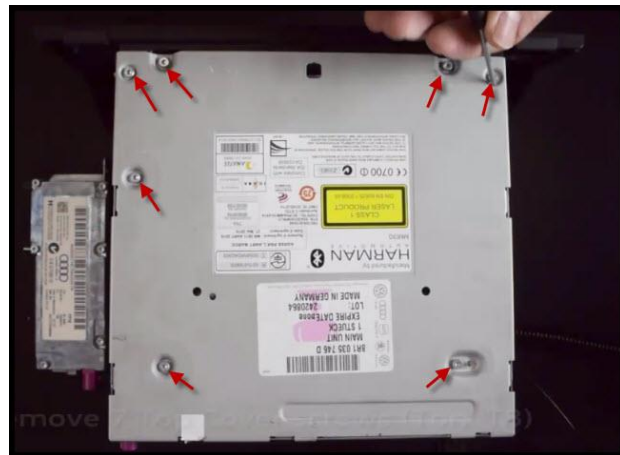
**Figure 5.** MMI main unit with screw locations for top cover indicated by the red arrows.

7. Remove the seven screws that are holding the MMI top cover in place (Figure 5).

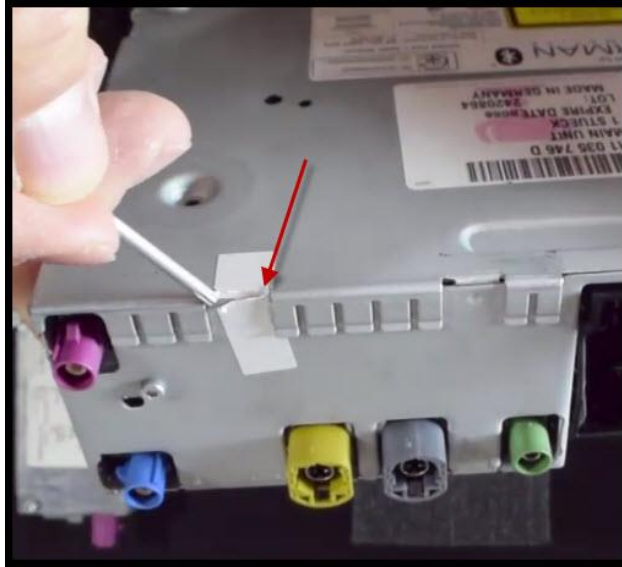
*Figure 6. Break white warranty seal.*

8. Break the white warranty seal on the back of the main unit (Figure 6).

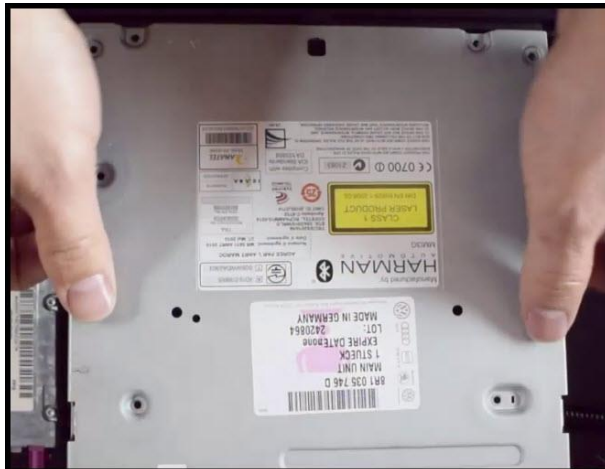
*Figure 7. Pry top cover off with fingers.*

9. Using a flat head screw driver, your fingers or a plastic wedge trim tool, remove the top cover (Figure 7) by prying it from the back of the cover at the location seen in Figure 8. If a flat head screw driver is used then touch the tool to the ESD mat to discharge the tool prior to touching the main unit.

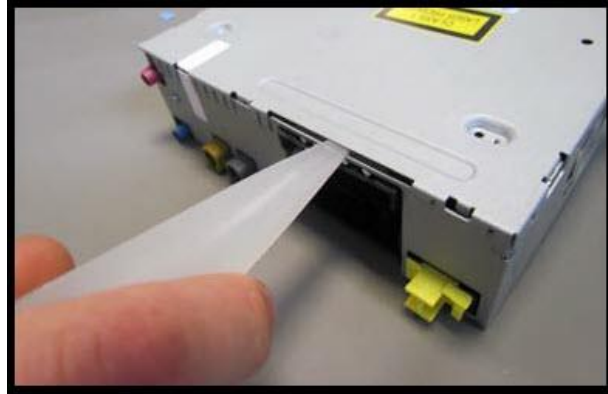
*Figure 8. Pry top cover off using plastic trim wedge tool.*

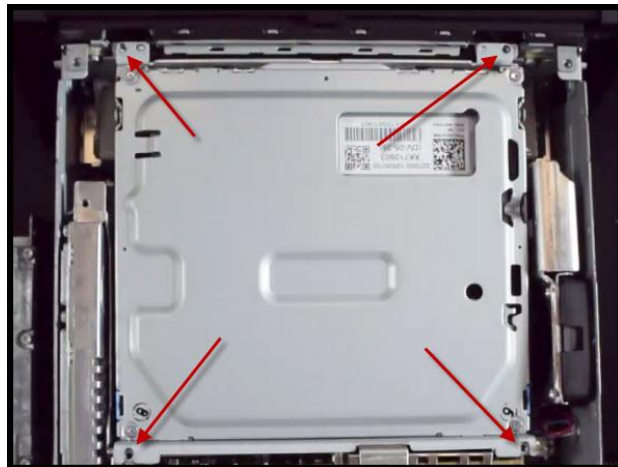
Do not flip the main unit over at this point. The CD drive, which was held in place by the top cover screws, is no longer secured. If it moves significantly, the ribbon cable can detach from the circuit board and disable the CD drive's functionality (Figure 9).

*Figure 9. CD drive mounting points are free to move.*

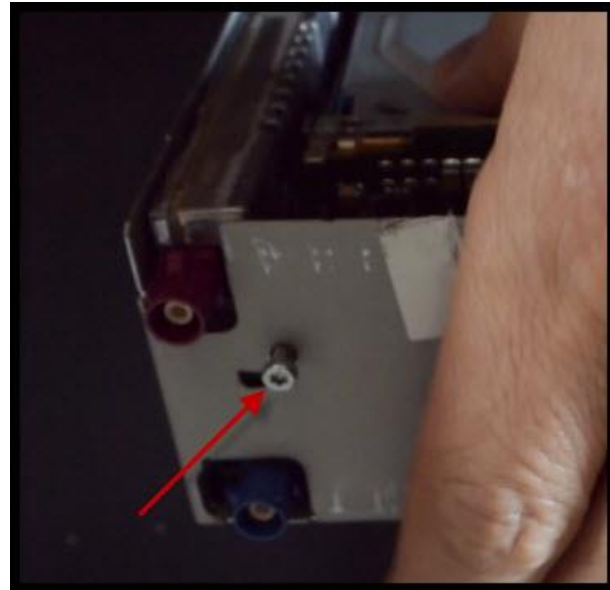
**Figure 10.** Telephone module retaining screw indicated by the red arrow.

10. On the back of the main unit, remove the retaining screw that holds the telephone module in place (Figure 10).

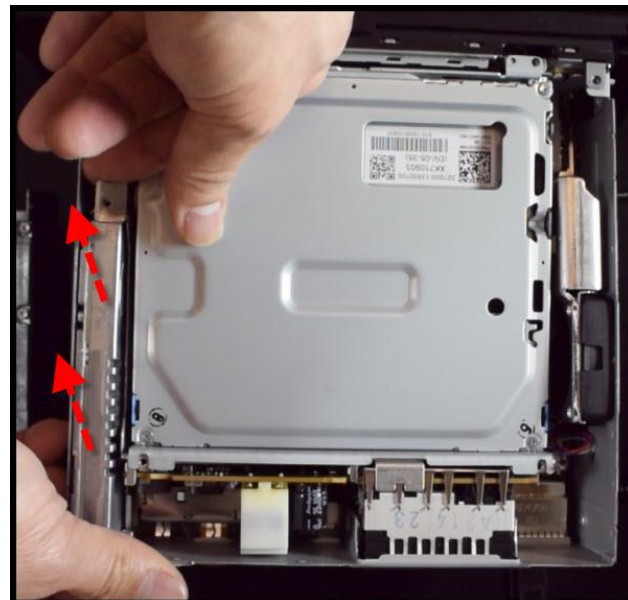
**Figure 11.** Lift up on both ends of the telephone module as indicated by the red arrows.

11. Carefully lift up the telephone module, using both ends as points of contact when pulling up (Figure 11). The module is held in place with a computer socket-type attachment and will release when enough force is used.

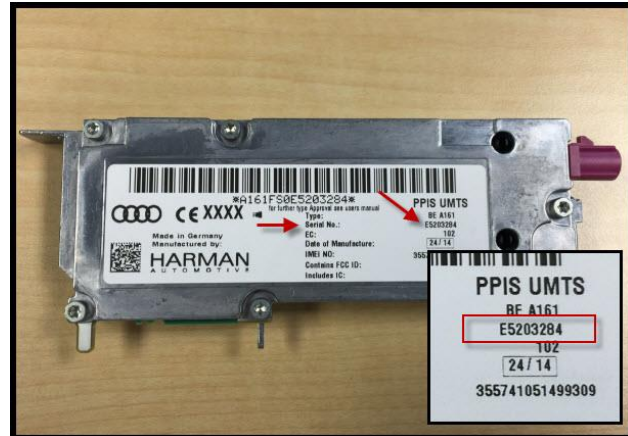
**Figure 12.** Serial number of the PPIS UMTS telephone module indicated by the red arrows and red box.

12. Before proceeding, write the serial number of the new replacement UMTS telephone module on the rework label (Figure 12).

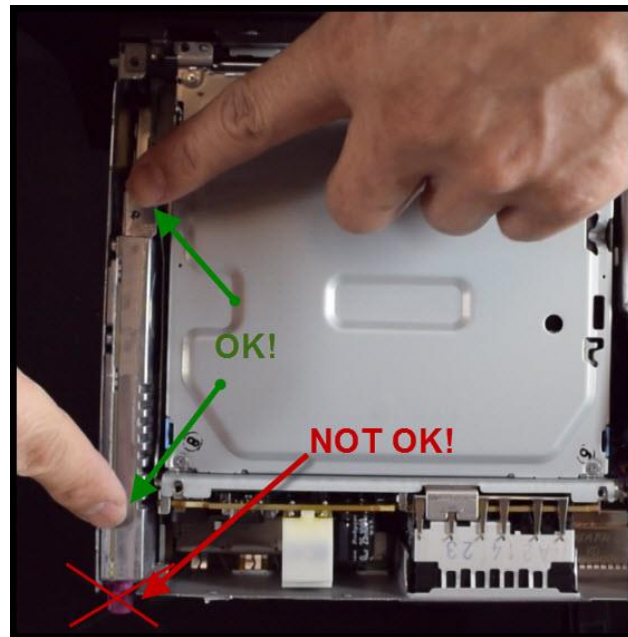
**Figure 13.** Do not press down using the purple FAKRA connector.

13. Place the new UMTS telephone module into the socket, making sure it is level before snapping it into place. Use both ends of the telephone module when pressing it into place. Do not press down using the purple FAKRA connector (Figure 13).

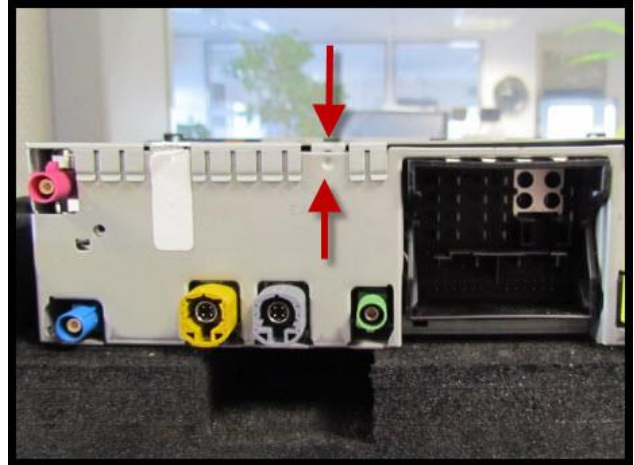
**Figure 14.** Place the new warranty seal over the location indicated by the red arrows.

17. Place the new warranty seal from the retrofit kit next to the original warranty seal (Figure 14).

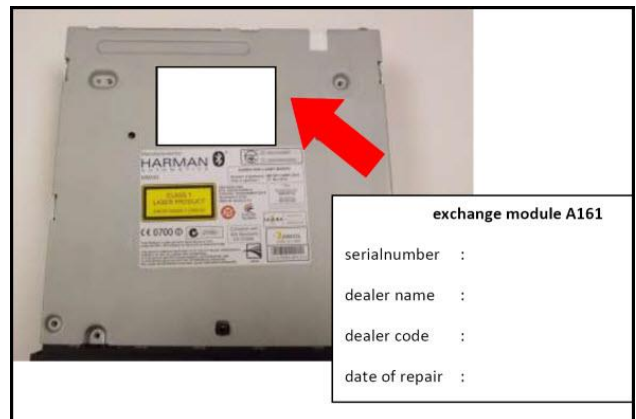
**Figure 15.** The white area indicates the “suggested” location for the repair label on the top cover of the main unit. Do not cover any existing part number labels.

18. Place the rework label on the top of the main unit cover. Do not cover any part number labels (Figure 15). Fill out all fields on the repair label.

Do not cover the yellow laser warning label. The repair label may need to be placed on sideways due to space limitations.
