# Technical Service Bulletin

## 91 SOS warning displayed in instrument cluster (DTC B105313)

91 17 58 2048360/2 November 6, 2017. Supersedes Technical Service Bulletin Group 97 number 17-57 dated July 13, 2017 for reasons listed below.

Model(s)	Year	VIN Range	Vehicle-Specific Equipment
Q7	2017	037860 - 999999	With connected gateway
Q7	2018	All	With connected gateway

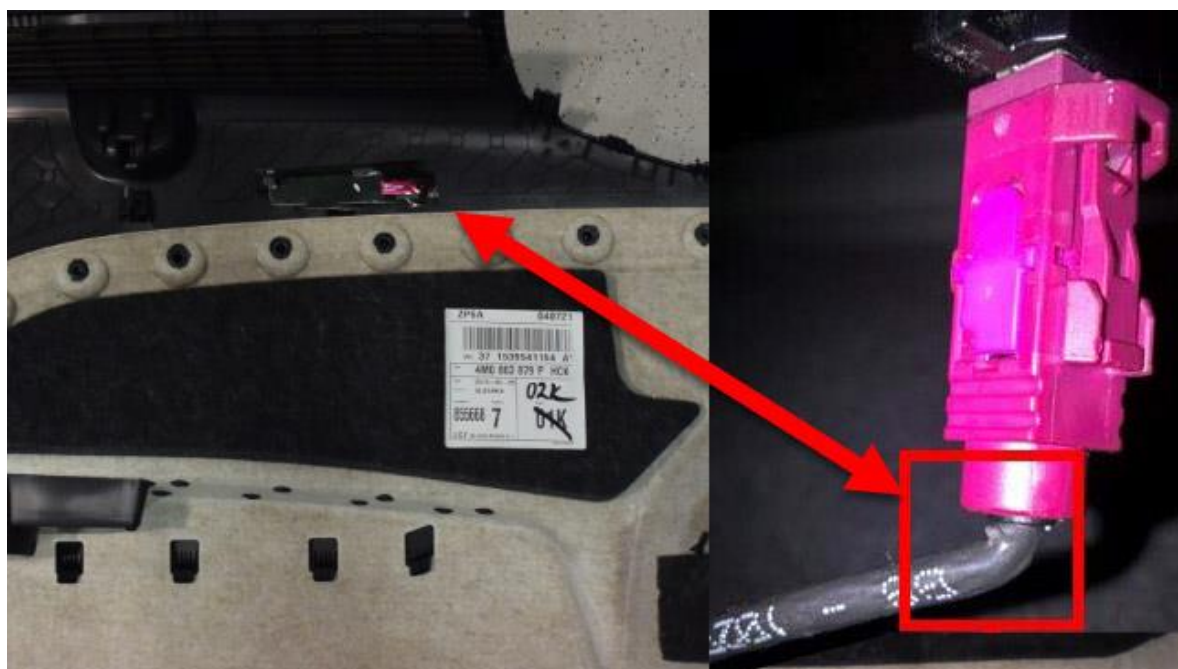
The contact on the wiring of the emergency call aerial may have been damaged in production.

**Figure 2.** Coaxial wire kinked at R263 SOS Antenna.

3. Repair existing coaxial harness:
  - Unplug the FAKRA connector from the R263 SOS Antenna.
  - Remove 200mm (7 ¾ inches) of coax wire from the existing harness. Measure from the front of the FAKRA connector (Figure 3).
  - Using the VAS 6720, install a new female FAKRA Terminal (Figure 4B) onto the vehicle's coaxial harness. Install a new Fakra Housing (Figure 4A) onto the newly installed terminal.

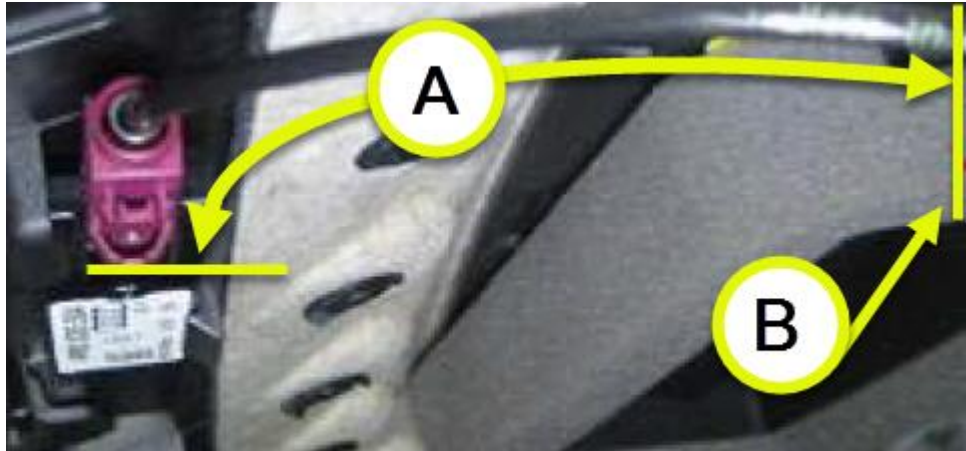
**Figure 3.** Cut the coaxial harness (B) 200mm (7 ¾ inches) (A) from the start of the Fakra connector.

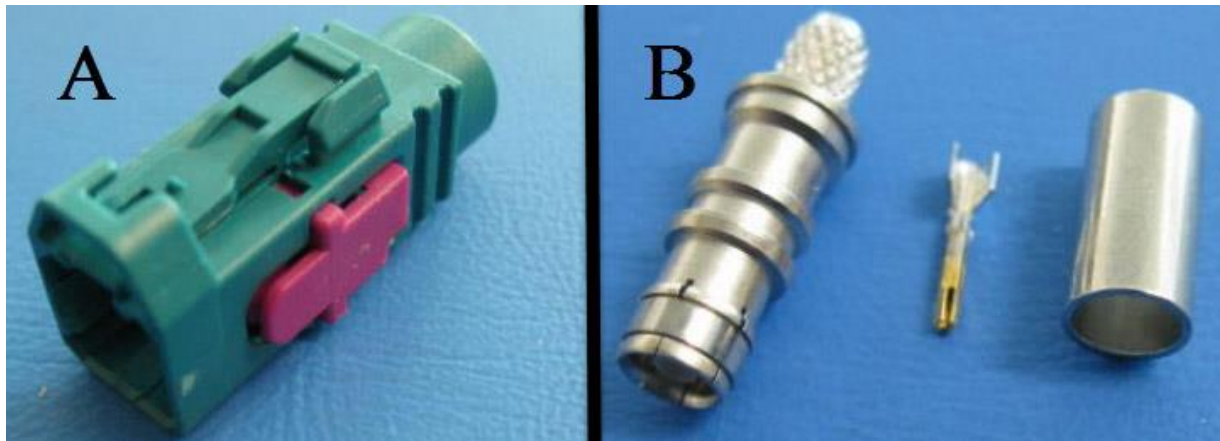
**Figure 4.** A: Fakra Housing 6Q0035576K, B: Fakra Terminal: 000979910.

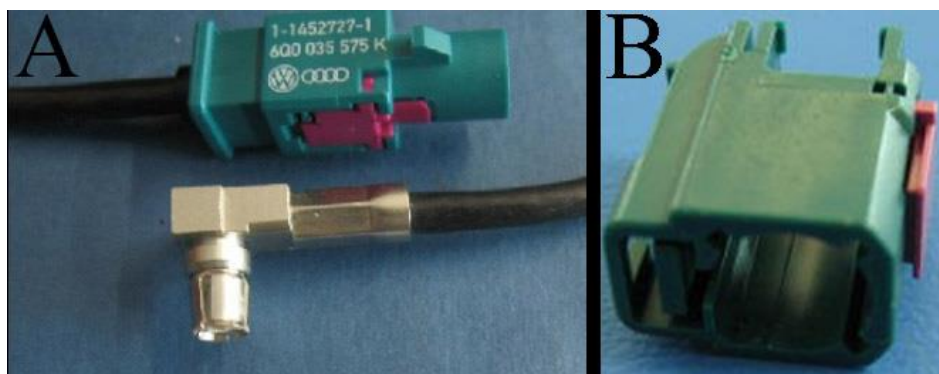
**Figure 5.** A: Adapter antenna cable 000098691. B: 4E0035675K Connector housing for angled-antenna-bush-plug.

- Install a 90 degree right angle adapter antenna cable (Figure 5) between the newly installed Fakra connector from step 3 and the SOS antenna. To complete the 90 degree right angle adapter cable assembly, you will need to install the connector housing for angled-antenna-bush-plug (5B) onto the adapter antenna cable (5A).
- Re-install all components.

**Tip:** The cable must be free of tension around the area of the connector.
