Technical Service Bulletin

91 MMI3G+ Navigation not available; error message "Navigation data is invalid" (DTC 03623 and 03677)

91 17 59 2040579/4 November 10, 2017. Supersedes Technical Service Bulletin Group 91 number 16-50 dated June 24, 2016 for reasons listed below.

Model(s)	Year	VIN Range	Vehicle-Specific Equipment
A4, A5, A5 Cabriolet, A8, Q3, Q5, and Q7	2015 - 2016	All	MMI3G+ navigation

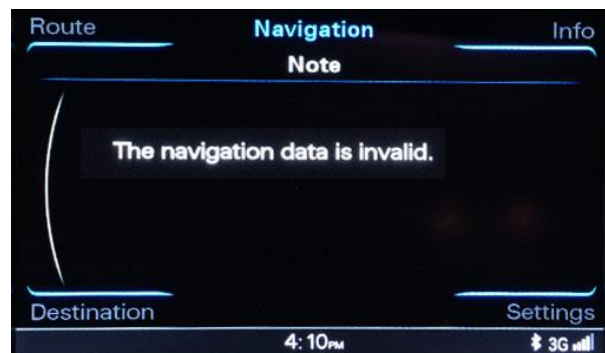
- The error message "Navigation data is invalid" appears in the MMI (Figure 1) and the Navigation map cannot be accessed.

Figure 1. "The navigation data is invalid"

During a certain production period, the software for the MMI was incorrectly configured. As a result, Navigation cannot be activated.

2. If both DTCs are present, update the software of the information electronics control module 1, J794 (address word 005F), according to TSB 2030465: *91 MMI 3G+ MMI inop; blank screen at startup; various technical issues (K0942 ZUG update; supersedes K0814 update)* with K0942.

3. If the error message is still present after the MMI software update is performed, use ODIS to perform the Guided Fault Finding Replacement test plan for the information electronics control module 1, J794 (address word 005F).
4. After all ODIS actions are completed, perform a quick verification check of all MMI functions.
