Technical Service Bulletin

91 MMI3G+ GPS navigation location inaccurate or navigation takes a very long time to acquire location

91 17 60 2040406/8 November 10, 2017. Supersedes Technical Service Bulletin Group 91 number 16-81 dated October 5, 2016 for reasons listed below.

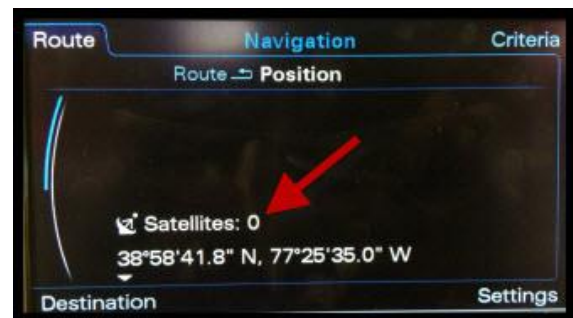
Figure 1. No satellite reception.

- When the issue occurs, the GPS navigation system satellite reception shows 0 satellites. Due to the infrequency of the issue, this might not be verifiable. (To view the number of satellites being received, go to *Nav >> Route >> Select Current Position* (first item in list) and scroll up (Figure 1)).

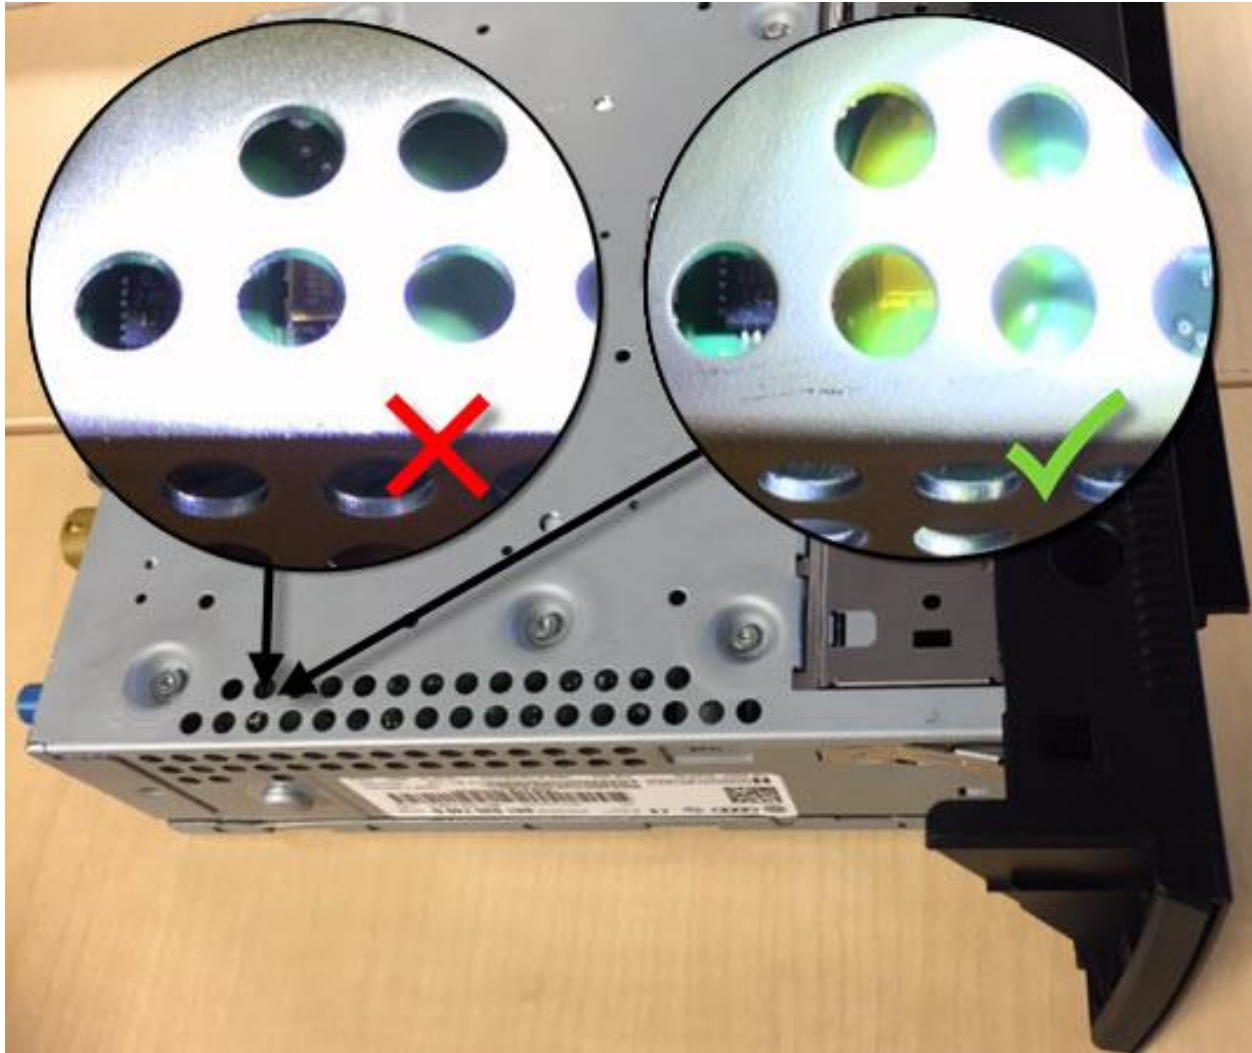
Figure 2. Example of integrated circuit chip without coating (left) and with coating (right). Parts without the coating over the integrated circuit chip are not okay and should be replaced.

Some early service parts did not have the coating despite the updated hardware part number (G suffix) and build date. All parts built after November 08, 2014 should have the coating over the integrated circuit chip. If the part does not have the coating over the integrated circuit chip, return the part and order a replacement.

3. Order a replacement MMI main unit using the applicable part number listed in the parts table below. There are different variants of main units that have support for a SIM card slot and some variants that do not. Once the new part arrives, check the integrated circuit chip of the GPS oscillator on the internal circuit board. The chip should have a translucent yellow coating (Figure 2).
