Technical Service Bulletin

94 Rear lights do not switch from bumper to hatchgate

94 17 92 2047618/2 November 1, 2017. Supersedes Technical Service Bulletin Group 94 number 17-87 dated April 25, 2017 for reasons listed below.

Model(s)	Year	VIN Range	Vehicle-Specific Equipment
Q7	2017	010120 - 999999	Not Applicable
Q7	2018	All	Not Applicable

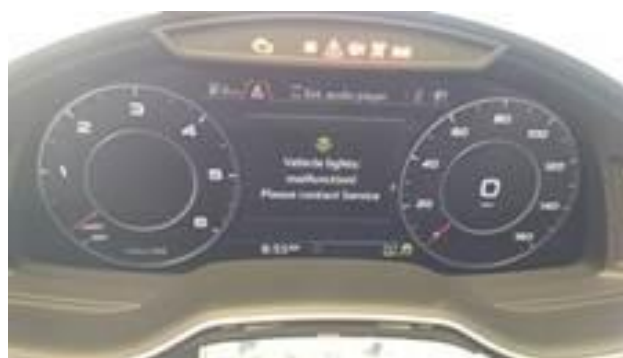
- When the rear lid is closed, the lights in the rear bumper do not switch over to the main lights on the rear lid.
- The error message “Vehicle lights: malfunction! Please contact Service” intermittently appears in the driver information system (Figure 1).
- All of the rear light bulbs are fully functional. None are found to be faulty or incorrect.

Figure 1. Error message.

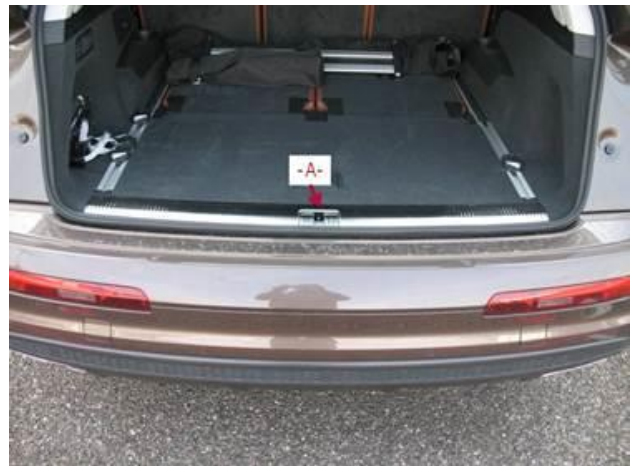
Figure 4. Striker cover opening.

1. Press down the striker cover on the loading sill cover -A- (Figure 4).

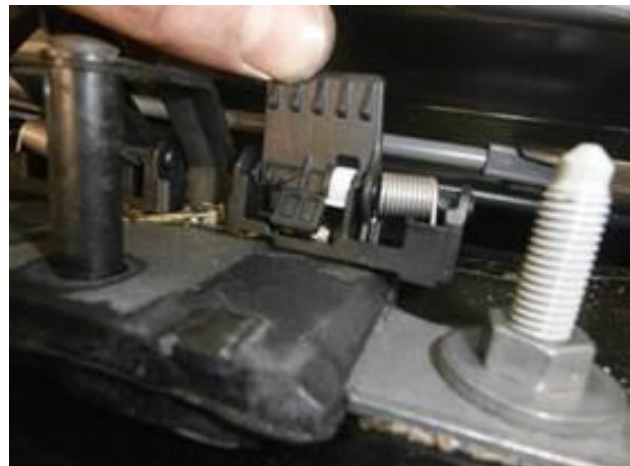
Figure 5. Debris trapped in the Rear Lid Closed Sensor.

2. Blow out any debris that might be causing an obstruction with compressed air (Figure 5).
