# Technical Service Bulletin

## 90K3 UPDATE – Software Update for Instrument Cluster (NVLW)

November 14, 2017

| Model(s) | Year | VIN Range | Vehicle-Specific Equipment |
|---|---|---|---|
| A6 and A7 | 2017 | See ELSA | See ELSA |

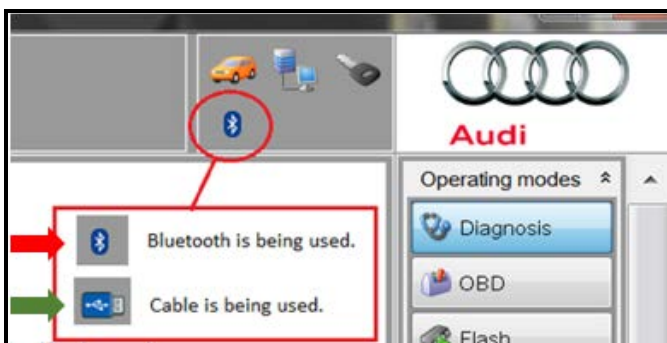
4. Attach the scan tool to the vehicle using an USB cable.
5. Confirm that the scan tool is communicating with the diagnostic head by USB <Green Arrow>. If the Bluetooth symbol is shown <Red Arrow> then disconnect the diagnostic head from the vehicle and then reattach the USB cable to the diagnostic head and then reattach to the vehicle.
