Technical Service Bulletin

91Q5 UPDATE – Software Update for MMI (NVLW)

November 14, 2017

Model(s)	Year	VIN Range	Vehicle-Specific Equipment
A3, A5 and Q5	2018	See ELSA	See ELSA

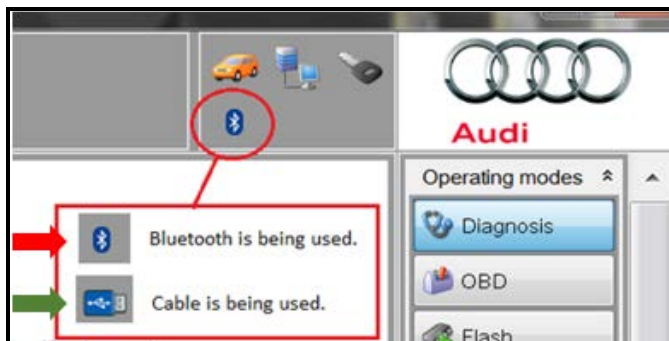
4. Attach the scan tool to the vehicle using an USB cable.
5. Confirm that the scan tool is communicating with the diagnostic head by USB <Green Arrow>. If the Bluetooth symbol is shown <Red Arrow> then disconnect the diagnostic head from the vehicle and then reattach the USB cable to the diagnostic head and then reattach to the vehicle.
