Emissions Recall

Code: 23V6

Subject	3.0L TDI Engine Emissions System Modification – Customer Only (Retail Sold) TDI Vehicles <u>USA ONLY</u>		
Release Date	November 6, 2017		
Affected Vehicles	<p>U.S.A.: 2013-2014 MY Volkswagen Touareg 3.0L TDI Generation 2.1</p> <p><i>Check Campaigns/Actions screen in Elsa on the day of repair to verify that a VIN qualifies for repair under this action. Elsa is the <u>only</u> valid campaign inquiry & verification source.</i></p> <ul style="list-style-type: none"> ✓ Campaign status must show “open.” ✓ If Elsa shows other open action(s), inform your customer so that the work can also be completed at the same time the vehicle is in the workshop for this campaign. 		
Problem Description	3.0L TDI vehicles were equipped with undisclosed Auxiliary Emission Control Devices which are not permitted by emissions regulations.		
Corrective Action	Install updated engine control module (ECM) software, transmission control module (TCM) software and hardware to bring affected vehicles into regulatory compliance.		
Code Visibility	On or about November 6, 2017, affected vehicles will be listed on the Inventory Vehicle Open Campaign Action report under My Dealersh

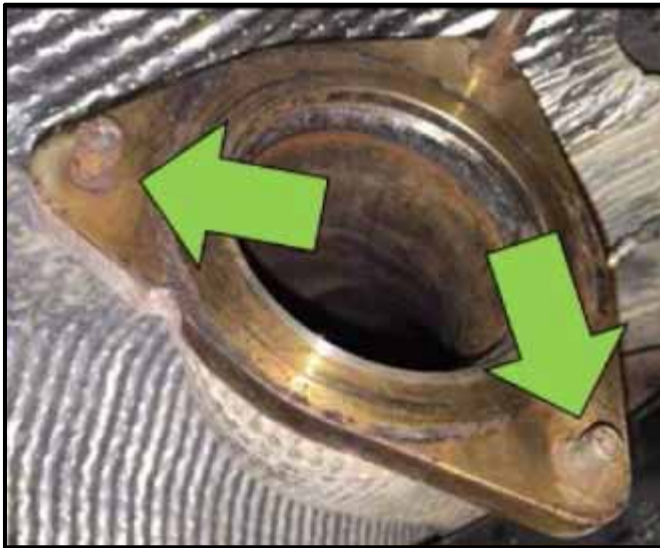
Due to corrosion, one or more of the mounting studs may break <arrows> when removing the SCR catalytic converter from the Diesel Particulate Filter (DPF) flange. Follow the steps below if one or more studs are broken or damaged.

DO NOT use a hammer and punch, heat, air hammer, or other method to remove the studs from the DPF. Consequential damage to the DPF or ancillary components **will NOT be covered** under this action due to damage from heat, impact, or vibration.

- If stud replacement is necessary, use a commercially available clevis pin press, such as an OTC 5057 (shown) or equivalent to press any broken or damaged studs out of the DPF flange.
 - It is advised if one stud breaks that all three studs are pressed out and replaced with the bolts/nuts included in the parts kit.
- Install the replacement bolts and corresponding nuts into the rear DPF flange.
