# Emissions Recall

## Code: 23V6

<b>Subject</b>	<b>3.0L TDI Engine Emissions System Modification – Customer Only (Retail Sold) TDI Vehicles <u>USA ONLY</u></b>
<b>Release Date</b>	November 9, 2017
<b>Revision Summary</b>	<b>Updated work procedure and added link to repair video.</b>
<b>Affected Vehicles</b>	<p><b>U.S.A.: 2013-2014 MY Volkswagen Touareg 3.0L TDI Generation 2.1</b></p> <p><i>Check Campaigns/Actions screen in Elsa on the day of repair to verify that a VIN qualifies for repair under this action. Elsa is the <u>only</u> valid campaign inquiry &amp; verification source.</i></p> <ul style="list-style-type: none"> <li>✓ Campaign status must show “open.”</li> <li>✓ If Elsa shows other open action(s), inform your customer so that the work can also be completed at the same time the vehicle is in the workshop for this campaign.</li> </ul>
<b>Problem Description</b>	3.0L TDI vehicles were equipped with undisclosed Auxiliary Emission Control Devices which are not permitted by emissions regulations.

<b>Corrective Action</b>	Install updated engine control module (ECM) software, transmission control module (TCM) software and hardware to bring affected vehicles into regulatory com

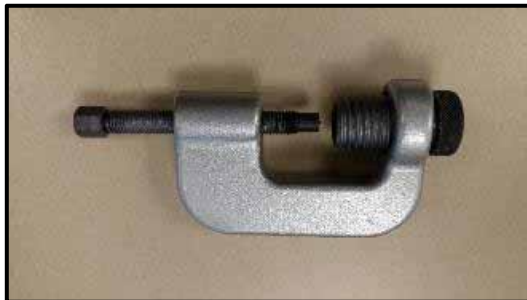
Due to corrosion, one or more of the mounting studs may break <arrows> when removing the SCR catalytic converter from the Diesel Particulate Filter (DPF) flange.

Consequential damage to Exhaust Gas Temperature Sensors, Diesel Particulate Filter, AdBlue Injector Feed Line, or any other ancillary components **WILL NOT BE COVERED** under this action due to damage from heat, impact, or vibration.

- If stud replacement is necessary, **IT IS REQUIRED** to use a press tool such as the OTC 5057 clevis pin press (or equivalent), or other available screw or hydraulic type clevis/stud press tool to remove all necessary studs from the rear DPF flange.
  - It is advised if one stud breaks that all three studs are pressed out and replaced with the bolts/nuts included in the parts kit.
  - For best results, cut any studs that do not break off as close to the flange as possible. Pressing a full length stud increases the chance of bending the stud, which may complicate the removal process.
  - Use a cap from the VAS 6122 Engine Bung Set (or equivalent) to cover the hole in the DPF to eliminate the chance of contaminating of the DPF substrate with metallic particles when cutting the studs.
- Install the replacement bolts and corresponding nuts into the rear DPF flange.

Part Number	Description	Quantity
N 01024713	Replacement Exhaust Bolt	3
N 91130802	Shouldered Hex Nut	3
