# Emissions Recall

## Code: 23V6

<b>Subject</b>	<b>3.0L TDI Engine Emissions System Modification</b>
<b>Release Date</b>	November 29, 2017
<b>Revision Summary</b>	<b>Updated resale information included.</b>
<b>Affected Vehicles</b>	<p><b>U.S.A.: 2013-2014 MY Volkswagen Touareg 3.0L TDI Generation 2.1</b></p> <p><i>Check Campaigns/Actions screen in Elsa on the day of repair to verify that a VIN qualifies for repair under this action. Elsa is the <u>only</u> valid campaign inquiry &amp; verification source.</i></p> <ul style="list-style-type: none"> <li>✓ Campaign status must show "open."</li> <li>✓ If Elsa shows other open action(s), inform your customer so that the work can also be completed at the same time the vehicle is in the workshop for this campaign.</li> </ul>
<b>Problem Description</b>	3.0L TDI vehicles were equipped with undisclosed Auxiliary Emission Control Devices which are not permitted by emissions regulations.

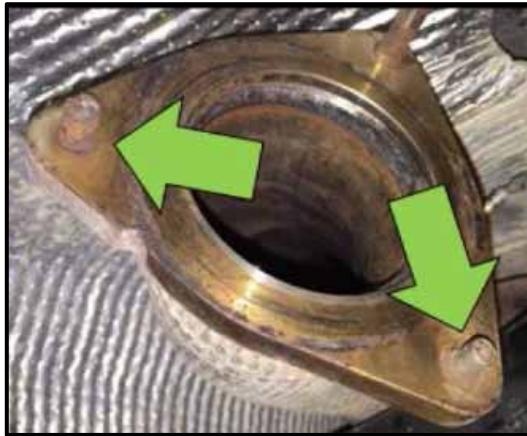
Due to corrosion, one or more of the mounting studs may break <arrows> when removing the SCR catalytic converter from the Diesel Particulate Filter (DPF) flange.

- If stud replacement is necessary, **IT IS REQUIRED** to use a press tool such as the OTC 5057 clevis pin press (or equivalent), or other available screw or hydraulic type clevis/stud press tool to remove all necessary studs from the rear DPF flange.

- It is advised if one stud breaks that all three studs are pressed out and replaced with the bolts/nuts included in the parts kit.
  - Lubricate the OTC 5057 clevis/stud press tool threads and the press pin contact tip with hot bolt paste or anti-sieze lubricant before each use.
