January 2017  
FL722AB  
NHTSA #16V-658  
Transport Canada #16-442

## **Subject: Freightliner Brake Caliper Bolts**

**Models Affected: Specific Freightliner 114SD and Business Class  
M2 vehicles manufactured March 10, 2015, through July 7, 2016.**

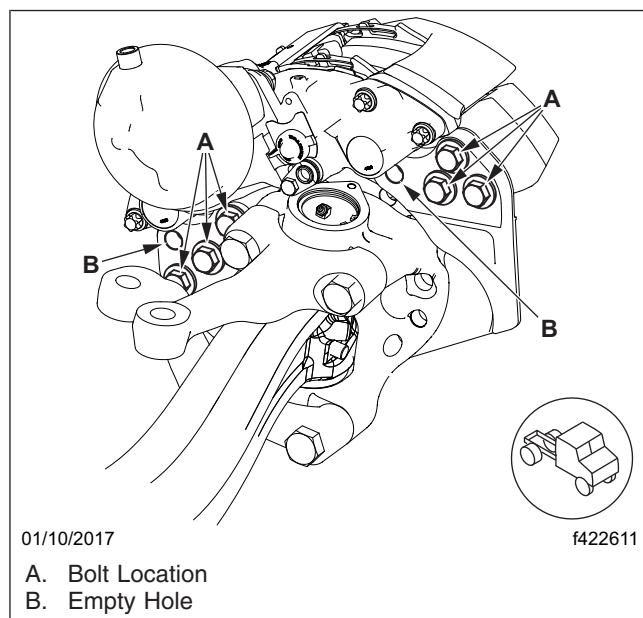
**Fig. 1, Caliper Bolts, Front Axle**

1. Raise the axle being serviced, and support it on a jack stand.
2. Remove the wheels. For instructions, refer to [Group 40](#) of the vehicle's workshop manual.
3. Inspect each brake caliper (front and rear) to make sure the caliper has all six caliper mounting bolts installed, that the bolts are all in the correct locations (see [Fig. 1](#) and [Fig. 2](#)), and that they are not loose.

If any of the bolts are in the wrong position, relocate them to the correct position.

4. Using a 30 mm socket, tighten the six caliper mounting bolts using an inside out torque pattern to  $400 \pm 40$  lbf·ft ( $543 \pm 54$  N·m). Use the special torque adaptor, (p/n 3256B1354), shown in **Table 3** where needed for access to the caliper mounting bolts. When using the special torque adaptor, use the settings shown in **Table 3**, for torque compensation.
