## Service Information Bulletin

SUBJECT	DATE
SPN 3226 (ACM) (EPA10;GHG14)	January 2017

## 2 SPN 3226/FMI 2 - EPA10 - GHG14

Selective Catalyst Reduction Outlet NOx Sensor – Drift

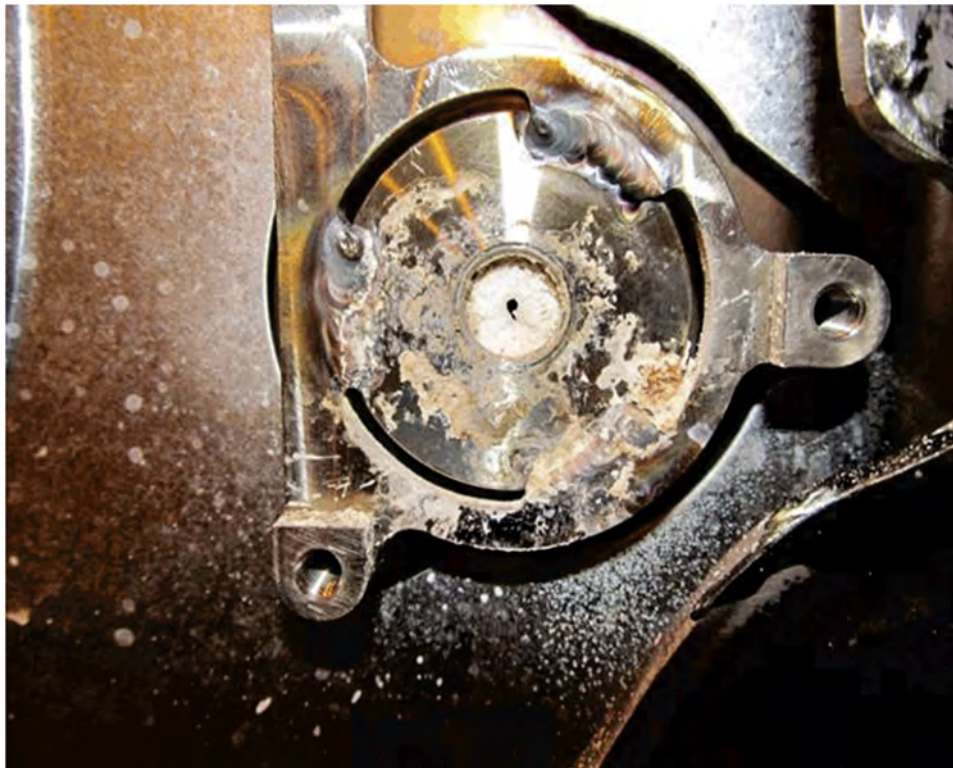
d140642

**Figure 1. Normal DEF Crystallization in the DEF Doser Port Hole**

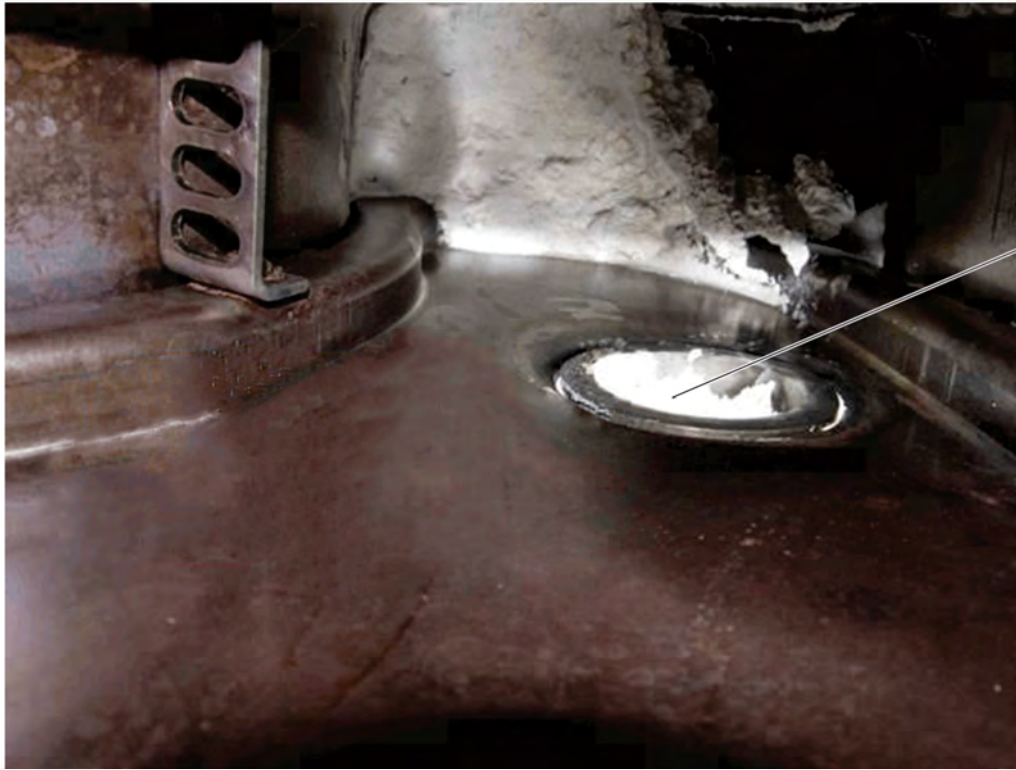
**Normal DEF crystallization inside the SCR mixing chamber.**

Looking inside SCR Mixing Chamber with DPF removed. Note: Doser Port Location

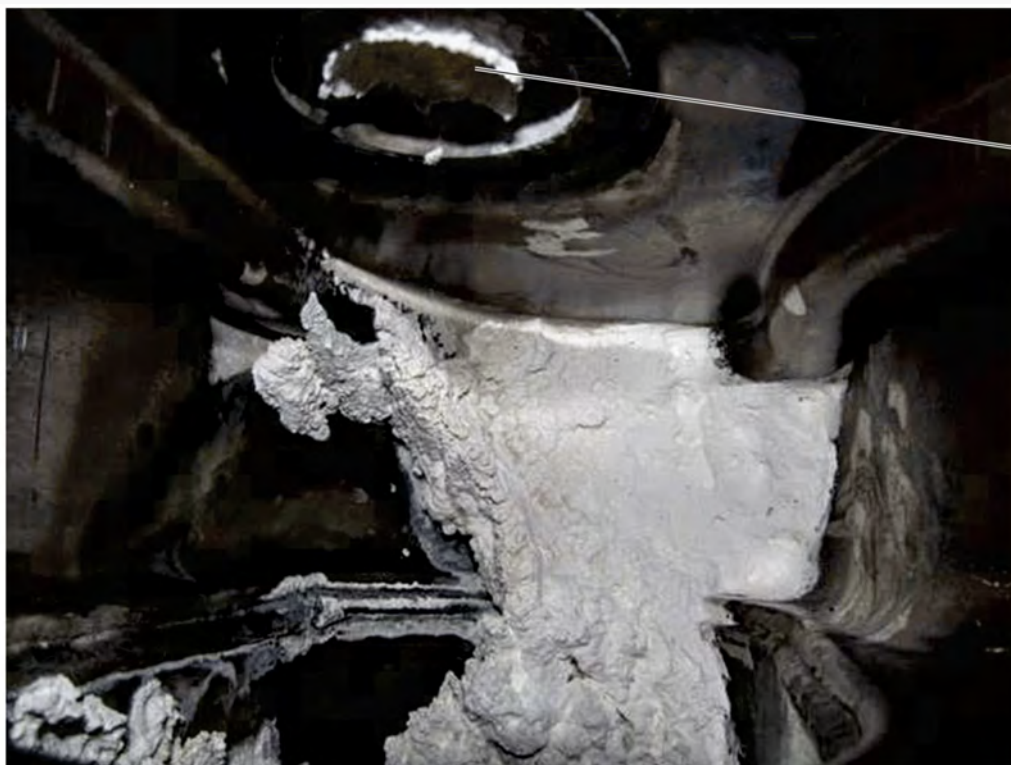
d140644

Normal DEF crystallization inside the SCR mixing chamber.

Doser Port

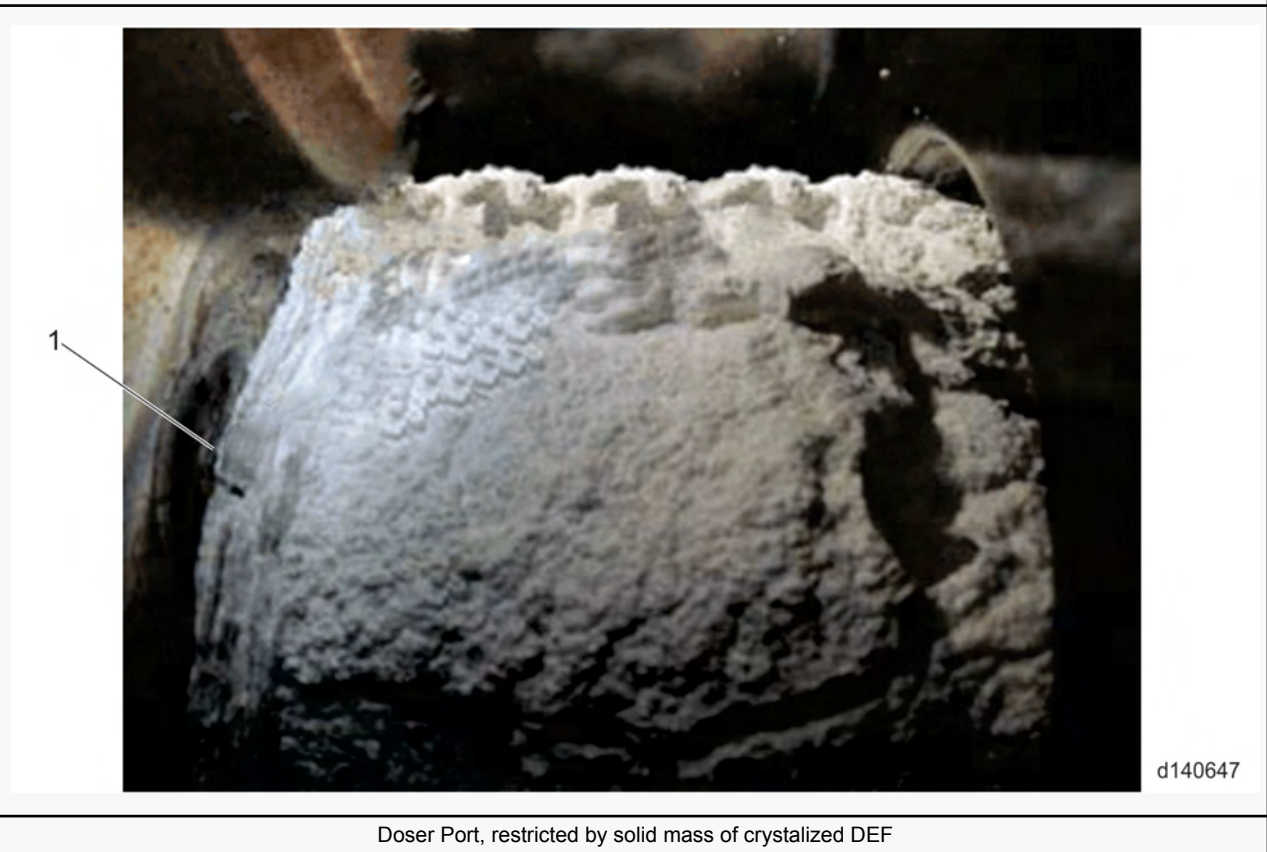
**NOTE: Excessive DEF build-up can cause inaccurate NOx readings. Excessive DEF build-up in the exhaust can be caused by a vehicle with a high speed, high average drive load.**

Doser Port, restricted by solid mass of crystalized DEF

- a. Yes; excessive DEF build-up can cause inaccurate NOx readings. The DEF build-up was cleared during the High Idle Parked Regeneration.  
FOR GHG14 VEHICLES ONLY: DEF build-up in the exhaust can be caused by a vehicle with a high speed, high average drive load.  
Install DEF awning Kit P/N: A0004921911 to help prevent this failure in the future. Refer to section "GHG14 1-BOX™ Diesel Exhaust Fluid (DEF) Awning".
- b. No; replace the SCR outlet NOx sensor.
