# Ferrari North America

## Technical Information

| Bulletin #: | 2437 |

**Model Type:** GTC4 Lusso  
**Model Year:** All  
**Subject:** Replacing internal rear view mirror

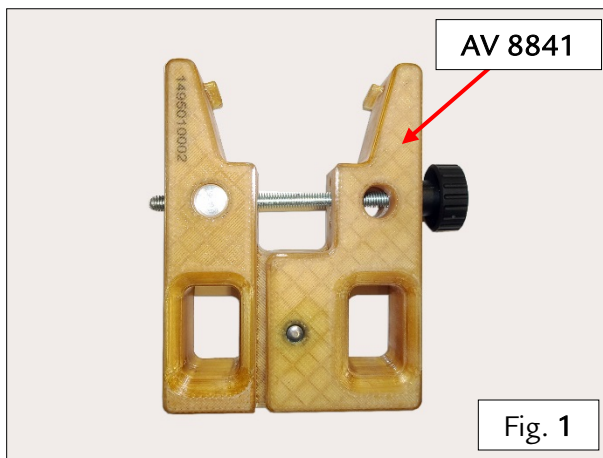
This procedure must be performed using the special tool **AV 8841 (095978841)**, which permits removal of the internal rear view mirror without damaging the windshield – Fig. 1.

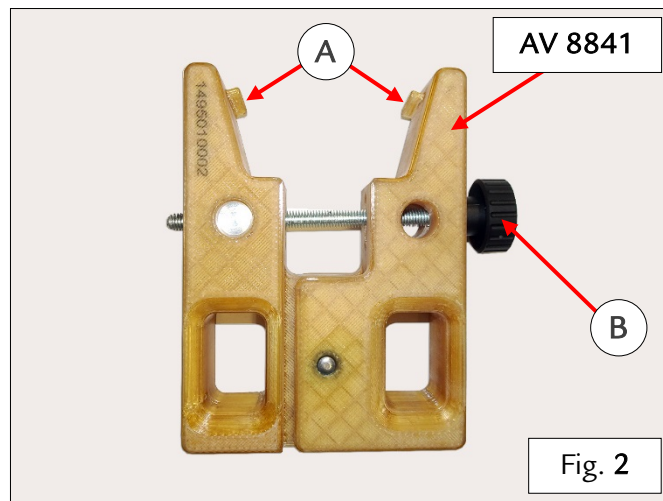
The tool **AV 8841** has two teeth **(A)** which engage in the slots in the rear view mirror cover, and a knob **(B)** for fastening the tool in place – Fig. 2.
